Release Notification and Corrective Action

Name of Company Burlington Resources Oil & Gas Company	Contact Crystal Tafoya
Address 3401 East 30th St, Farmington, NM	Telephone No. (505) 326-9837
Facility Name: Thurston Com 101	Facility Type: Gas Well

**RE: Below Grade Tank Closure Report
Thurston Com #101
San Juan County, New Mexico**

FIGURE 2
AERIAL SITE MAP
BELOW GRADE TANK CLOSURE
JANUARY 2013
 ConocoPhillips
 THURSTON COM #101
 SAN JUAN COUNTY, NEW MEXICO
 NW¼ NW¼, SECTION 31, T31N, R11W
 N36.86106, W108.03651

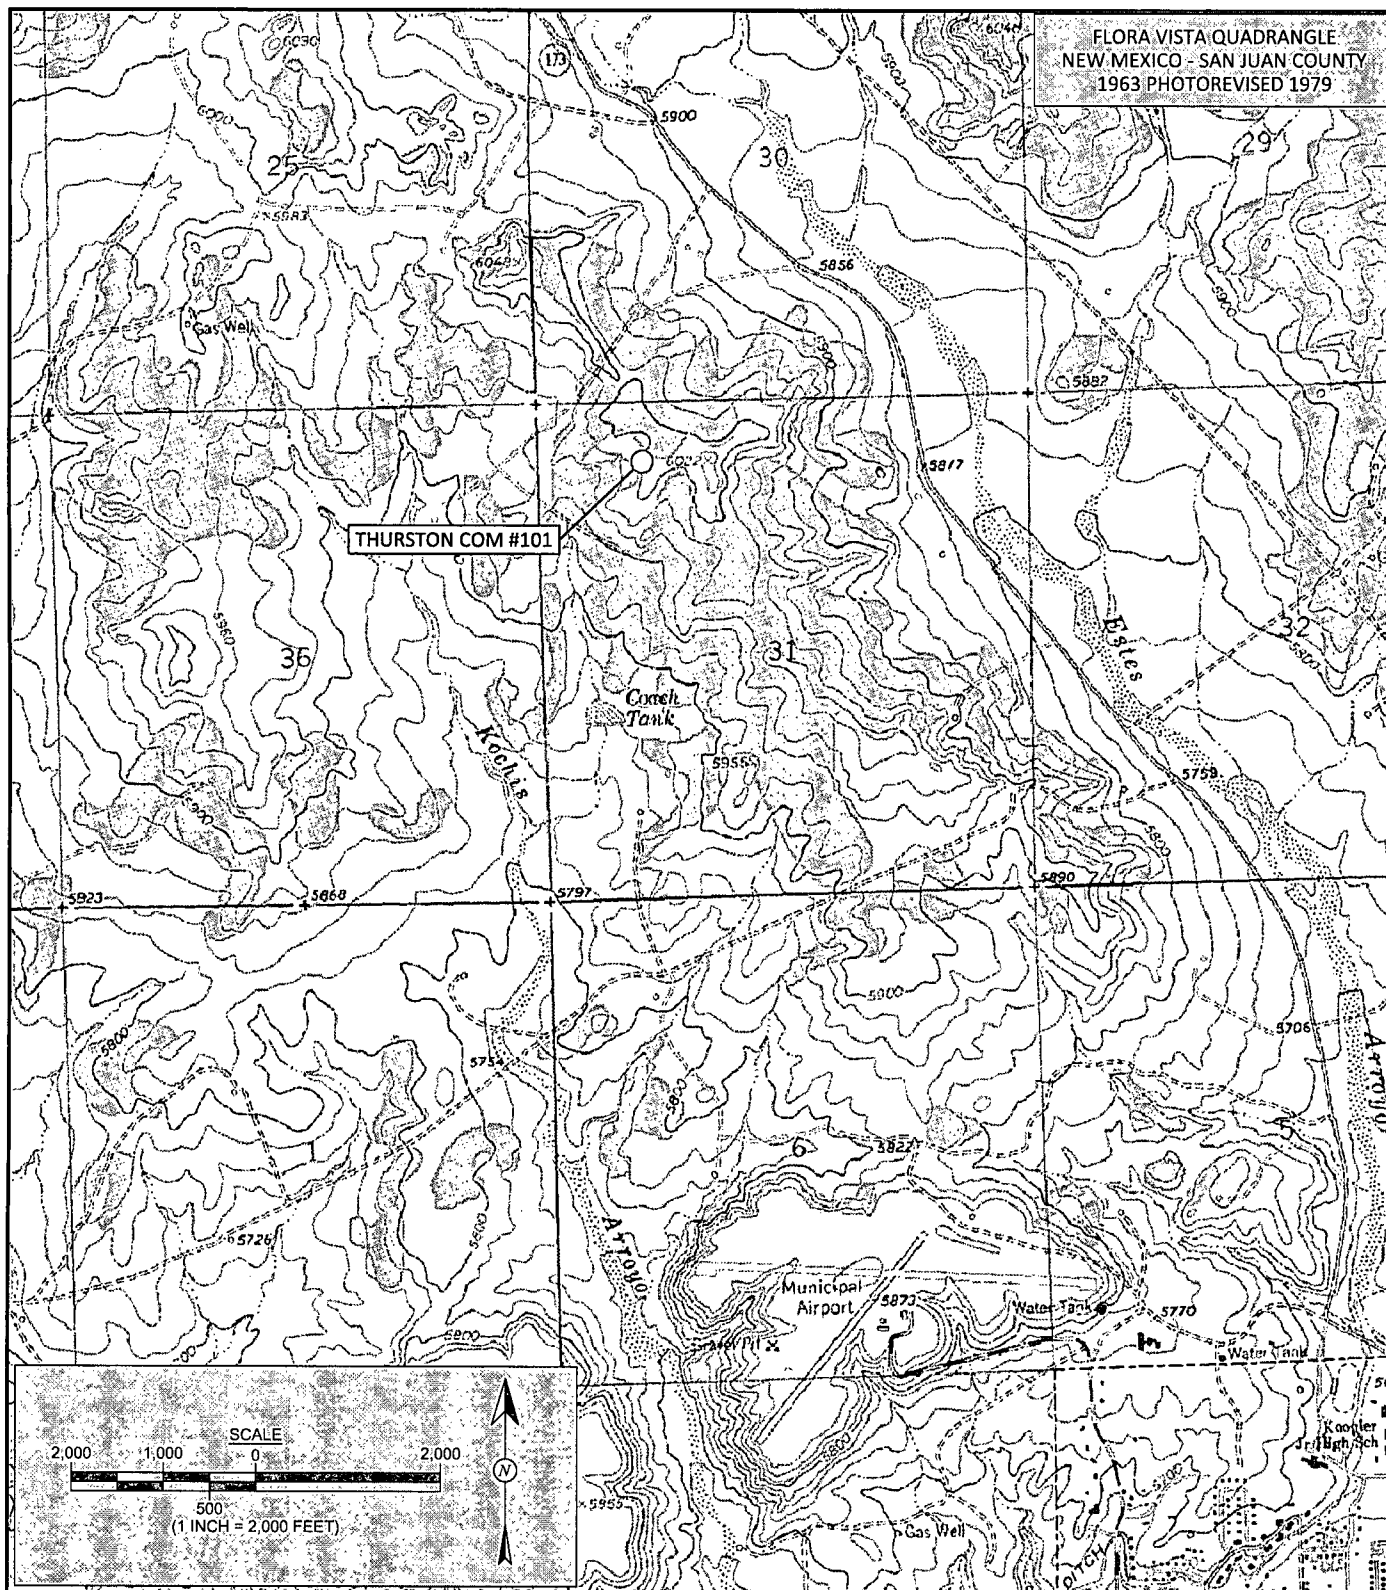
FIGURE 1

TOPOGRAPHIC SITE LOCATION MAP
ConocoPhillips
THURSTON COM #101
SAN JUAN COUNTY, NEW MEXICO
NW¼ NW¼, SECTION 31, T31N, R11W
N36.86106, W108.03651
