## Release Notification and Corrective Action

**RE: SPILL ASSESSMENT DOCUMENTATION FOR THE SAN JUAN 32-9 #228S (hBr) WELL SITE, SAN JUAN COUNTY, NEW MEXICO**

San Juan 32-9 #228S (h8r)  
SECTION 36, TWP 32 NORTH, RANGE 9 WEST  
SAN JUAN COUNTY, NEW MEXICO

Table 1, Summary of Analytical Results  
 ConocoPhillips  
 San Juan 32-9 #228S (hBr)  
 Spill Assessment  
 San Juan County, New Mexico  
 Project Number 92115-2437

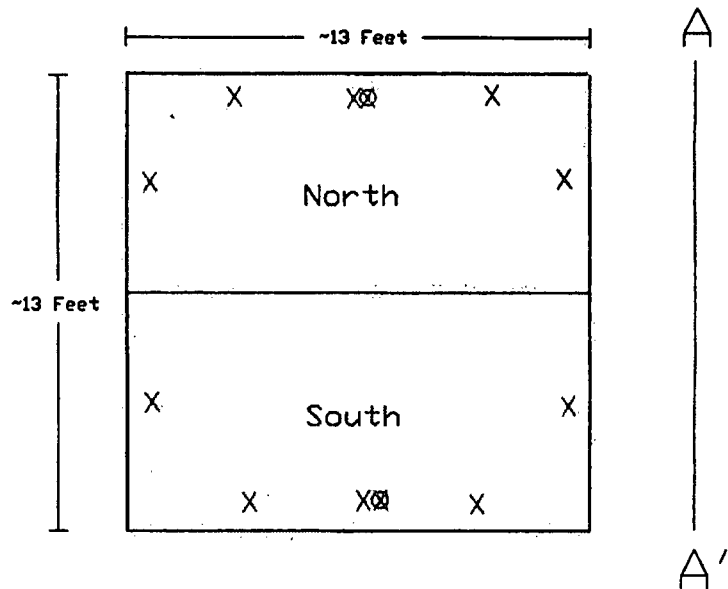
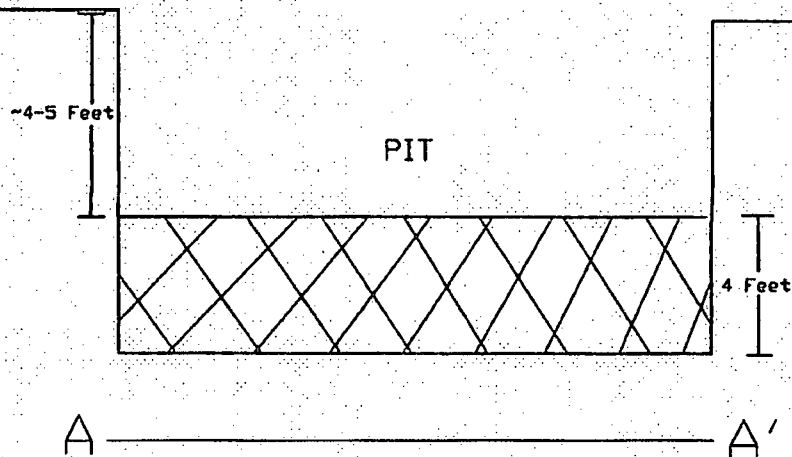
FIGURE NO. 1

## Site Map ConocoPhillips

1 x 2:5-pt. composites

13' x 13'

Envirotech, Inc. made the recommendation to excavate the pit to the dimensions of 13 feet wide by 13 feet long by an additional four (4) feet BGS, followed by additional sampling for closure; see enclosed *Site Map* for contamination extents.
