Release Notification and Corrective Action

**RE: Initial Release Assessment and Final Excavation Report
San Juan 28-4 #27A
Rio Arriba County, New Mexico**

Location - SW¼ SE¼, Section 19, T28N, R4W, Rio Arriba County, New Mexico
Well Head Latitude/Longitude – N36.64183 and W107.28809, respectively
Release Location Latitude/Longitude – N36.64162 and W107.28819, respectively
Land Jurisdiction – U.S. Forest Service
Figure 1. Topographic Site Location Map
Figure 2. Aerial Site Map, February 2013

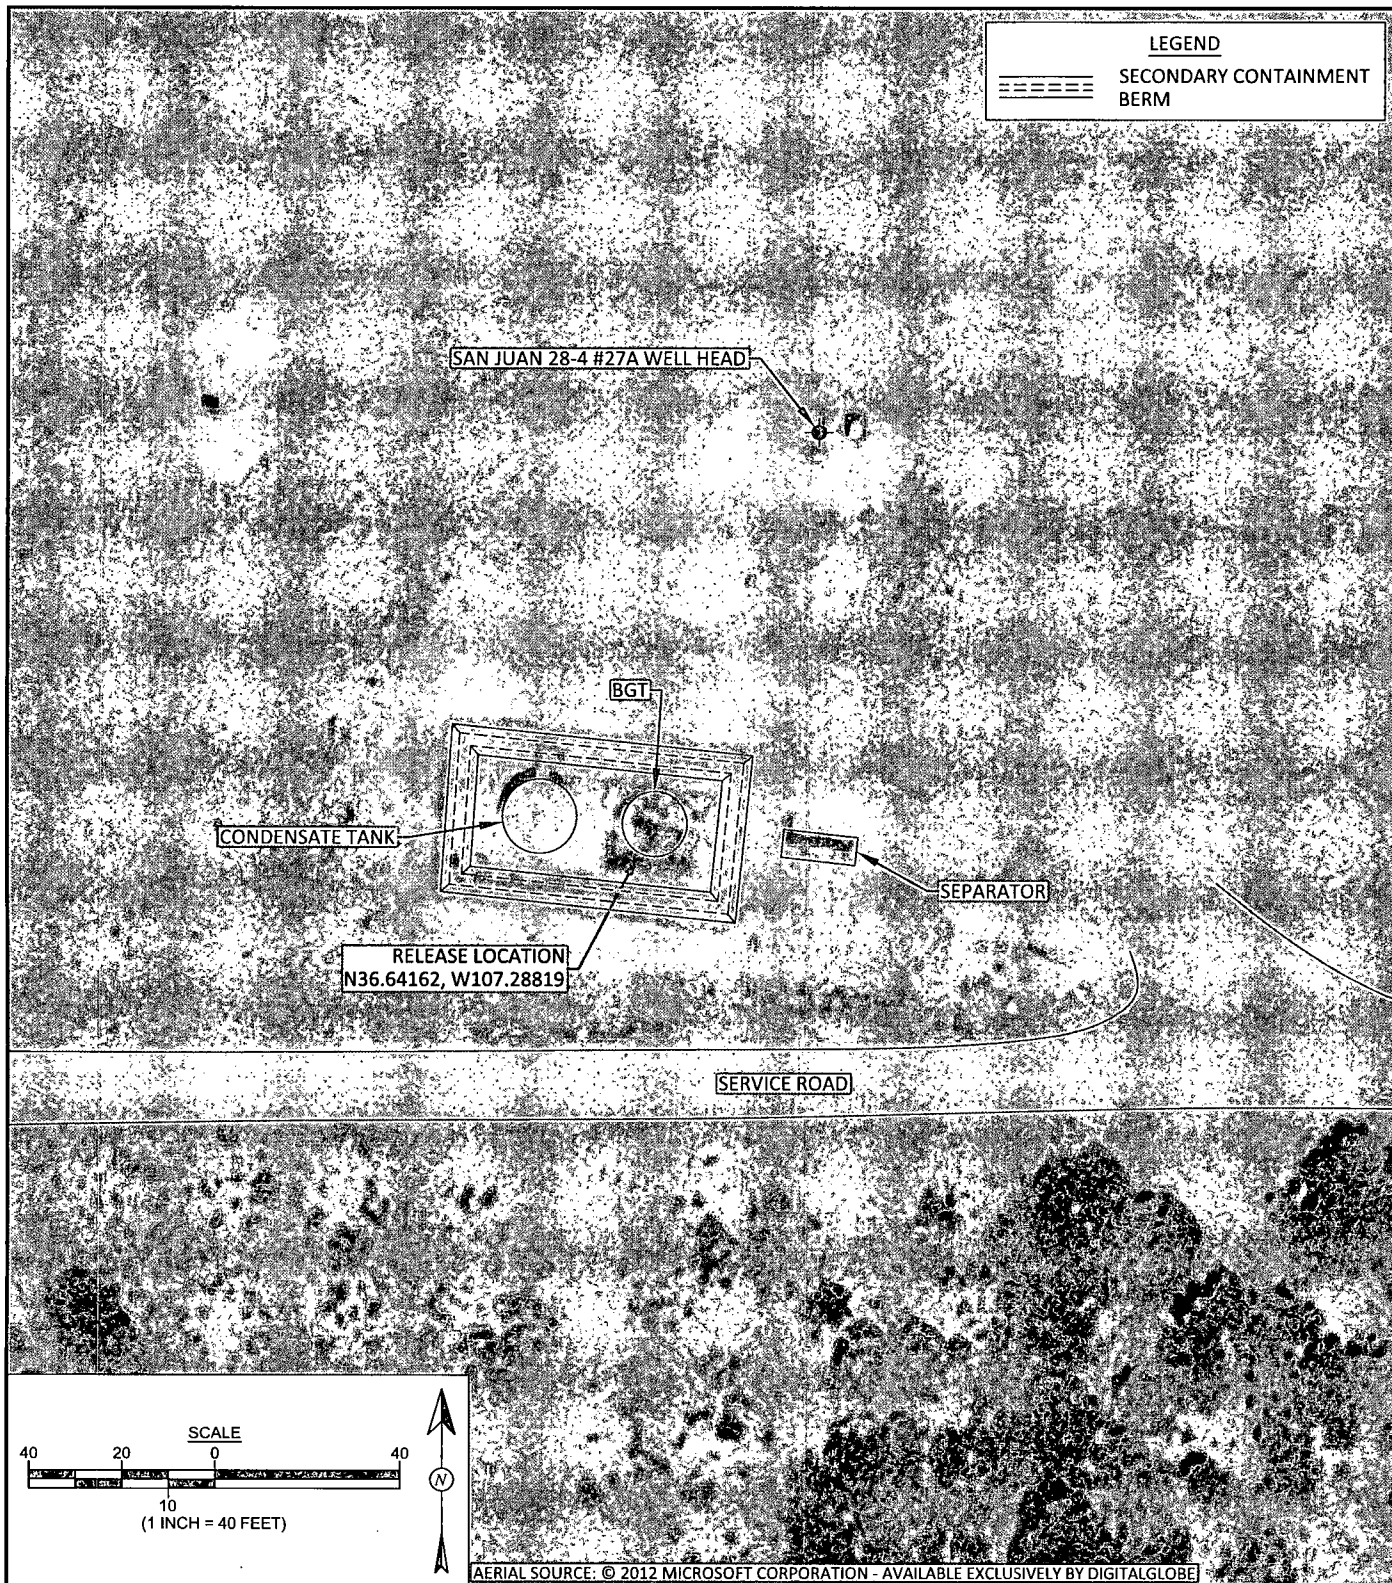
FIGURE 2

AERIAL SITE MAP FEBRUARY 2013

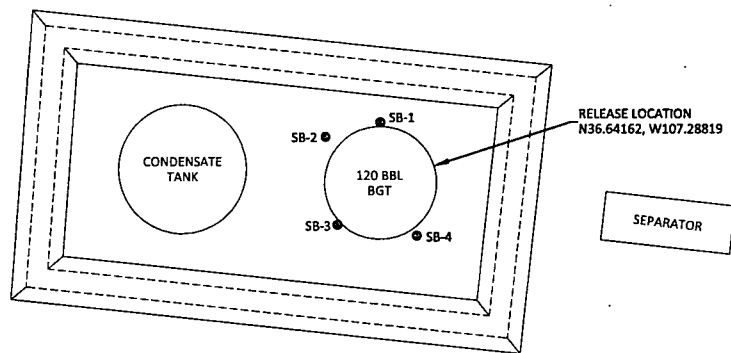
FIGURE 3

AES was initially contacted by Lisa Hunter of CoP on February 18, 2013, and on February 21, 2013, Heather Woods and Corwin Lameman of AES completed the release assessment field work. The assessment included collection and field screening of 12 soil samples from four soil borings (SB-1 through SB-4). Based on field screening results, AES recommended excavation of the release area. Sample locations are shown on Figure 3.

On February 21, 2013, initial assessment field screening readings for VOCs via OVM ranged from 4.0 ppm in SB-1 up to 2,492 ppm in SB-3. Field TPH concentrations ranged from less than 20.0 mg/kg in SB-1 to greater than 5,000 mg/kg in SB-3.

Field Screening Results				
Sample ID	Date	Depth (ft)	QVM-PID (ppm)	TPH (mg/kg)
NMOCD ACTION LEVEL			100	1,000
SB-1	2/21/13	Surface	4.0	<20.0
SB-2	2/21/13	Surface	1,561	>2,500
SB-3	2/21/13	Surface	1,901	NA
		2	1,979	NA
		3.5	2,492	>5,000
SB-4	2/21/13	Surface	1,463	NA
		2	524	NA
		4	1,930	NA
		6	2,118	NA
		8	2,359	NA
		10	1,540	NA
		12	2,091	>2,500

INITIAL ASSESSMENT SAMPLE
LOCATIONS AND RESULTS
FEBRUARY 2013
ConocoPhillips
SAN JUAN 28-4 #27A
SW¼ SE¼, SECTION 19, T28N, R4W
RIO ARriba COUNTY, NEW MEXICO
N36.64183, W107.28809

On February 21, 2013, AES conducted an initial assessment associated with a release from the onsite below grade tank at the San Juan 28-4 #27A. Action levels for releases are determined by the NMOCD ranking score per *NMOCD Guidelines for Leaks, Spills, and Releases* (August 1993), and the site was assigned a rank of 10. Field screening results above the NMOCD action levels of 100 ppm VOCs and 1,000 mg/kg TPH were reported in SB-2 through SB-4. The highest VOC concentration was 2,492 ppm in SB-3, and the highest TPH concentration was reported as greater than 5,000 mg/kg in SB-3.

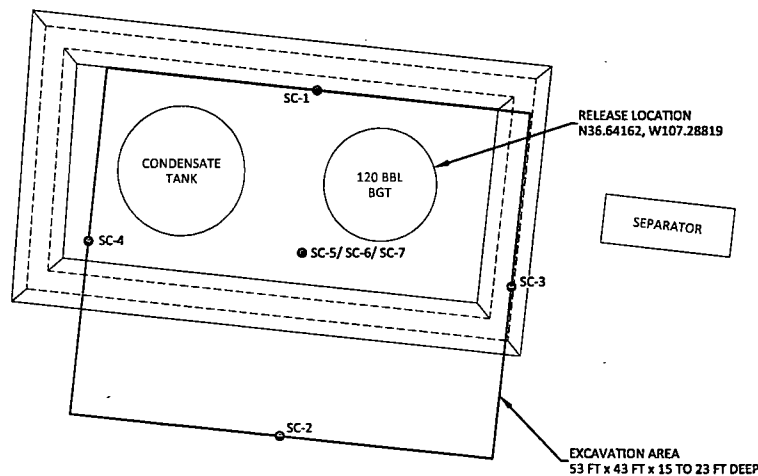
FIGURE 4

On April 23, 2013, AES returned to the location to collect confirmation soil samples of the excavation. The field screening activities included collection of five confirmation soil samples (SC-1 through SC-5) of the walls and base of the excavation. The excavation was approximately 53 feet by 43 feet by 15 feet in depth. While on site, AES identified an area of concern near soil sample SC-5 where visible soil contamination was observed and confirmed during field screening. The excavation was extended to a depth of 18 feet, and on April 25, 2013, AES returned to collect soil sample SC-6. Based on field screening and laboratory analytical results, further excavation was recommended. The final depth of the excavation was determined by a competent sandstone layer encountered at 23 feet bgs. Sample SC-7 was collected from the base of the excavation on April 29, 2013. The final excavation was approximately 53 feet by 43 feet by 23 feet in depth. Sample locations and final excavation extents are shown on Figure 4.

In April 2013, laboratory analytical results for SC-1 through SC-4, SC-6, and SC-7 were used to confirm field screening results from excavation activities. Benzene concentrations ranged from less than 0.50 mg/kg in SC-1 through SC-4 and SC-7 up to 0.29 mg/kg in SC-6. BTEX concentrations ranged from 0.25 mg/kg in SC-3 up to 60 mg/kg in SC-6. TPH concentrations (as GRO/DRO) were reported at 2,300 mg/kg (SC-6) and 1,450 mg/kg (SC-7). Results are presented in Table 2 and on Figure 4. Laboratory analytical reports are attached.

Field Screening Results				
Sample ID	Date	Depth (ft)	OVM-PID (ppm)	TPH (mg/kg)
NMOCD ACTION LEVEL			100	1,000
SC-1	4/23/13	1 to 15	502	967
SC-2	4/23/13	1 to 15	259	158
SC-3	4/23/13	1 to 15	284	50.6
SC-4	4/23/13	1 to 15	540	114
SC-5	4/23/13	15	3,360	>2,500
SC-6	4/25/13	18	3,045	3,040
SC-7	4/29/13	23	2,218	2,680

Laboratory Analytical Results						
Sample ID	Date	Depth (ft)	Benzene (mg/kg)	Total BTEX (mg/kg)	TPH - GRO (mg/kg)	TPH - DRO (mg/kg)
NMOCD ACTION LEVEL			10	50	1,000	
SC-1	4/23/13	1 to 15	<0.50	4.7	NA	NA
SC-2	4/23/13	1 to 15	<0.050	2.1	NA	NA
SC-3	4/23/13	1 to 15	<0.050	0.25	NA	NA
SC-4	4/23/13	1 to 15	<0.50	1.7	NA	NA
SC-6	4/25/13	18	0.29	60	900	1,400
SC-7	4/29/13	23	<0.50	23	350	1,100

FINAL EXCAVATION SAMPLE LOCATIONS AND RESULTS
APRIL 2013
 ConocoPhillips
 SAN JUAN 28-4 #27A
 SW¼ SE¼, SECTION 19, T28N, R4W
 RIO ARriba COUNTY, NEW MEXICO
 N36.64183, W107.28809

On April 23, April 25, and April 29, 2013, final assessment of the excavation area was completed. Field screening results of the excavation extents showed that VOC concentrations exceeded the NMOC action level of 100 ppm for VOCs in all of the final four walls and the base. Field TPH concentrations above the applicable NMOCD action level of 1,000 mg/kg were reported in base samples SC-5 (>2,500 mg/kg), SC-6 (3,040

mg/kg), and SC-7 (2,680 mg/kg). Laboratory analytical results from April 23, 2013, reported benzene and total BTEX concentrations below NMOCD action levels in all of the final four walls. TPH concentrations as GRO/DRO were reported above the NMOCD action level of 1,000 mg/kg in SC-7, the final base sample, with 1,450 mg/kg. Continued excavation was not possible due to the presence of a competent sandstone layer at 23 feet bgs.

Based on final field screening and laboratory analytical results of the excavation of petroleum contaminated soils at the San Juan 28-4 #27A, benzene, total BTEX, and TPH concentrations were below applicable NMOCD action levels for each of the sidewalls of the excavation. However, the base of the excavation exceeded the applicable NMOCD action level for TPH. On April 30, 2013, Lisa Hunter of CoP received approval to backfill the excavation from Brandon Powell, NMOCD; J.J. Miller, U.S. Forest Service; and Mark Kelly, BLM. On May 1, 2013, the excavation was subsequently backfilled. No further work is recommended at the San Juan 28-4 #27A.
