Release Notification and Corrective Action

Name of Company ConocoPhillips Company	Contact Lisa Hunter
Address 3401 East 30th Street, Farmington, NM	Telephone No. 505-326-9786
Facility Name Hammond WN Federal 7A	Facility Type Gas Well

**RE: Initial Release Assessment and Final Excavation Report
Hammond WN Federal #7A
San Juan County, New Mexico**

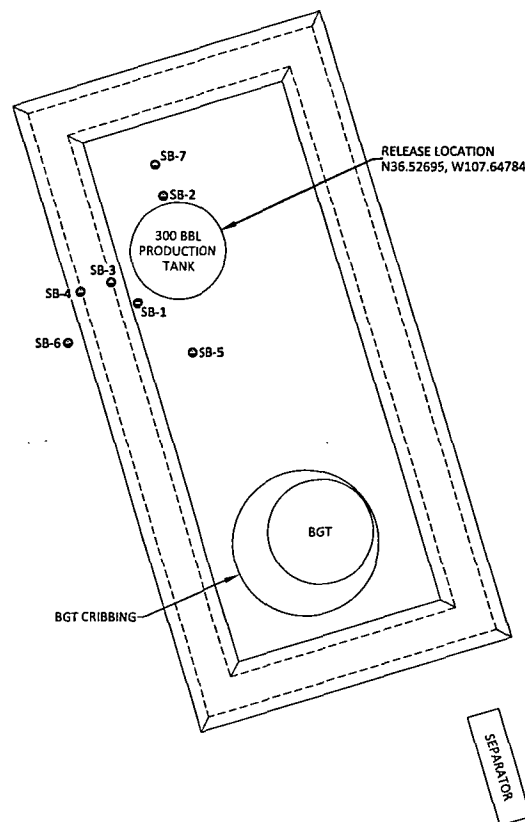
FIGURE 3

AES was initially contacted by Lisa Hunter of CoP on March 25, 2013, and on the same day, Heather Woods and Kelsey Christiansen of AES completed the release assessment field work. The assessment included collection and field screening of 12 soil samples from 7 soil borings (SB-1 through SB-7). Soil borings were terminated between 1 and 1.5 feet at a shale layer. Based on field screening results, AES recommended excavation of the release area. Sampling locations are shown on Figure 3.

On March 25, 2013, initial assessment field screening results for VOCs via OVM ranged from 0.0 ppm in SB-2 and SB-4 through SB-7 up to 1,889 ppm in SB-1. Field TPH concentrations ranged from 31.7 mg/kg in SB-6 up to greater than 10,000 mg/kg in SB-1.

Field Screening Results				
Sample ID	Date	Depth (ft)	OVM-PID (ppm)	TPH (mg/kg)
NMOCD ACTION LEVEL			100	100
SB-1	3/25/13	0.5	0.0	124
SB-2	3/25/13	Surface	0.0	NA
		0.5	0.0	NA
SB-3	3/25/13	0.5	647	NA
		1.5	1,491	3,260
SB-4	3/25/13	Surface	0.0	NA
		1	187	2,780
SB-5	3/25/13	Surface	0.0	41.4
		1	0.0	NA
SB-6	3/25/13	Surface	0.0	31.7
		1	0.0	NA
SB-7	3/25/13	0.5	0.0	58.2
NA - NOT ANALYZED

INITIAL ASSESSMENT SAMPLE LOCATIONS AND RESULTS MARCH 2013

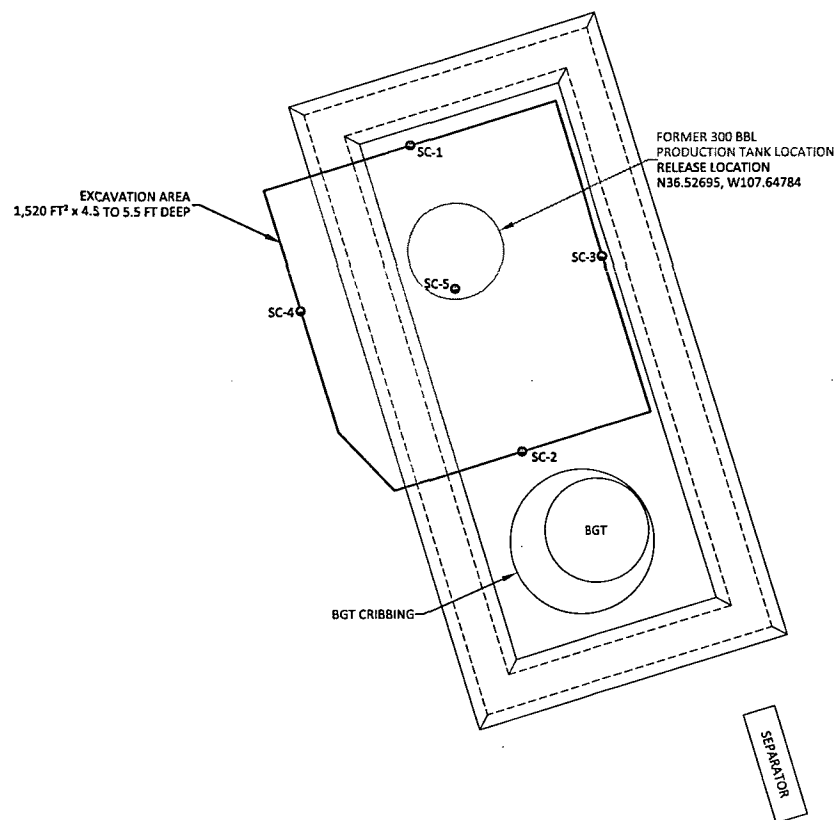
FIGURE 4

On March 28, 2013, AES returned to the location to provide excavation guidance, and AES again returned to the location on April 11, 2013, to collect confirmation soil samples of the excavation. On April 11, 2013, the field screening activities included collection of five confirmation soil samples (SC-1 through SC-5) of the walls and base of the excavation. The area of the final excavation was approximately 1,520 square feet by 4.5 to 5.5 feet in depth. Note that excavation depth was limited by a sandstone layer at 4.5 to 5.5 feet bgs. Sample locations and final excavation extents are shown on Figure 4.

On April 11, 2013, final excavation field screening results for VOCs via OVM showed concentrations ranging from 3.8 ppm in SC-1 and SC-4 to 15.8 ppm in SC-5. Field TPH concentrations ranged from 24.7 mg/kg in SC-3 up to 209 mg/kg in SC-5. Results are included below in Table 1 and on Figures 3 and 4. The AES Field Screening Reports are attached.

Field Screening Results				
Sample ID	Date	Depth (ft)	OVM-PID (ppm)	TPH (mg/kg)
NMOCD ACTION LEVEL			100	100
SC-1	4/11/13	1 to 4.5	3.8	91.1
SC-2	4/11/13	1 to 4.5	5.3	178
SC-3	4/11/13	1 to 4.5	4.9	24.7
SC-4	4/11/13	1 to 4.5	3.8	27.4
SC-5	4/11/13	5.5	15.8	209
ALL SAMPLES ARE 5-POINT COMPOSITES.

Laboratory Analytical Results				
Sample ID	Date	Depth (ft)	TPH - GRO (mg/kg)	TPH - DRO (mg/kg)
NMOCD ACTION LEVEL			100	
SC-2	4/11/13	1 to 4.5	<5.0	66
SC-5	4/11/13	5.5	<5.0	99
ALL SAMPLES WERE ANALYZED PER EPA METHOD 8015B.

**FINAL EXCAVATION SAMPLE
LOCATIONS AND RESULTS
APRIL 2013**
ConocoPhillips
HAMMOND WN FEDERAL #7A
NE¼, SE¼, SECTION 35, T27N, R8W
SAN JUAN COUNTY, NEW MEXICO
N36.52680, W107.64756

Based on the final field screening and laboratory analytical results of the excavation of petroleum contaminated soils at the Hammond WN Federal #7A, VOCs and TPH concentrations were reported below applicable NMOCD action levels. No further work is recommended.
