1. Operator: NM&O Operating Company OGRID #: 15938
Address: 320 S. Boston, Ste. 2000, Tulsa, OK. 74103
Facility or well name: Rucker Lake #2 SWD
API Number: 30-039-23231 OCD Permit Number:
U/L or Qtr/Qtr K Section 24 Township 25N Range 2W County: Rio Arriba
Center of Proposed Design: Latitude Longitude NAD: 192
Surface Owner: Federal State XPrivate Tribal Trust or Indian Allotment

NM&O OPERATING COMPANY
BELOW-GRADE TANK CLOSURE PLAN

Lease Name: Rucker Lake #2 SWD

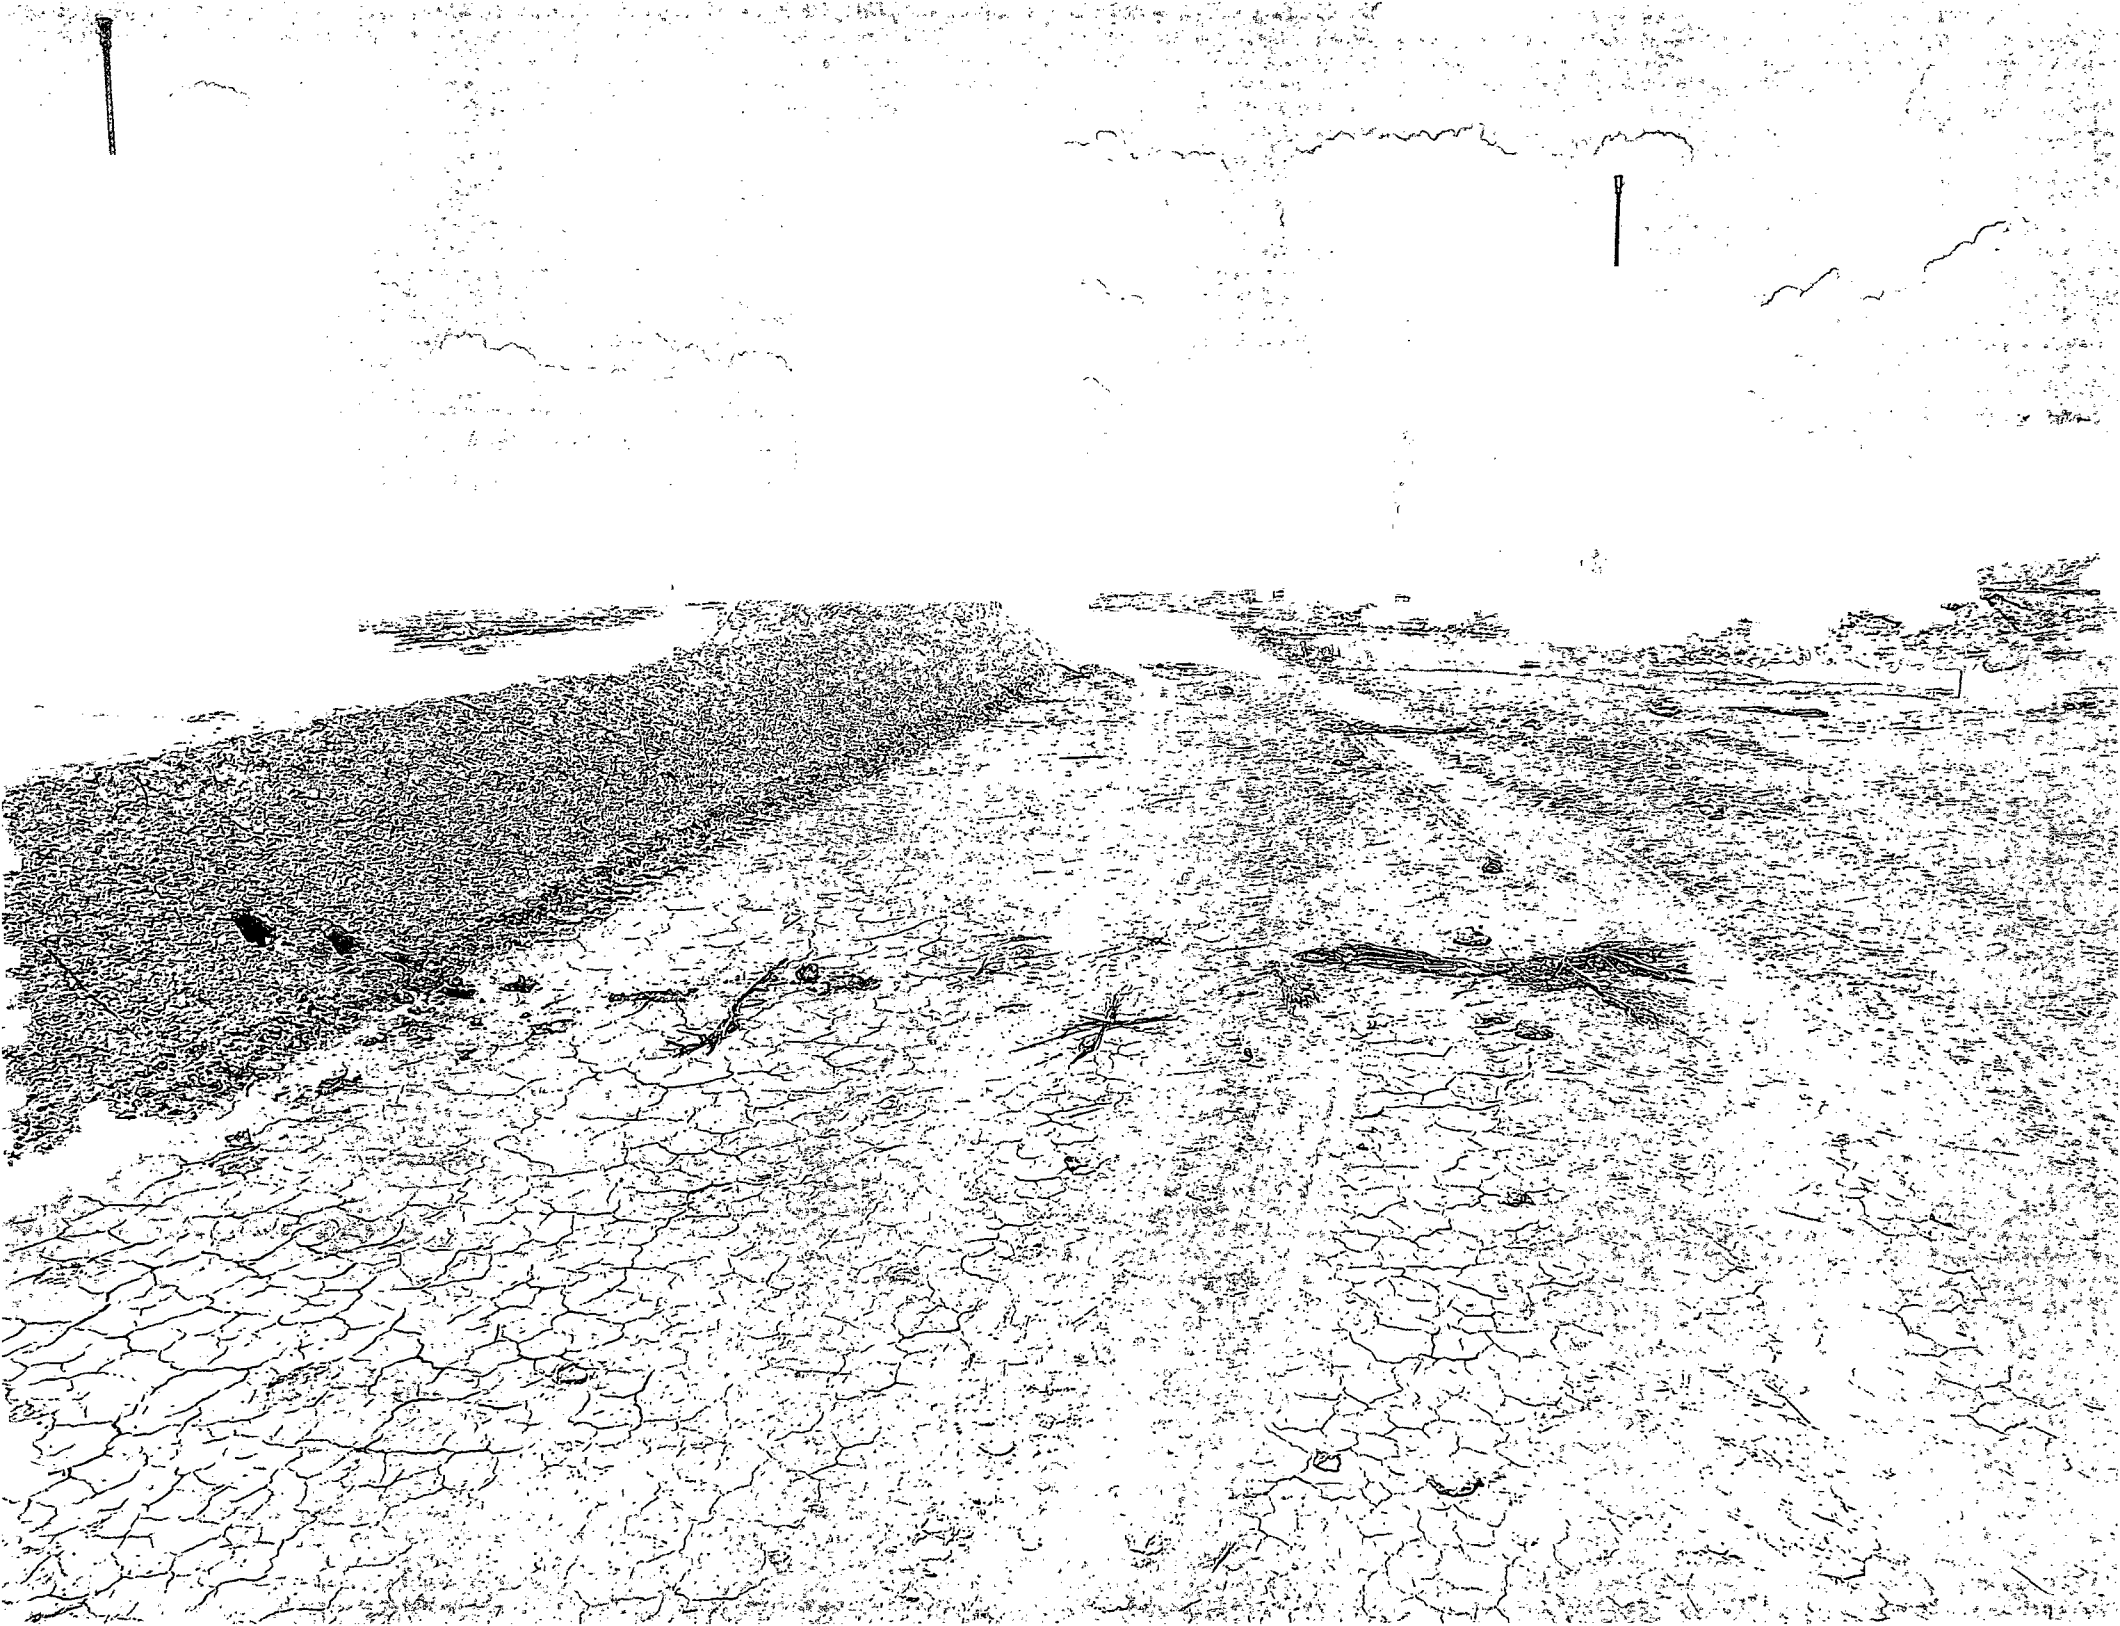
5. Mr. Jonathan Kelly of the disriect office was notified on or around May 30, 2013.
6. The location has been recontoured to match the fit, shape, line form and texture of the surrounding area. Re-shaping include damage conrrol, prevent ponding and prevent erosion. The final re-contour has a uniform appearance with smooth surface, fitting the natural landscape.

7. The excavations have been backfilled with fresh dirt meeting the requirementf of the NMOCD.
8. No vegetation was included in the leak, no re-seeding necessary.
