Release Notification and Corrective Action

Enterprise Products
Newsom B#8 Meter Run Release
Latitude North 36.512099, Longitude West -107.716951
SE1/4, SE1/4 Section 6 T26N R8W
San Juan County, New Mexico

**RELEASE &
REMEDATION REPORT**

NEWSOM B#8 WELL SITE

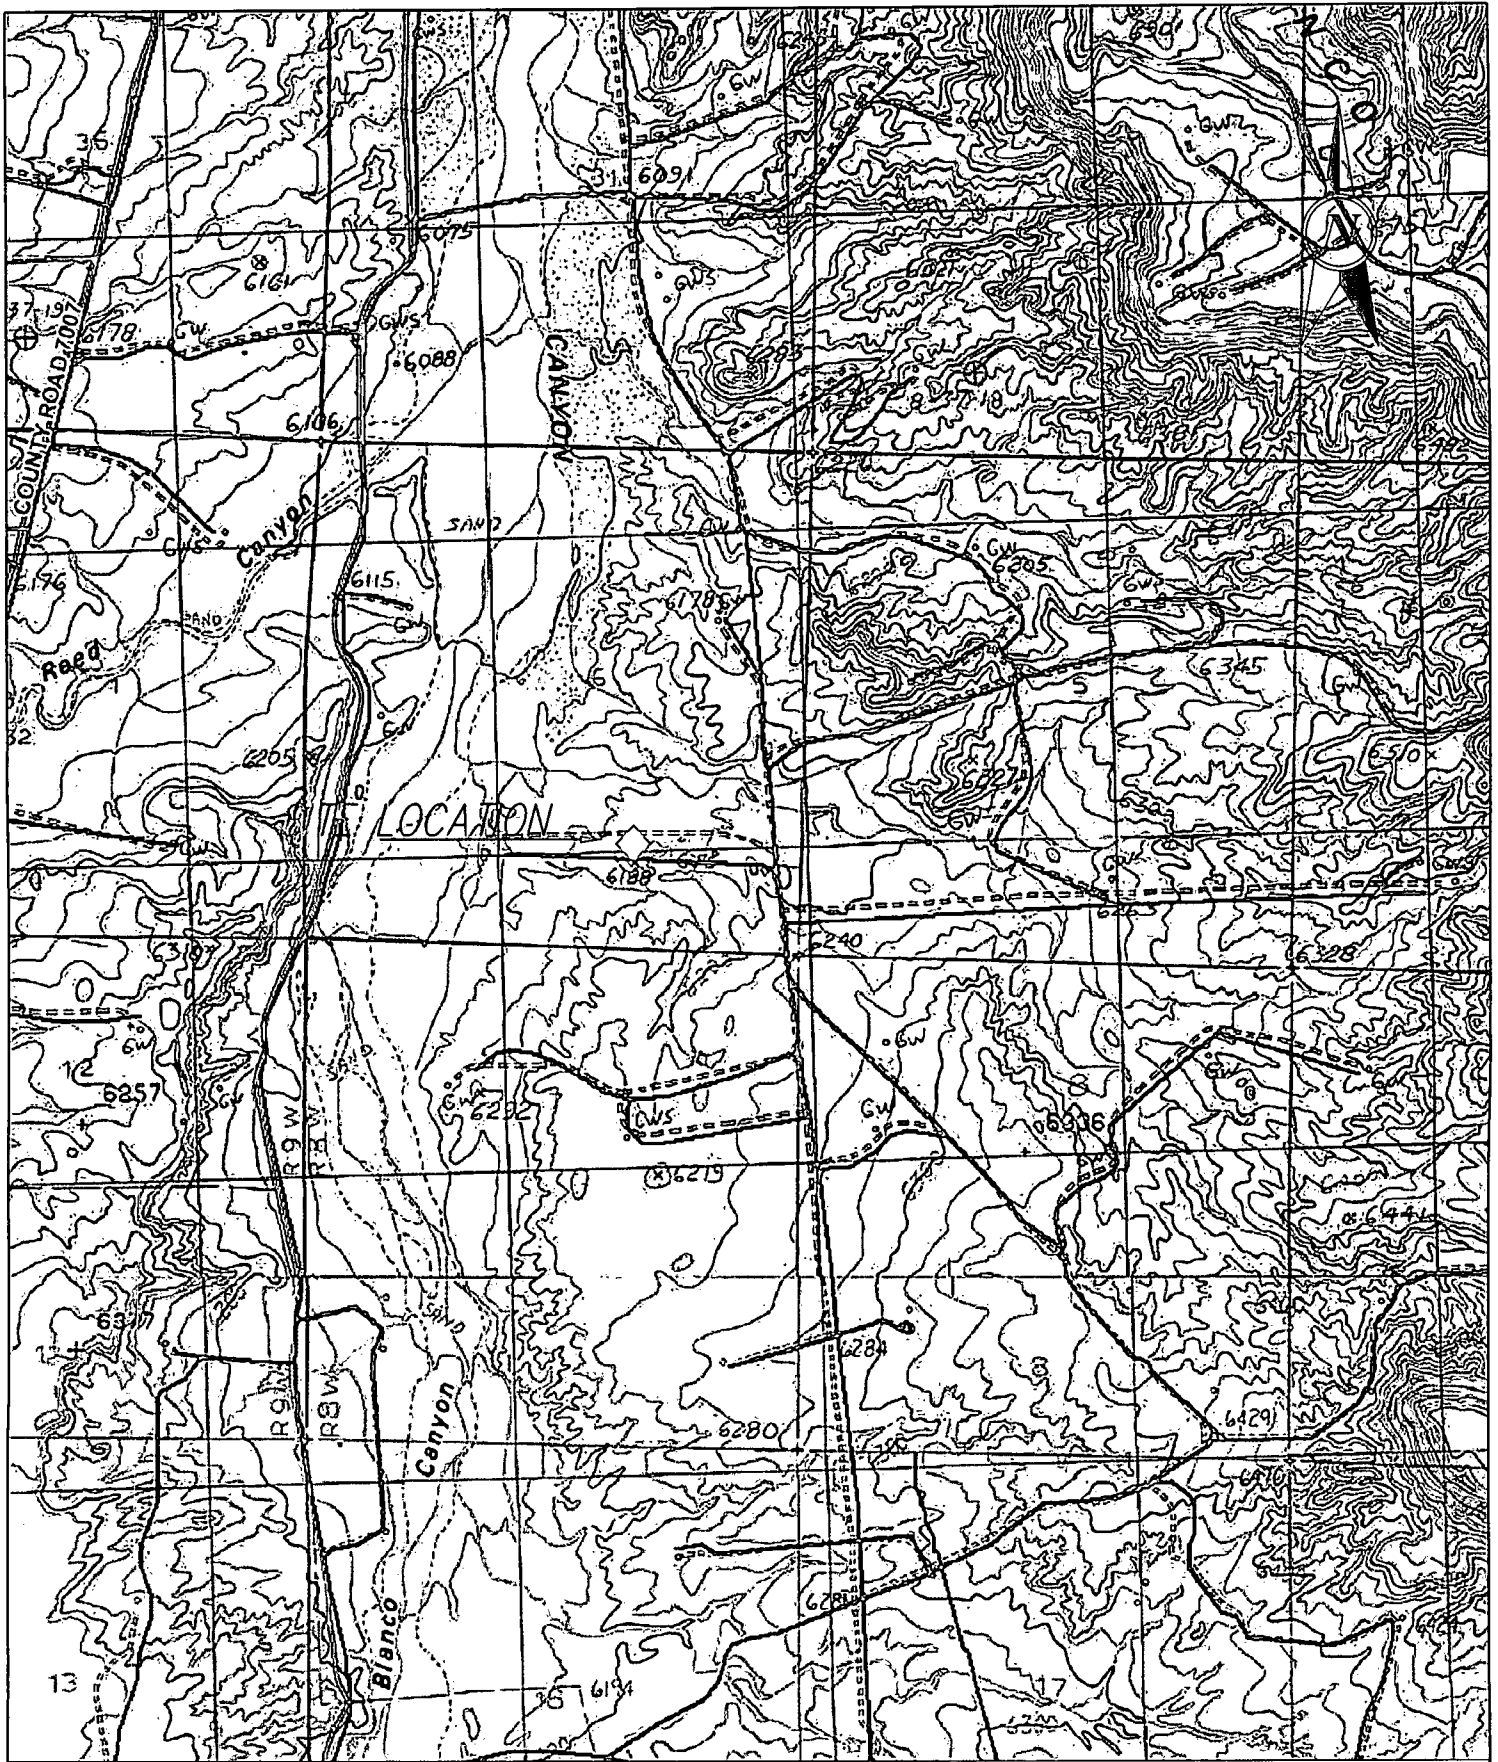
APPROVED: RSA	DATE: 11/12/2012
DRAWN BY: TLONG	DATE: 11/12/2012
REVISIONS BY:	DATE:
PROJECT # 5122104	FIGURE: 1

On behalf of Enterprise Products Operating, LLC. (Enterprise), SMA has prepared this report that describes remediation of a hydrocarbon release associated with the Newsom B#8 well site. The Newsom B#8 well site release was a result of a leaking valve on the upstream side of the meter house. The release was reported on October 31, 2012. The well site is located in Unit P (SE ¼, SE ¼) Section 6, Township 26 North, Range 8W, 36.512099, -107.716951, San Juan County, New Mexico. Figure 1, Vicinity Map, illustrates the location of the release.

VICINITY MAP
NEWSOM B#8 RELEASE SITE
SE 1/4 SE 1/4 SECTION 6 T26N R8W
SAN JUAN COUNTY, NEW MEXICO

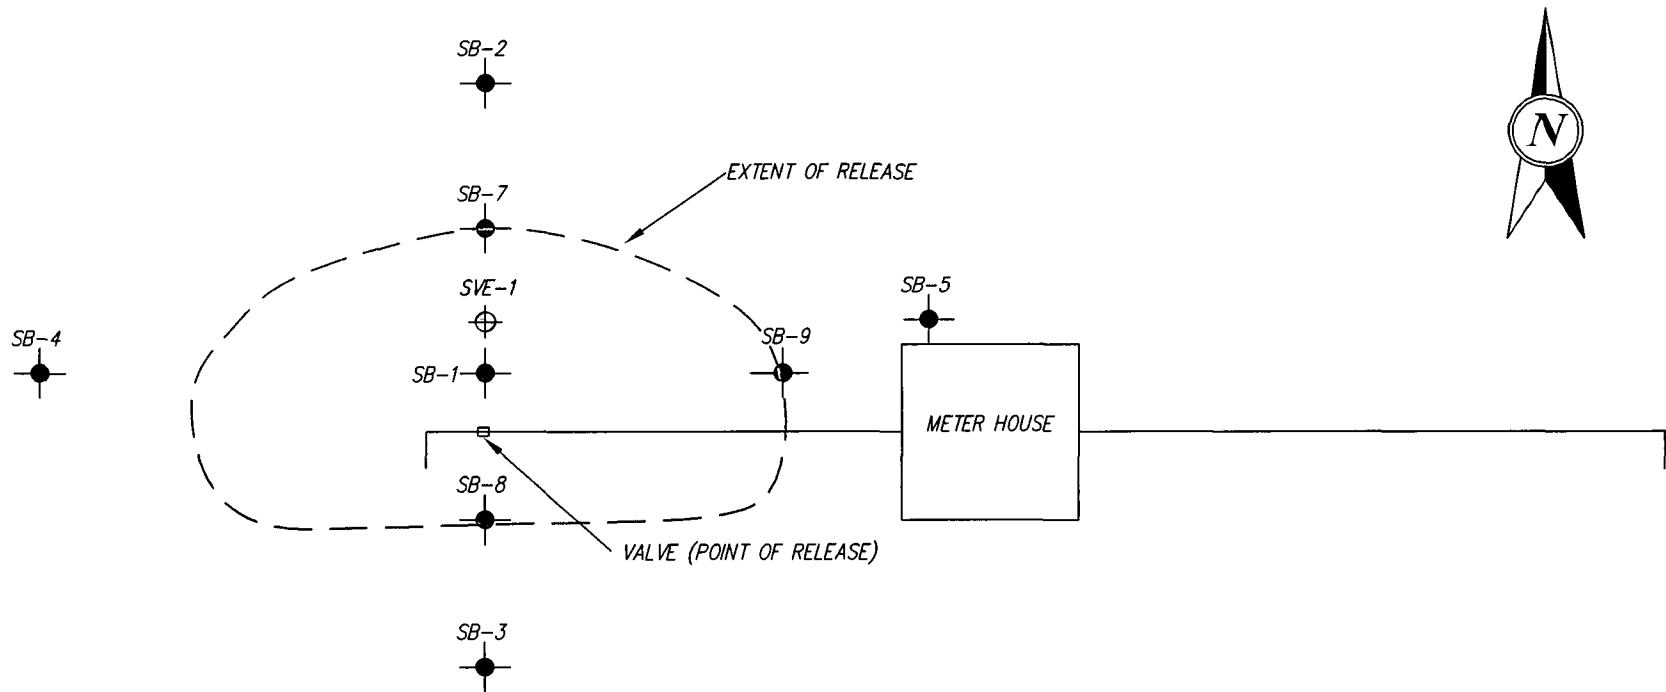
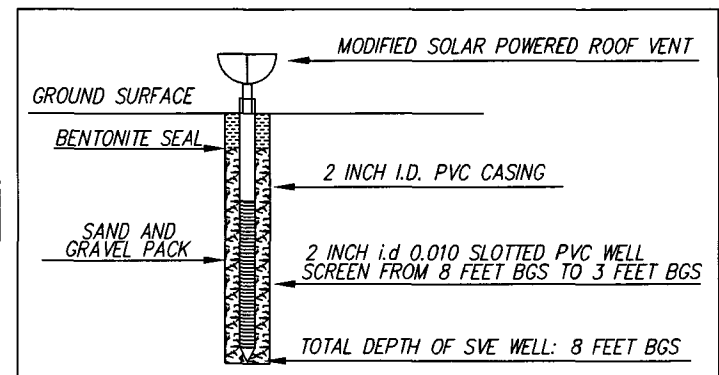
FIGURE: 2

Site Activities: On November 28, 2012, SMA installed a soil vapor extraction (SVE) well near the point of release. The SVE well was installed to a total depth of eight feet below ground surface (bgs). The well was constructed with two-inch inside diameter 0.010 inch slotted PVC well screen from total depth to three feet bgs and three feet of two-inch inside diameter blank PVC well casing. The annulus was backfilled with sand and gravel to approximately one foot bgs. Then 3/8" bentonite chips were placed from one foot bgs to ground surface and hydrated to seal the annulus.

A modified solar powered roof vent was installed on the SVE well to actively remediate the subsurface hydrocarbon contamination. Initial hydrocarbon vapor concentrations were approximately 62 parts per million. An additional one cubic foot of contaminated soil was removed from the surface of the site and transported to an offsite soil disposal bin.

SOIL VAPOR EXTRACTION REMEDIATION SYSTEM DIAGRAM

SITE MAP AND SOIL VAPOR EXTRACTION
 REMEDIATION SYSTEM DIAGRAM
 NEWSOM B#8 RELEASE SITE
 SE 1/4 SE 1/4 SECTION 6 T26N R8W
 SAN JUAN COUNTY, NEW MEXICO

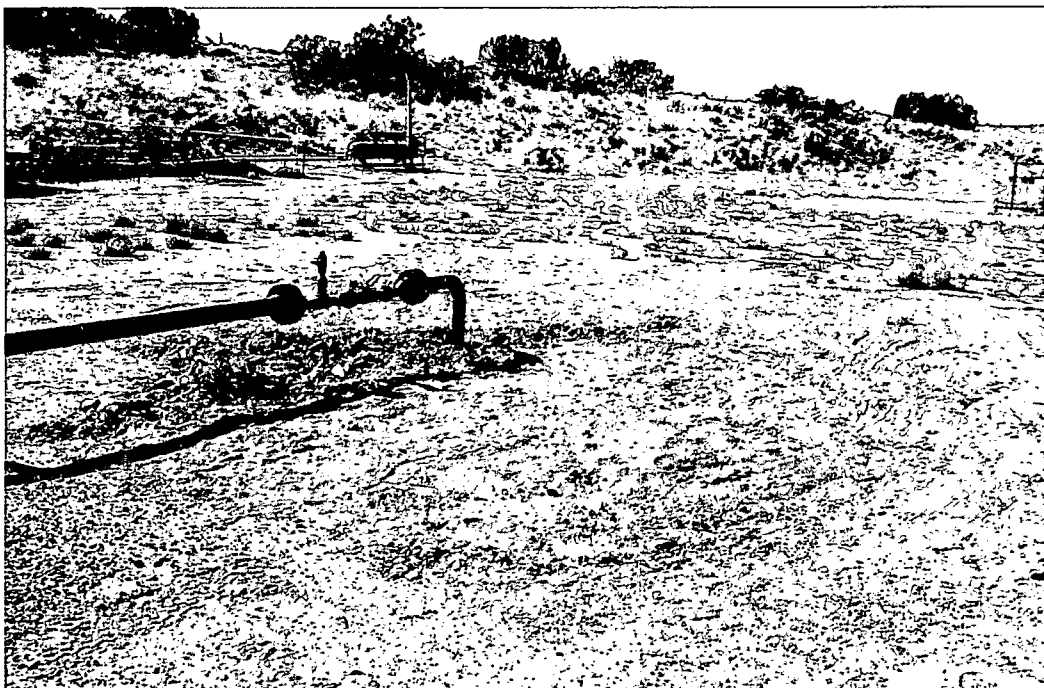
Site Assessment: On November 2, 2012, Souder, Miller and Associates (SMA) performed a site assessment at the Newsom B#8 well site. The release was a result of a leaking valve on the upstream side of the meter house. Eight soil borings were installed using a hand auger to delineate the release. Soil samples were field screened at one foot intervals with a calibrated photo ionization detector and five soil samples were collected for laboratory analysis. All soil samples were analyzed per United States Environmental Protection Agency Method 8021 BTEX and 8015 Diesel Range Organics and Gasoline Range Organics. The site assessment revealed that the impacted area was approximately 20 feet long by 10 feet wide by 8 feet deep. Field screening and laboratory results are included in the attached tables and the soil analytical results are attached.

Photo 1: Extent of the release.

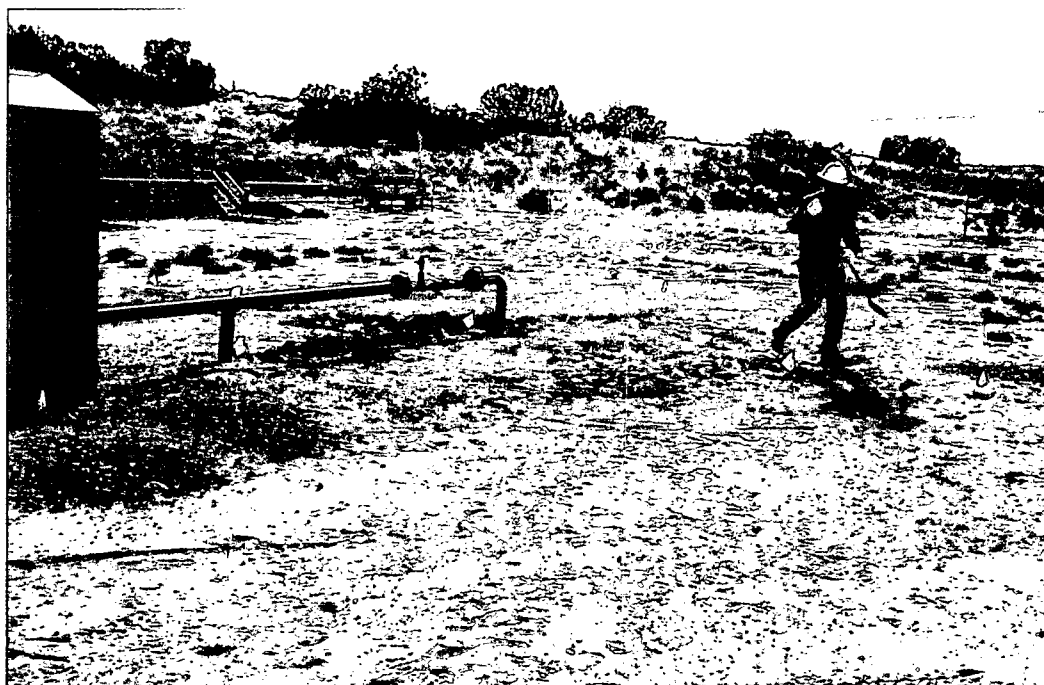
Photo 2: Soil investigation borings delineated with lime-green pin flags

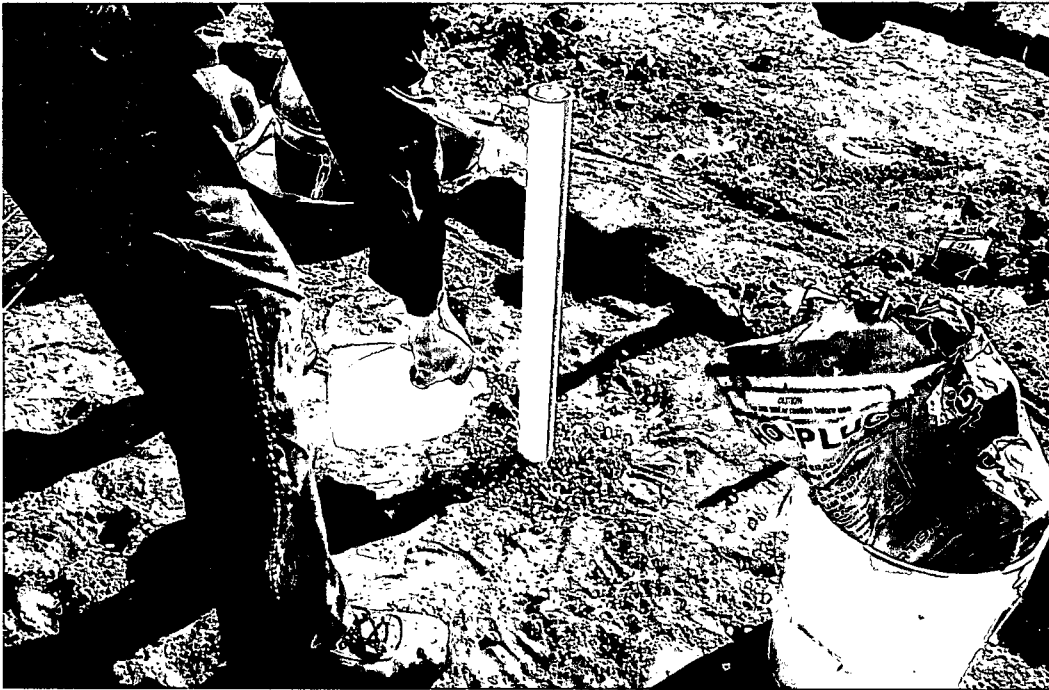
Photo 3: View of the soil vapor extraction well.

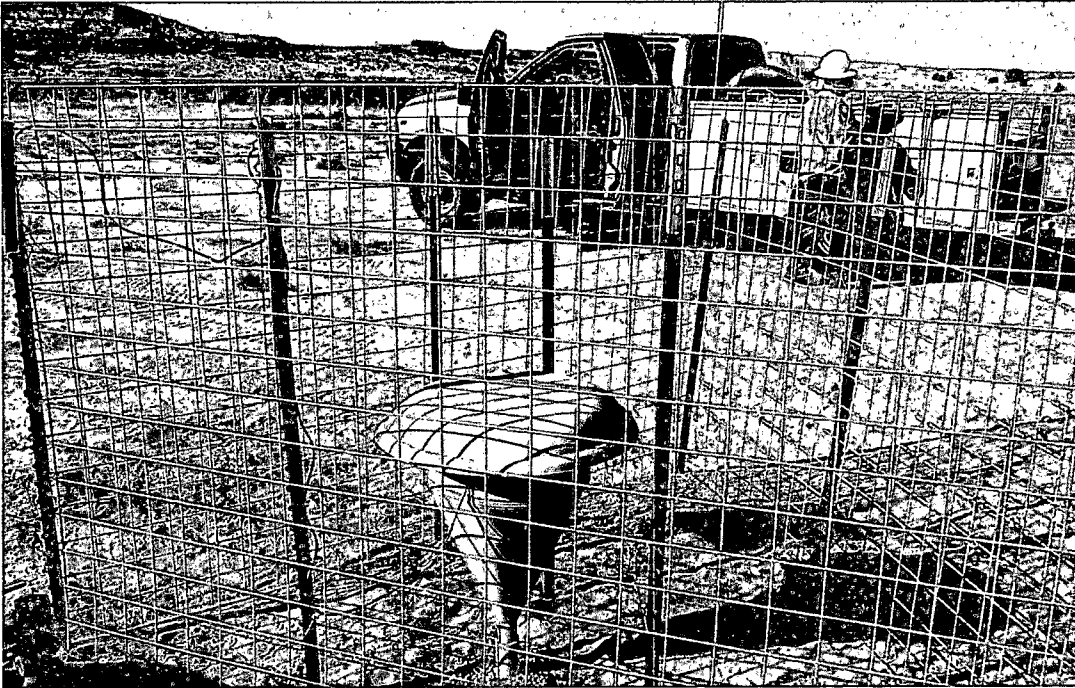
Photo 5: View of the soil vapor extraction ventilation system with security fencing.

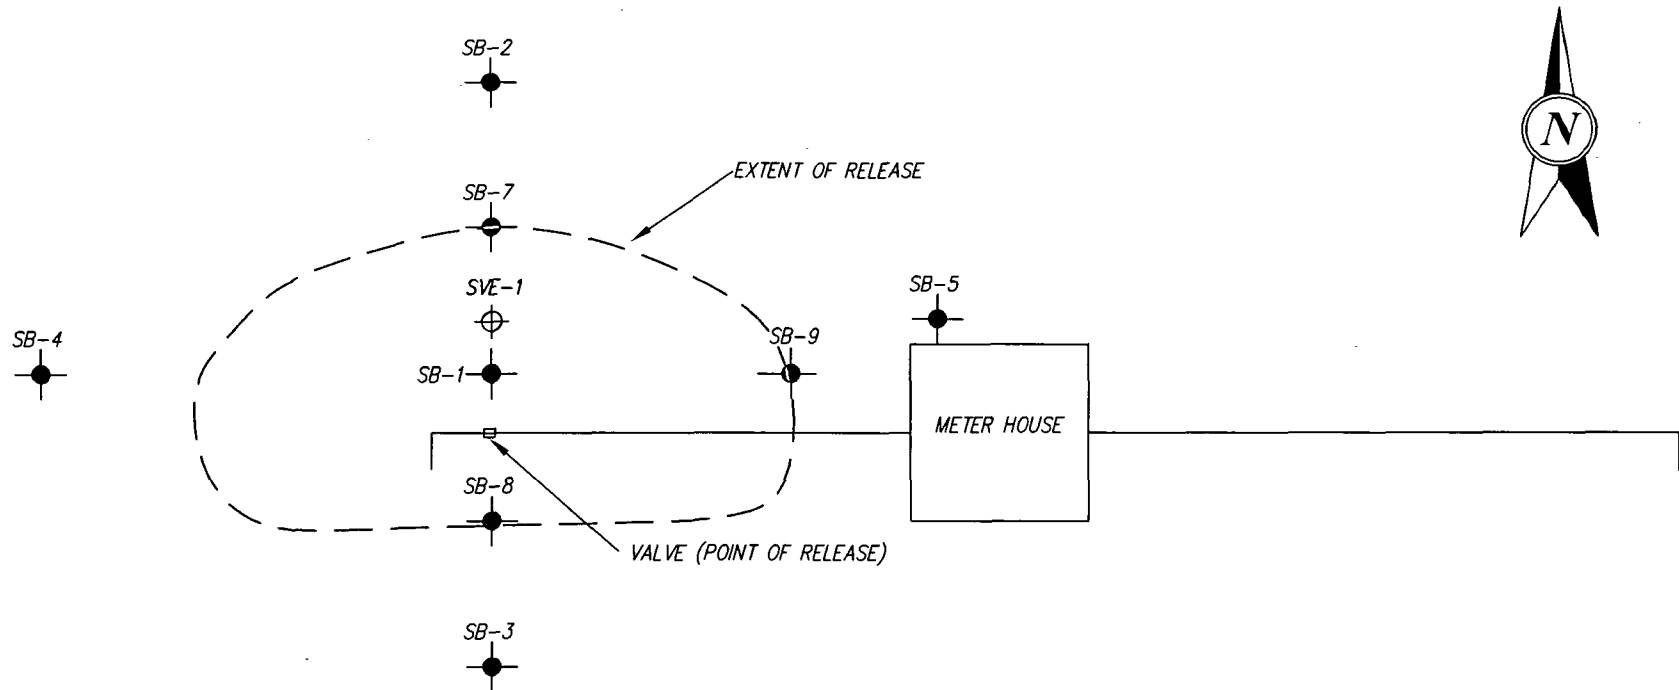
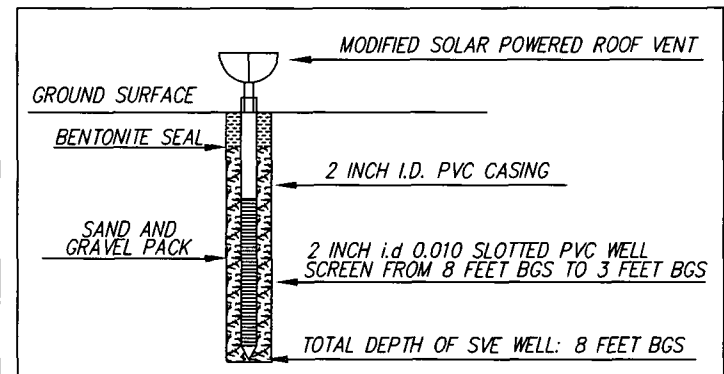
Souder, Miller & Associates (SMA) is pleased to submit this letter report summarizing the first quarterly vapor monitoring event for the Newsom B#8 release site. The site is located in the SE ¼ SE ¼ Section 6 T26N R8W, San Juan County, New Mexico. Figure 1 illustrates the location of the site. The release occurred on October 31, 2012 and is a result of natural gas liquids leaking from a valve on the upstream side of the meter tube. SMA performed a site assessment on November 2, 2012 and subsequently installed a soil vapor extraction (SVE) system on November 28, 2012 to remediate the subsurface hydrocarbon contamination. Initial hydrocarbon vapor concentrations measured approximately 62 parts per million (ppm) with a calibrated photo ionization detector. Figure 2 illustrates the location of the soil vapor extraction system.

SOIL VAPOR EXTRACTION REMEDIATION SYSTEM DIAGRAM

The quarterly vapor monitoring conducted on February 8, 2013 revealed that the average hydrocarbon vapor concentration has been reduced to 4.9 ppm. It appears that the SVE system is remediating the residual subsurface hydrocarbon contamination. SMA recommends operating the soil vapor extraction system for one additional quarter. During the second quarterly vapor monitoring event, SMA recommends installing soil borings within the release area and collecting soil samples for laboratory analysis to confirm that the subsurface hydrocarbon contamination has been remediated. If laboratory analytical results indicate the subsurface hydrocarbon contamination has been remediated, SMA recommends decommissioning of the soil vapor ventilation system.

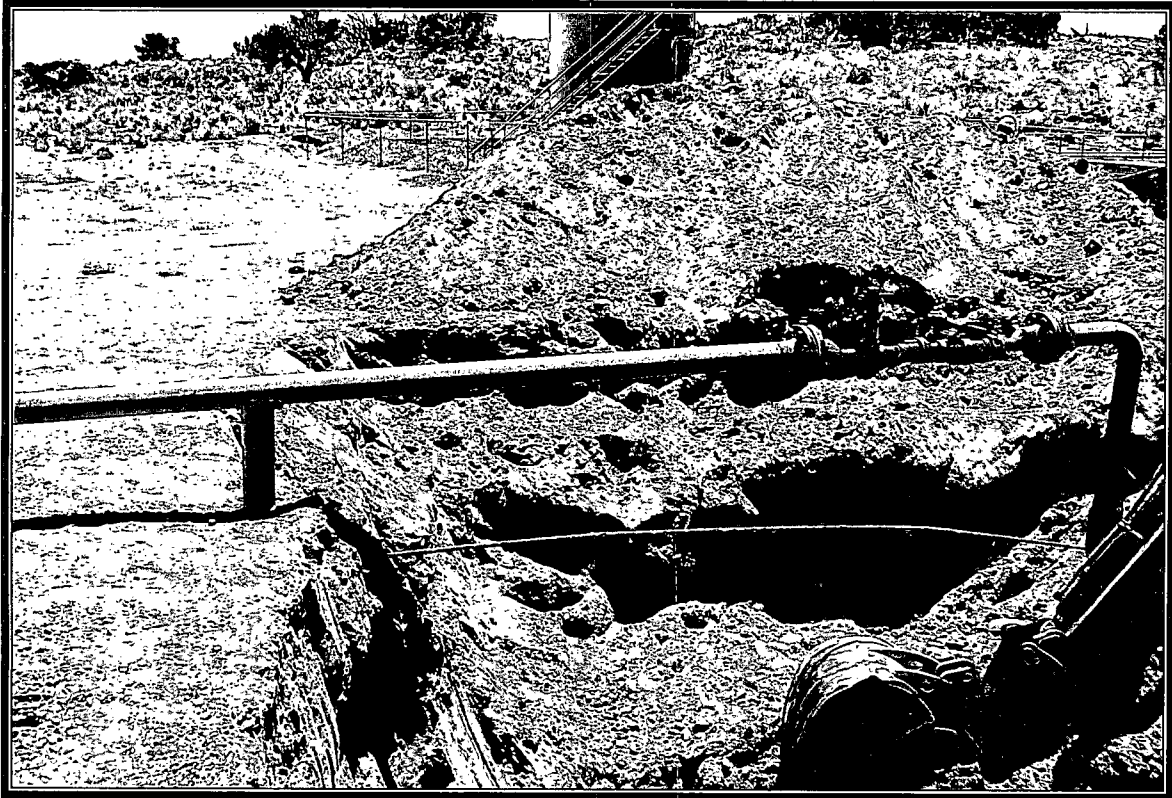
On July 2, 2013, under the supervision of SMA, EMS excavated the hydrocarbon contaminated soil at the Newsome B#8 well site. SMA monitored the progression of the excavation with a PID. Field screening results are included in Table 5. Field notes are included in Appendix B. The final dimensions of the excavation measured approximately 24 feet long by 22 feet wide by 11 feet deep. Site photography is included in Appendix C.

Photo 1: View of the excavation for the Newsom B#8 well site.

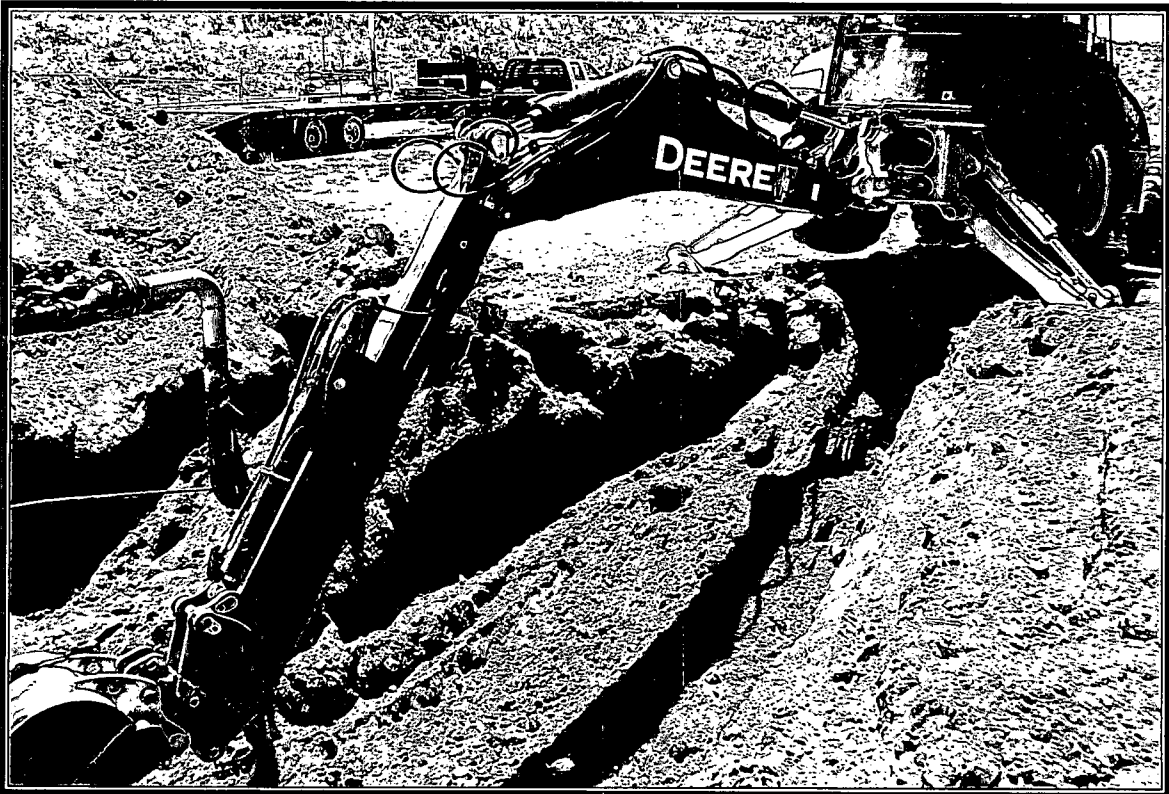
Photo 2: View of the excavation for the Newsom B#8 well site.

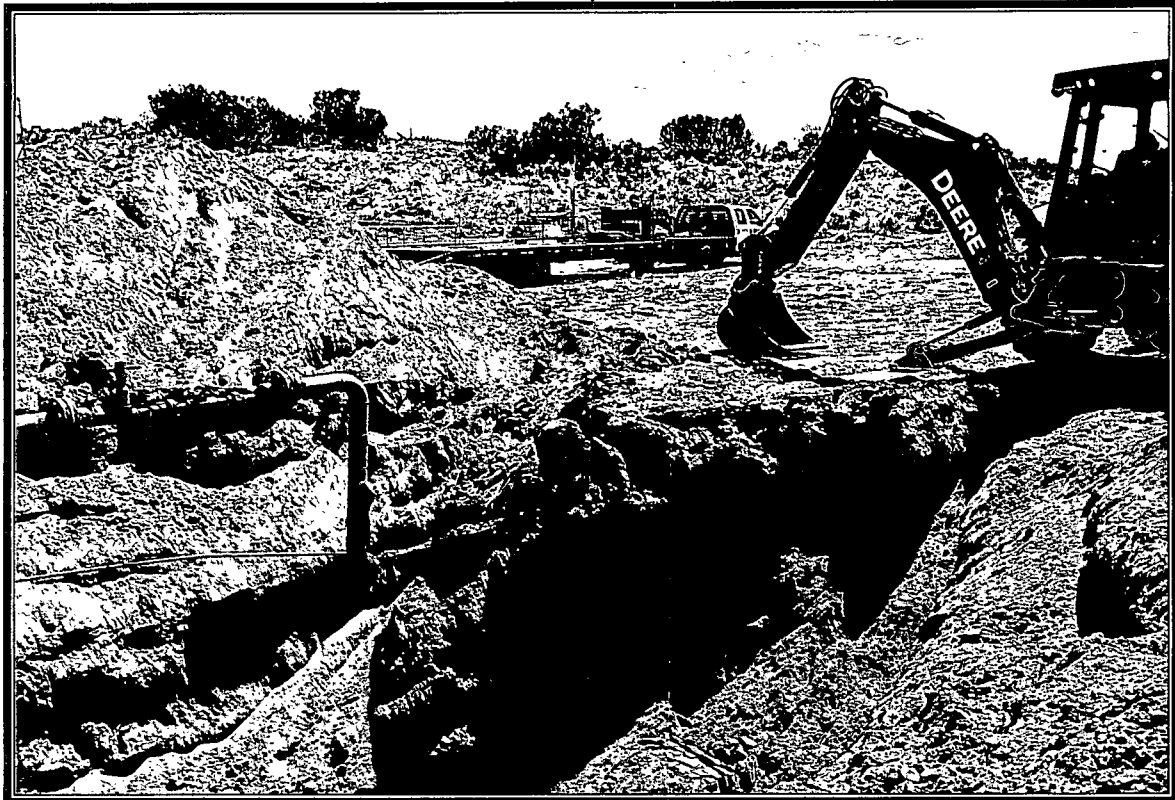
Photo 3: View of the excavation for the Newsom B#8 well site.

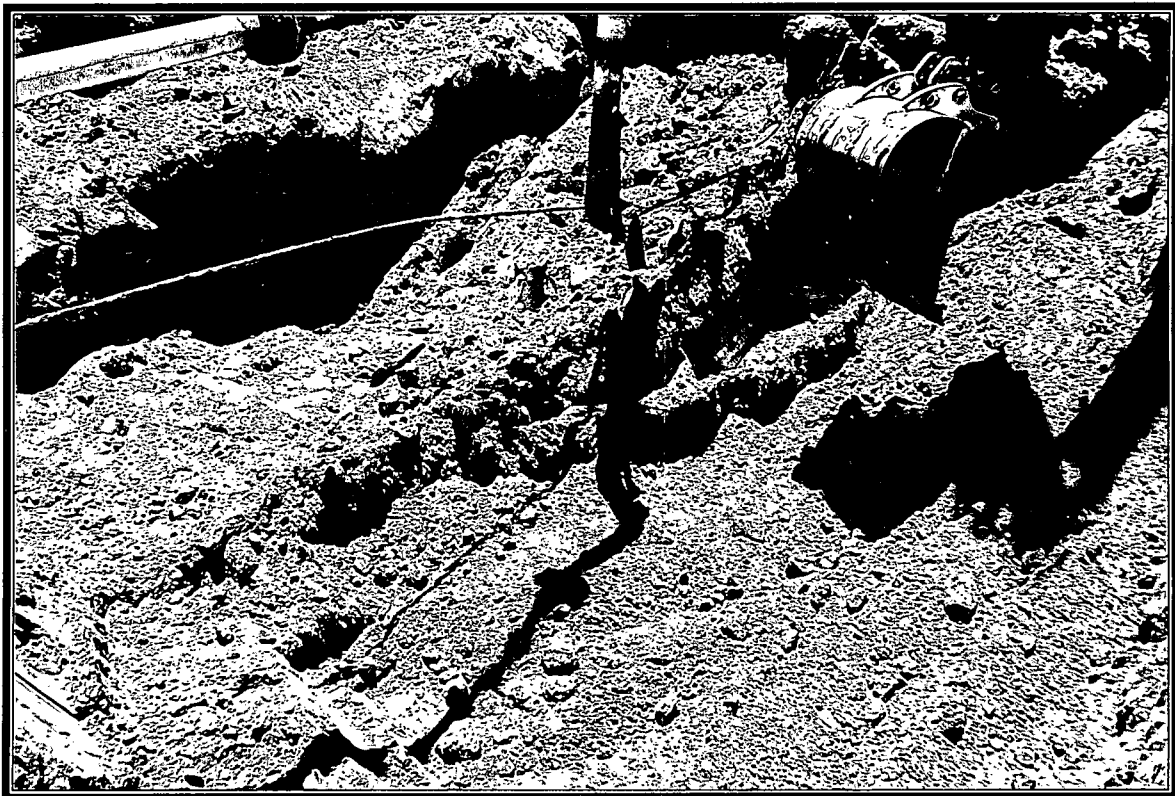
Photo 4: View of the excavation for the Newsom B#8 well site.
