Release Notification and Corrective Action

Name of Company Enterprise Products	Contact Aaron Dailey
Address 614 Reilly Avenue, Farmington NM 87401	Telephone No. (505)599-2286
Facility Name Atlantic Fruitland 24 Com #2	Facility Type Well location meter run
Surface Owner BLM	Mineral Owner BLM
API No.

**RE: Release Assessment and Mitigation Report
Atlantic Fruitland 24 Com #2
San Juan County, New Mexico**

On July 19, 23, 25, and August 8, 2012, Animas Environmental Services, LLC (AES) completed an assessment associated with a release of natural gas condensate from the Enterprise Products Company (Enterprise) Atlantic Fruitland 24 Com #2 meter run. The release, which is located approximately 9.5 miles northeast of Aztec, San Juan County, New Mexico, resulted from a leaking meter tube.

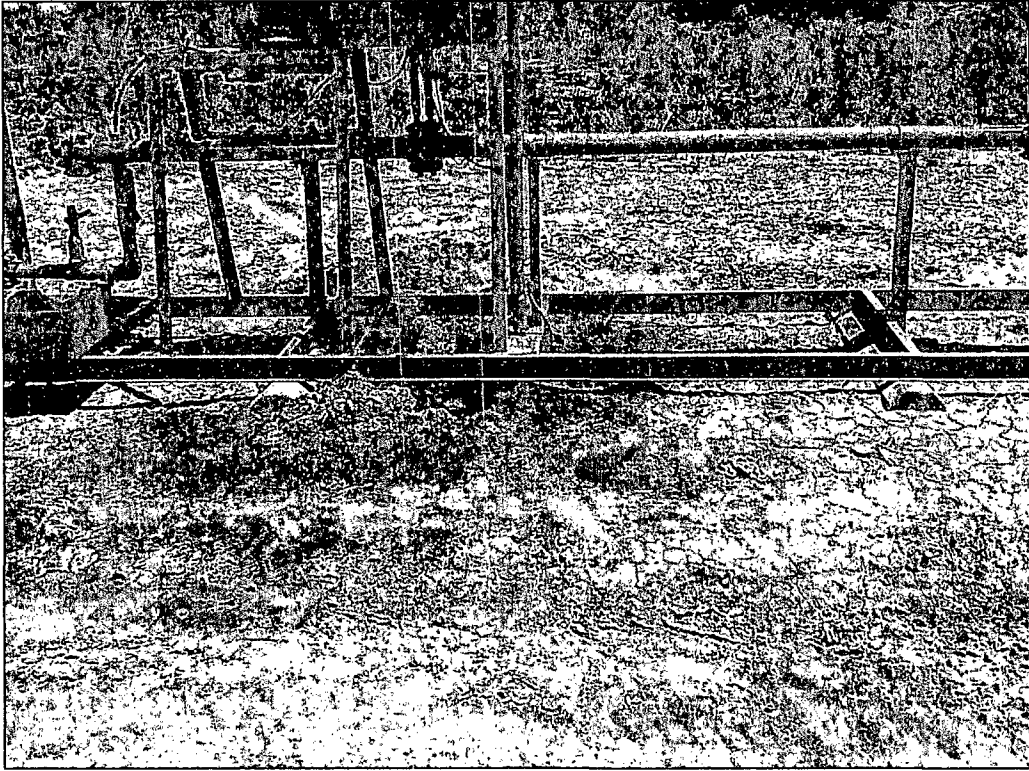
Photo #1

Client: Enterprise Products Company	
Project: Atlantic Fruitland 24 Com #2 Meter Run Release	
Taken by: Enterprise Personnel	
AES Project No: 120715	Description: View of the release area prior to excavation.

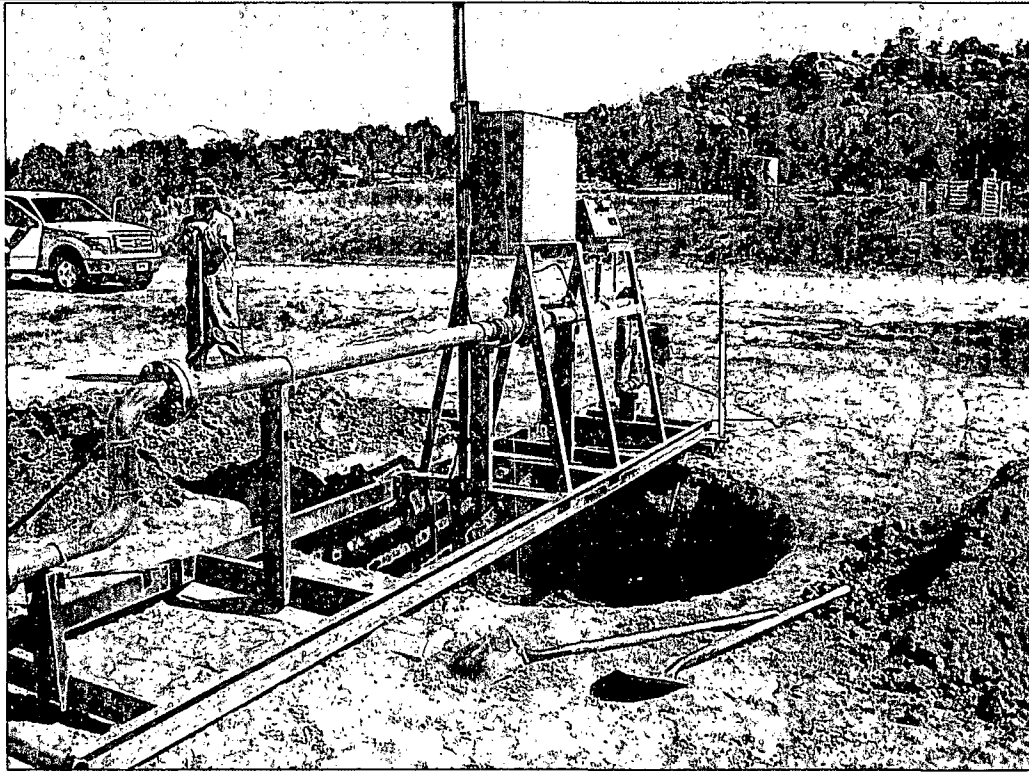
Photo #2

Client: Enterprise Products Company.	
Project: Atlantic Fruitland 24 Com #2 Meter Run Release	
Taken by: Tom Long	
July 23, 2012	
AES Project No: 12715	Description: View of the initial excavation below the meter run at the Atlantic Fruitland 24 Com #2 well site.
