Release Notification and Corrective Action

Name of Company Burlington Resources, a Wholly Owned Subsidiary of ConocoPhillips Company	Contact Lisa Hunter
Address 3401 E. 30th St., Farmington, NM 87402	Telephone No. 505-326-9786
Facility Name San Juan 28-6 186N	Facility Type Gas Well

**RE: Initial Release Assessment and Final Excavation Report
San Juan 28-6 Unit #186N
Rio Arriba County, New Mexico**

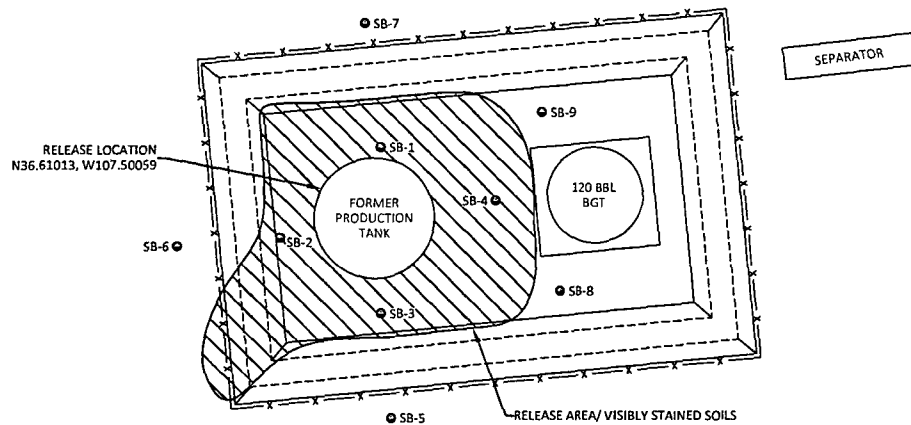
FIGURE 3

Laboratory Analytical Results						
Sample ID	Date	Depth (ft)	Benzene (mg/kg)	Total BTEX (mg/kg)	TPH - GRO (mg/kg)	TPH - DRO (mg/kg)
NMOCD ACTION LEVEL			10	50	1,000	
SB-1	7/2/13	12	<0.93	29	730	260
SB-3	7/2/13	Surface	<0.24	5.3	240	260
SB-4	7/2/13	12	<0.12	1.8	110	110

Field Screening Results				
Sample ID	Date	Depth (ft)	OVM-PID (ppm)	TPH (mg/kg)
NMOCD ACTION LEVEL			100	1,000
SB-1	7/2/13	Surface	2,879	NA
		2	1,266	NA
		4	1,288	NA
		6	1,156	NA
		8	1,133	NA
		10	2,057	NA
SB-2	7/2/13	12	2,244	1,710
		Surface	1,869	>2,500
		2	1,424	NA
		4	1,257	NA
		6	2,871	891
		8	28.4	NA
SB-3	7/2/13	4	53.1	NA
		6	7.4	NA
		8	31.2	NA
		10	7.7	NA
		12	12.4	NA
		Surface	3,292	>2,500
SB-4	7/2/13	2	1,873	NA
		4	2,005	NA
		6	1,670	NA
		8	2,952	NA
		10	2,304	NA
		12	2,262	567
SB-5	7/2/13	Surface	6.2	NA
		2	15.0	62.4
		4	9.9	NA
SB-6	7/2/13	Surface	2.5	NA
		2	3.2	NA
		4	5.3	NA
		6	6.5	NA
SB-7	7/2/13	8	9.0	58.1
		Surface	3.3	NA
		2	3.0	NA
		4	3.1	NA
		6	26.0	49.7
SB-8	7/2/13	8	3.0	NA
		Surface	3.2	NA
		2	7.5	NA
		4	7.0	NA
SB-9	7/2/13	Surface	2.9	NA
		2	2.0	NA
		4	2.1	NA

SAN JUAN 28-6 UNIT #186N WELL HEAD

INITIAL ASSESSMENT SAMPLE
LOCATIONS AND RESULTS
JULY 2013
ConocoPhillips
SAN JUAN 28-6 UNIT #186N
NE1/4, NE1/4, SECTION 6, T27N, R6W
RIO ARriba COUNTY, NEW MEXICO
N36.60987, W107.50052

AES was initially contacted by Lisa Hunter of CoP on June 27, 2013, and on July 2, 2013, Heather Woods and Jesse Christopherson of AES completed the release assessment field work. The assessment included collection and field screening of soil samples (SB-1 through SB-9) in and around the release area. Based on the field screening results, AES recommended further excavation of the release area. Sample locations are presented on Figure 3.

On July 2, 2013, initial assessment field screening results for VOCs via OVM showed concentrations ranging from 2.0 ppm in SB-9 up to 3,292 ppm in SB-4. Field TPH concentrations ranged from 49.7 mg/kg in SB-7 to greater than 2,500 mg/kg in SB-2 and SB-4.

Laboratory analyses for SB-1, SB-3, and SB-4 were used to confirm field screening results of the initial release assessment. Benzene concentrations were reported below laboratory detection limits in each sample. Total BTEX concentrations were reported at 28 mg/kg (SB-1), 5.3 mg/kg (SB-3), and 1.8 mg/kg (SB-4). TPH concentrations as GRO/DRO were reported at 990 mg/kg (SB-1), 500 mg/kg (SB-3), and 220 mg/kg (SB-4). Results are presented in Table 2 and on Figure 3. The laboratory analytical report is attached.

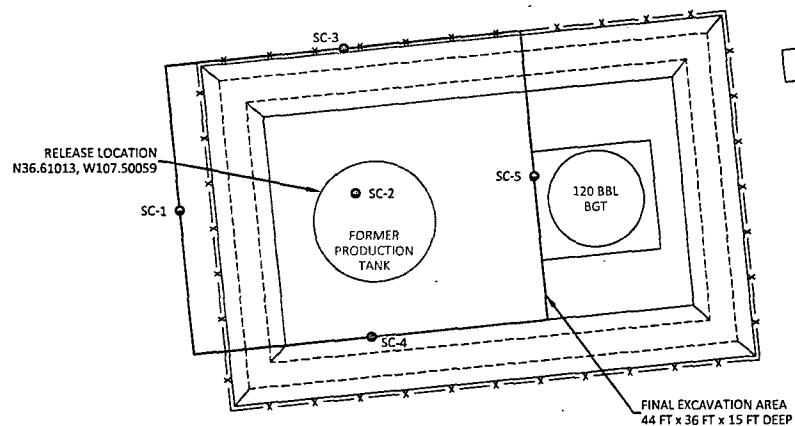
FIGURE 4

Field Screening Results				
Sample ID	Date	Depth (ft)	OVM-PID (ppm)	TPH (mg/kg)
NMOCD ACTION LEVEL			100	1,000
SC-1	7/16/13	1 to 15	53.5	54.6
SC-2	7/16/13	15	3,103	300
SC-3	7/16/13	1 to 15	2,889	420
SC-4	7/16/13	1 to 15	3,028	729
SC-5	7/16/13	1 to 15	26.8	97.0

Laboratory Analytical Results				
Sample ID	Date	Depth (ft)	Benzene (mg/kg)	Total BTEX (mg/kg)
NMOCD ACTION LEVEL			10	50
SC-2	7/16/13	15	<0.12	29
SC-3	7/16/13	1 to 15	<0.10	2.4
SC-4	7/16/13	1 to 15	<0.20	55

SAN JUAN 28-6 UNIT #186N WELL HEAD

FINAL EXCAVATION SAMPLE LOCATIONS AND RESULTS JULY 2013
 ConocoPhillips
 SAN JUAN 28-6 UNIT #186N
 NE¼, NE¼, SECTION 6, T27N, R6W
 RIO ARRIBA COUNTY, NEW MEXICO
 N36.60987, W107.50052

On July 16, 2013, AES returned to the location to collect confirmation soil samples of the excavation. The field screening activities included collection of five confirmation soil samples (SC-1 through SC-5) of the walls and base of the excavation. The area of the final excavation was approximately 44 feet by 36 feet by 15 feet in depth. Sample locations and final excavation extents are shown on Figure 4.

On July 16, 2013, final excavation field screening results for VOCs via OVM ranged from 26.8 ppm in SC-5 (east wall) up to 3,103 ppm in SC-2 (base). Field TPH concentrations ranged from 54.6 mg/kg in SC-1 (west wall) up to 729 mg/kg in SC-4 (south wall). Results are included below in Table 1 and on Figures 3 and 4. The AES Field Screening Reports are attached.

Laboratory analyses for SC-2 through SC-4 were used to confirm field screening results during excavation activities. Benzene concentrations were reported below laboratory detection limits in each sample. Total BTEX concentrations were reported at 29 mg/kg (SC-2), 2.4 mg/kg (SC-3), and 55 mg/kg (SC-4). Results are presented in Table 2 and on Figure 4. The laboratory analytical report is attached.

On July 16, 2013, final assessment of the excavation area was completed. Field screening results of the excavation extents showed that VOC concentrations were below applicable NMOCD action levels for the final west and east walls of the excavation. However, the base (SC-2), north wall (SC-3), and south wall (SC-4) exceeded the NMOCD action level of 100 ppm for VOCs with 3,103 ppm, 2,889 ppm, and 3,028 ppm, respectively. Field TPH concentrations were below the applicable NMOCD action level of 1,000 mg/kg for the final walls and base of the excavation. Laboratory analytical results reported benzene and total BTEX concentrations in SC-2 and SC-3 below NMOCD action levels. However, the total BTEX concentration in SC-4 was above the NMOCD action level of 50 mg/kg with 55 mg/kg.

Based on the final field screening and laboratory analytical results of the excavation of petroleum contaminated soils at the San Juan 28-6 Unit #186N, benzene, total BTEX, and TPH concentrations were below the applicable NMOCD action levels for three of the final sidewalls and the base of the excavation. However, the south wall of the excavation exceeded applicable NMOCD action levels for total BTEX with 55 mg/kg. On July 18, 2013, CoP received approval to backfill the excavation from Mark Kelly of the BLM and Brandon Powell of the NMOCD. No further work is recommended at the San Juan 28-6 Unit #186N.
