# Burlington Resources Oil Gas Company, LP San Juan Basin Closure Report

Lease Name: THOMPSON 7M

API No.: 30-045-35258

In accordance with Rule 19.15.17.13 NMAC the following information describes the closure of the temporary pit referenced above. All proper documentation regarding closure activities is being included with the C-144. The temporary pit for this location was constructed and location drilled before June 16, 2008 (effective date for Rule 19.15.17). While closure of the temporary pit did fall within the rule some dates for submittals are after the rig release date.

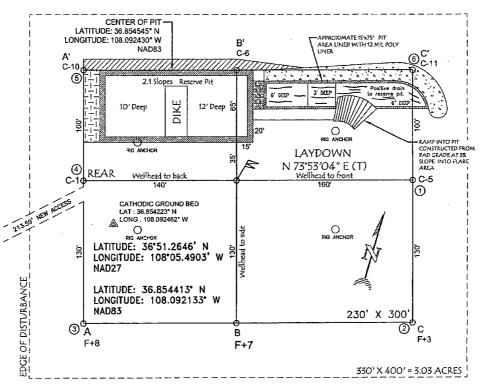
THOMPSON #7M, 2185," FSL & 825," FWL SECTION 34, T-31-N, R-12-W, NMPM, SAN JUAN COUNTY, NM GROUND ELEVATION: 6065, DATE: OCTOBER 5, 2010

- VECTOR SURVEYS IS NOT LIABLE FOR UNDERGROUND UTILITIES OR PIPELINES. CONTRACTOR SHOULD CALL
  ONE-CALL FOR LOCATION OF ANY MARKED OR UNMARKED BURIED PIPELINES OR CABLES ON WELL PAD AND OR
  ACCESS ROAD AT LEAST TWO (2) WORKING DAYS PRIOR TO CONSTRUCTION.
- 2. RESERVE PIT DIKE TO BE 8' ABOVE DEEP SIDE (OVERFLOW ~ 3' WIDE AND 1' ABOVE SHALLOW SIDE).
