# ConocoPhillips Company San Juan Basin Closure Report

Lease Name: San Juan 28-7 Unit 154F

API No.: 30-039-31145

In accordance with Rule 19.15.17.13 NMAC the following information describes the closure of the temporary pit referenced above. All proper documentation regarding closure activities is being included with the C-144. The temporary pit for this location was constructed and location drilled before June 16, 2008 (effective date for Rule 19.15.17). While closure of the temporary pit did fall within the rule some dates for submittals are after the rig release date.

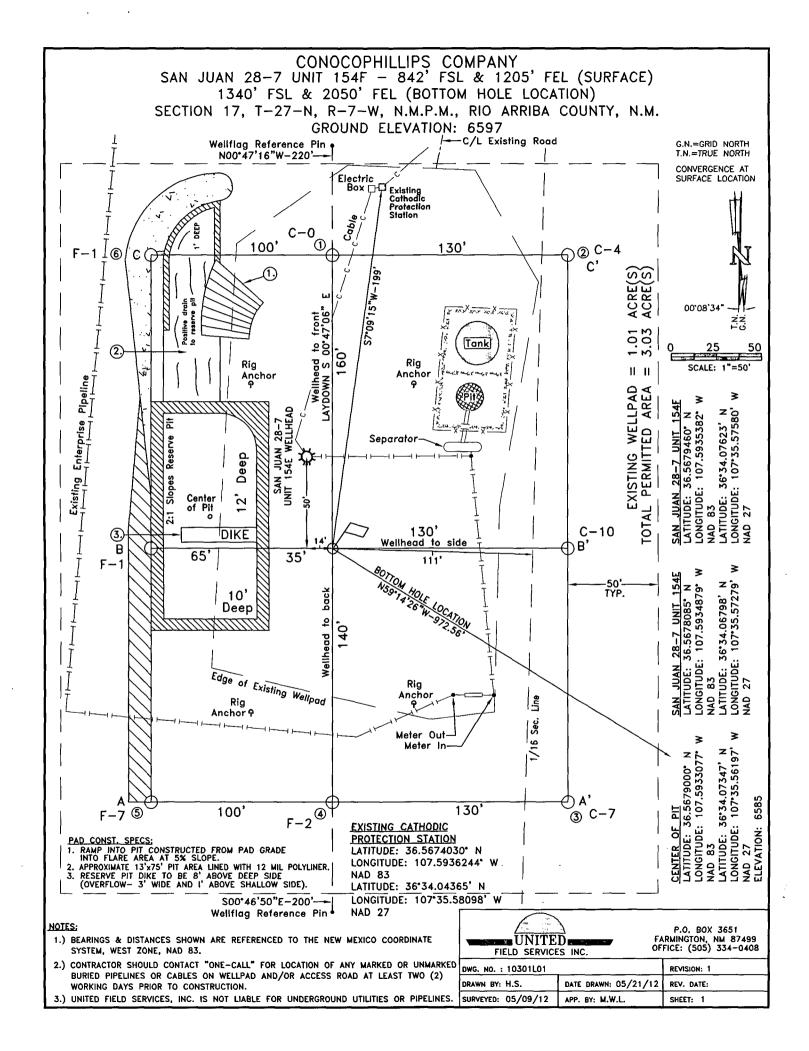
#### WELL LOCATION AND ACREAGE DEDICATION PLAT

<sup>10</sup> Surface Location

UL or lot no.	Section	Township	Range	Lot Idn	Feet from the	North/South line	Feet from the	East/West line	County
Р	17	27 N	7 W		842	SOUTH	1205	EAST	RIO ARRIBA
			11 22 11	77 1	T 1: Te	Diff 1 B	a .

<u> </u>		<b>-</b> ⊚	Y
16	N 89°59'40" W	2646.68	S 89°52'35" W	2647.26'	Ĭ	17 OPERATOR CERTIFICATION
2745 31.	= FOUND 1955 = POSITION D	OCATION OLE LOCATION 5 B.L.M. BRASS CAP ERIVED FROM WC	BEARINGS & DISTA ARE REFERENCED NEW MEXICO COO SYSTEM, WEST Z UNLESS OTHERWI	O TO THE PRDINATE ONE, NAD 83,	2736.34'	I hereby certify that the information contained herein is true and complete to the best of my knowledge and belief, and that this organization either owns a working interest or unleased mineral interest in the land including the proposed bottom hole location or has a right to drill this well at this location pursuant to a contract with an owner of such a mineral or working interest, or to a voluntary pooling agreement or a compulsory pooling order heretofore entered by the division.
1 1 1 1 1 1 1 1 1 1 1 1 1 1 1 1 1 1 1	G.N.=GRID NO T.N.=TRUE NO CONVERGENCE SURFACE LOC	ORTH E AT ATION	       <sub>ION 17</sub> USA SF	-078640	N 1°07'23" E	Signature Date  Printed Name  E-mail Address

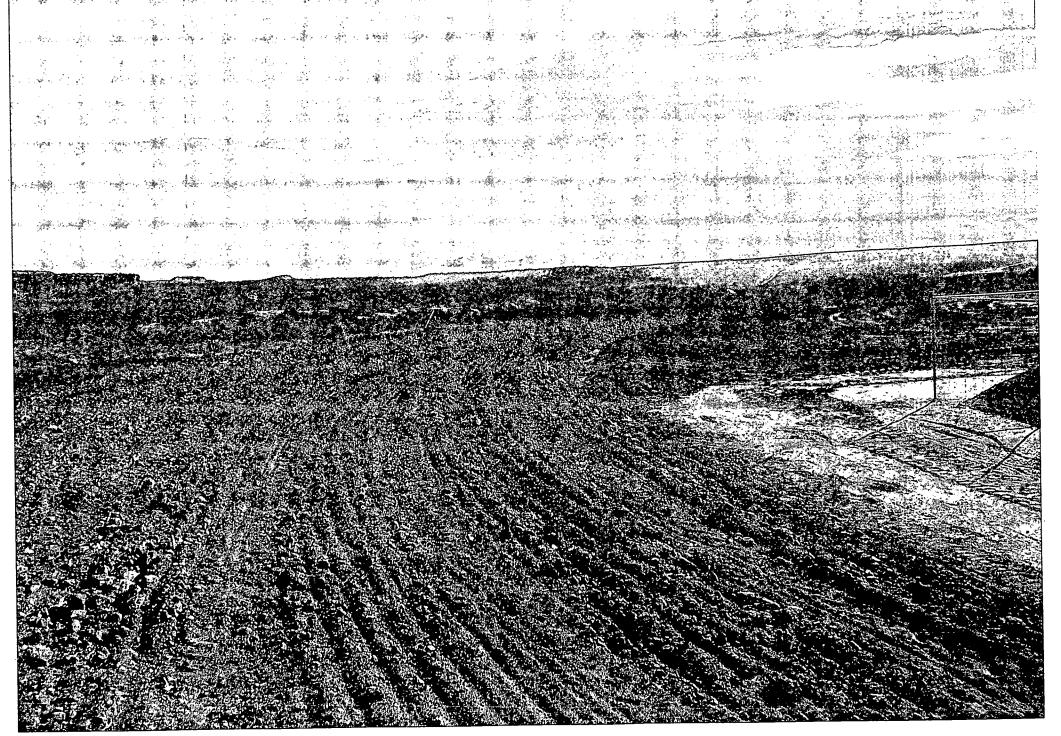
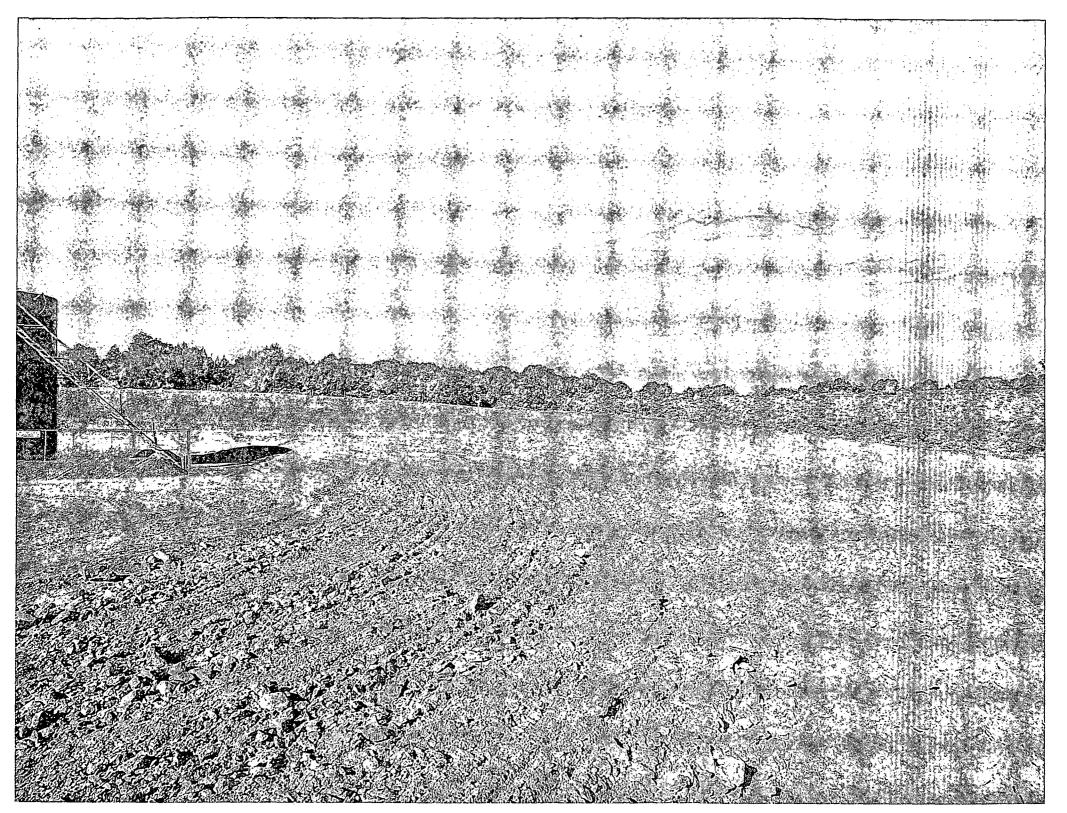
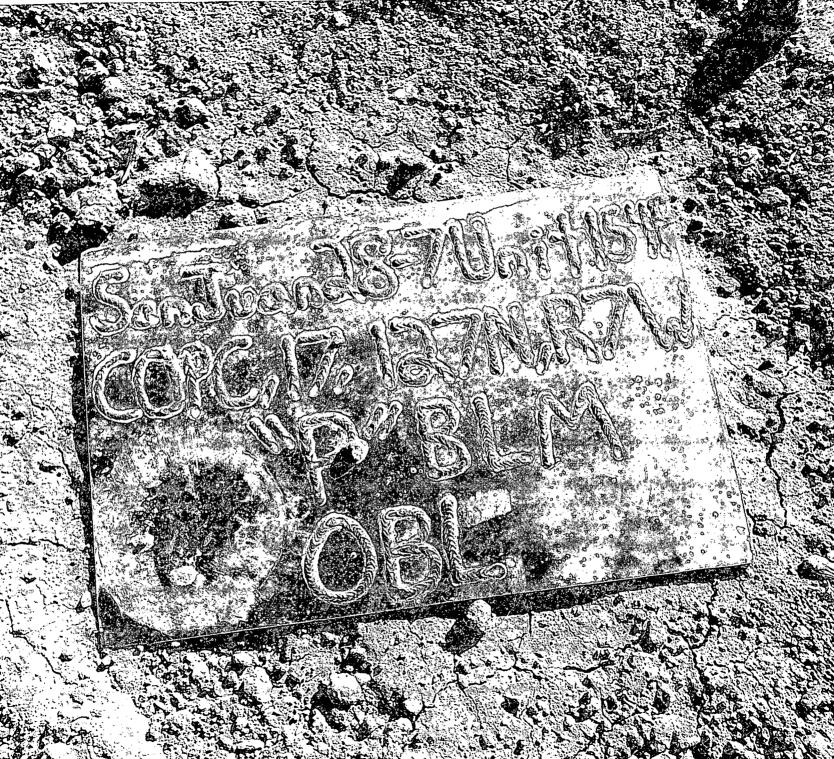
UNIT P SEC 17 T27N RO7W / LEASE# SF-078640 BH: SWSE SEC 17 T27N R07W API \$30-039-31145 ELEV. 6597' UA # NM-78413C

V Latitude 36° 34 min. 05 sec. n (nad 83) \ \ Longitude 107° 35 Min. 37 Sec. W (nad 83) I RIO ARRIBA COUNTY, NEW MEXICO EMERGENCY CONTACT: 1-505-324-5170
