# Pit, Closed-Loop System, Below-Grade Tank, or Proposed Alternative Method Permit or Closure Plan Application

# ConocoPhillips Company San Juan Basin Closure Report

Lease Name: Hardie 2N API No.: 30-045-35070

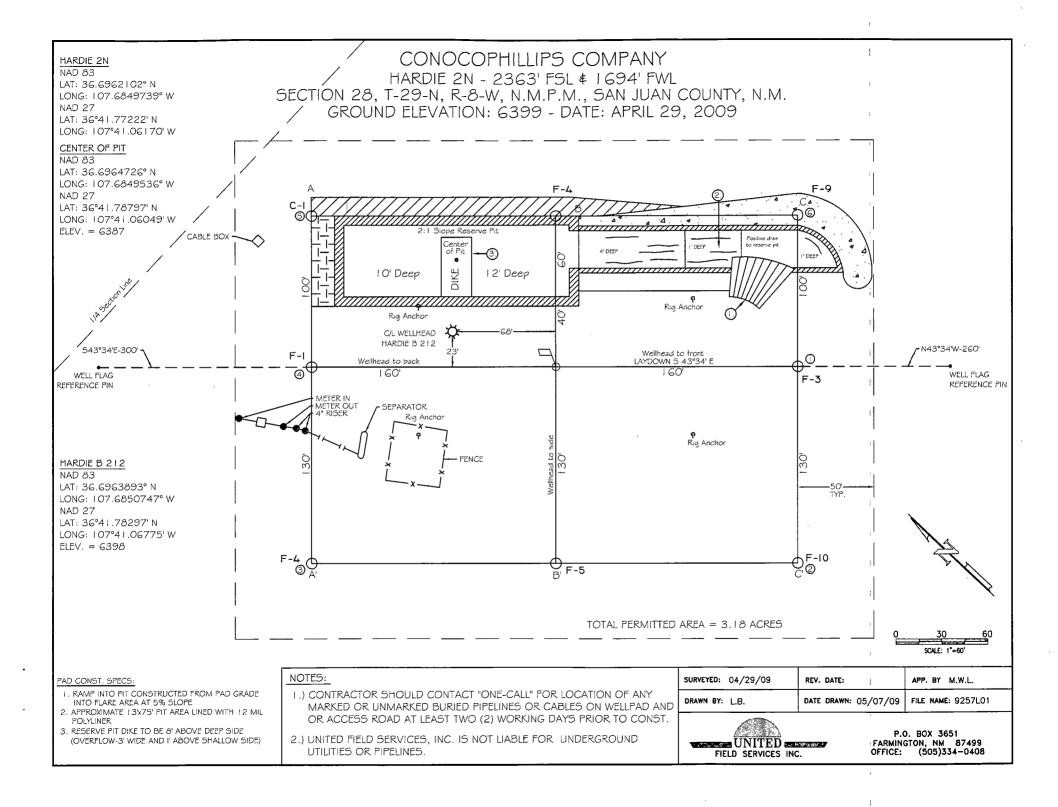
## WELL LOCATION AND ACREAGE DEDICATION PLAT

<sup>1</sup> API Number 30-045-	*Pool Code 71599 / 72319	BASIN DAKOTA / BLANCO	MESA VERDE
Property Code	<sup>6</sup> Proper	Well Number	
31728	HAF	2N	
OGRID No.	*Opera	<sup>9</sup> Elevation	
217817	CONOCOPHILL	6399

UL or lot no.	Section	Township	Range	Lot Idn	Feet from the	North/South line	Feet from the	East/West line	County
Κ	28	29 N	8 W		2363	SOUTH	1694	WEST	SAN JUAN
<sup>11</sup> Bottom Hole Location If Different From Su									
UL or lot no.	Section	Township	Range	Lot Idn	Feet from the	North/South line	Feet from the	East/West line	County
K	28	29 N	8 W		2163	SOUTH	1694	WEST	SAN JUAN
Dedicated Acre	s	18 Joint or I	nfill	14 Con	solidation Code	18 Order No.			
320 (W	/2)
