Release Notification and Corrective Action

Name of Company Conoco Burlington Resources, a Wholly Owned Subsidiary of ConocoPhillips Company	Contact Lisa Hunter
Address 3401 East 30th St, Farmington, NM	Telephone No. (505) 326-9786
Facility Name: San Juan 30-6 Unit 489	Facility Type: Natural Gas

**RE: Release Assessment Report
San Juan 30-6 #489
Rio Arriba County, New Mexico**

On October 29, 2013, Animas Environmental Services, LLC (AES) completed a release assessment at the ConocoPhillips (CoP) San Juan 30-6 #489, located in Rio Arriba County, New Mexico. Rain water from within the containment berm broke through the berm and flowed off location.

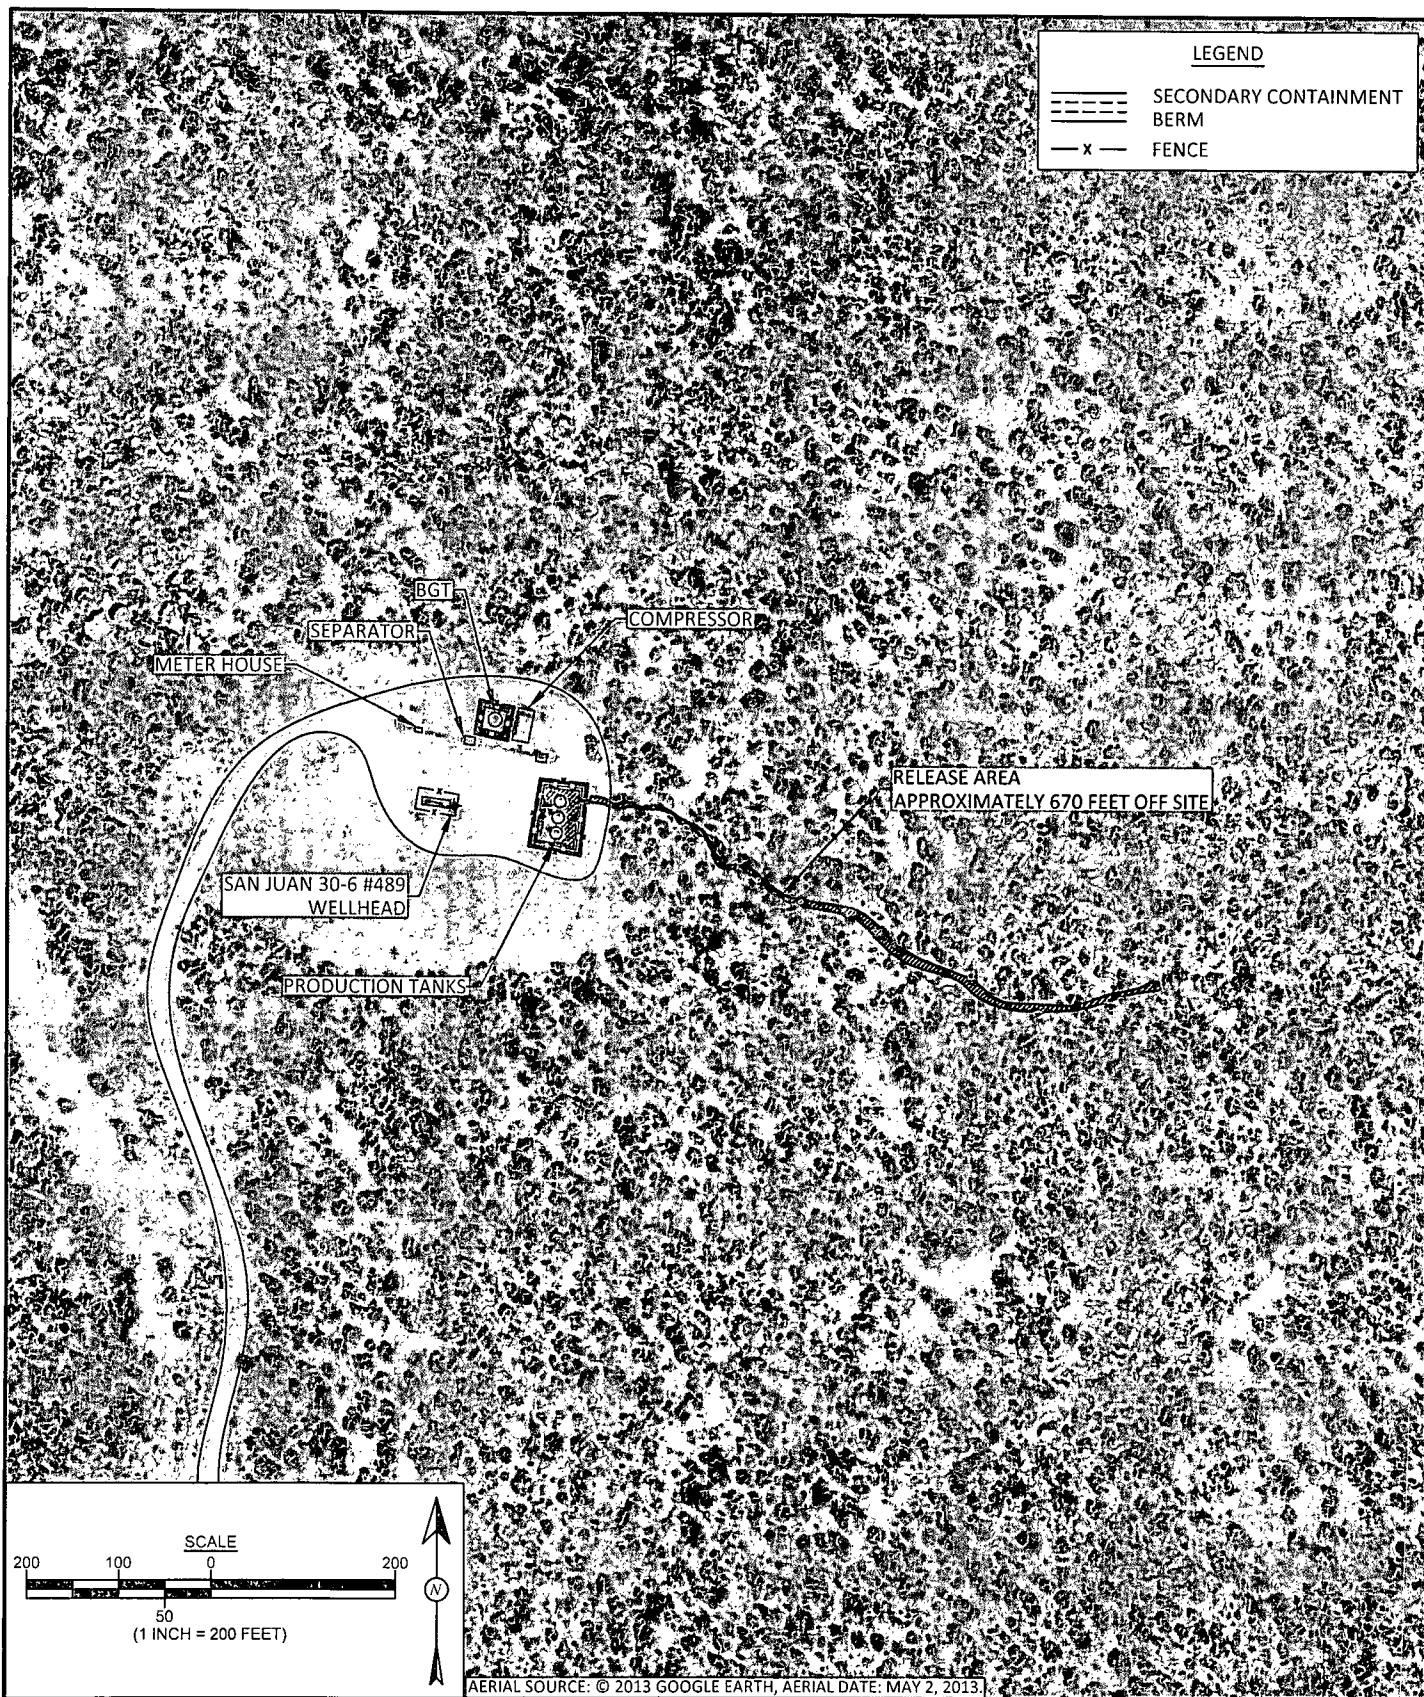
FIGURE 2

AERIAL SITE MAP OCTOBER 2013
