Release Notification and Corrective Action

SPILL ASSESSMENT AND CONFIRMATION SAMPLING REPORT

LOCATION:
CONOCOPHILLIPS
SAN JUAN 32-9 #14C (HBR)
SECTION 9, TOWNSHIP 31 NORTH, RANGE 9 WEST
SAN JUAN COUNTY, NEW MEXICO

CONOCOPHILLIPS
SPILL ASSESSMENT AND CONFIRMATION SAMPLING REPORT
SAN JUAN 32-9 #14C (HBR) WELL SITE
SECTION 9, TOWNSHIP 31 NORTH, RANGE 9 WEST
SAN JUAN COUNTY, NEW MEXICO

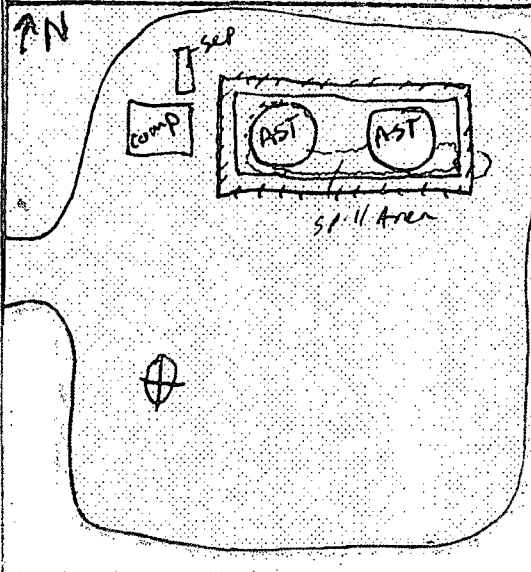
SPILL PERIMETER

SAMPLE ID	FIELD HEADSPACE PID (ppm)
Comp	10.3
6"	0.0
2'	0.0
5'	0.0

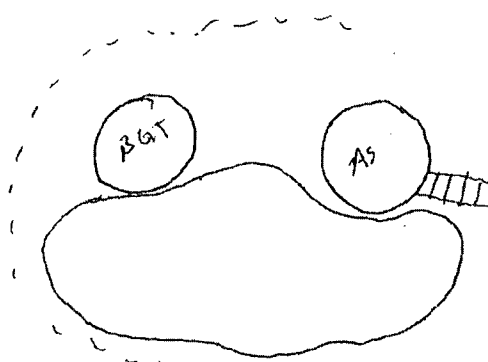
SPILL PERIMETER

SAMPLE ID	FIELD HEADSPACE PID (ppm)
<u>BWC</u>	<u>1.9</u>
<u>NWC</u>	<u>2.2</u>
<u>SWC</u>	<u>1.9</u>
<u>EW C</u>	<u>2.1</u>
<u>WWC</u>	<u>2.1</u>
<u>BEC</u>	<u>1.8</u>
<u>VLBT</u>	<u>2.0</u>
