### Release Notification and Corrective Action

Name of Company <b>Burlington Resources</b>	Contact <b>Lindsay Dumas</b>	
Address <b>3401 East 30<sup>th</sup> St, Farmington, NM</b>	Telephone No. <b>(505) 599-4089</b>	
Facility Name: <b>Canyon Largo 240</b>	Facility Type: <b>Gas</b>	
Surface Owner <b>BLM</b>	Mineral Owner <b>BLM (SF-07884)</b>	API No. <b>30-039-20640</b>

**RE: Initial Release Assessment and Final Excavation Report  
Canyon Largo #240  
Rio Arriba County, New Mexico**

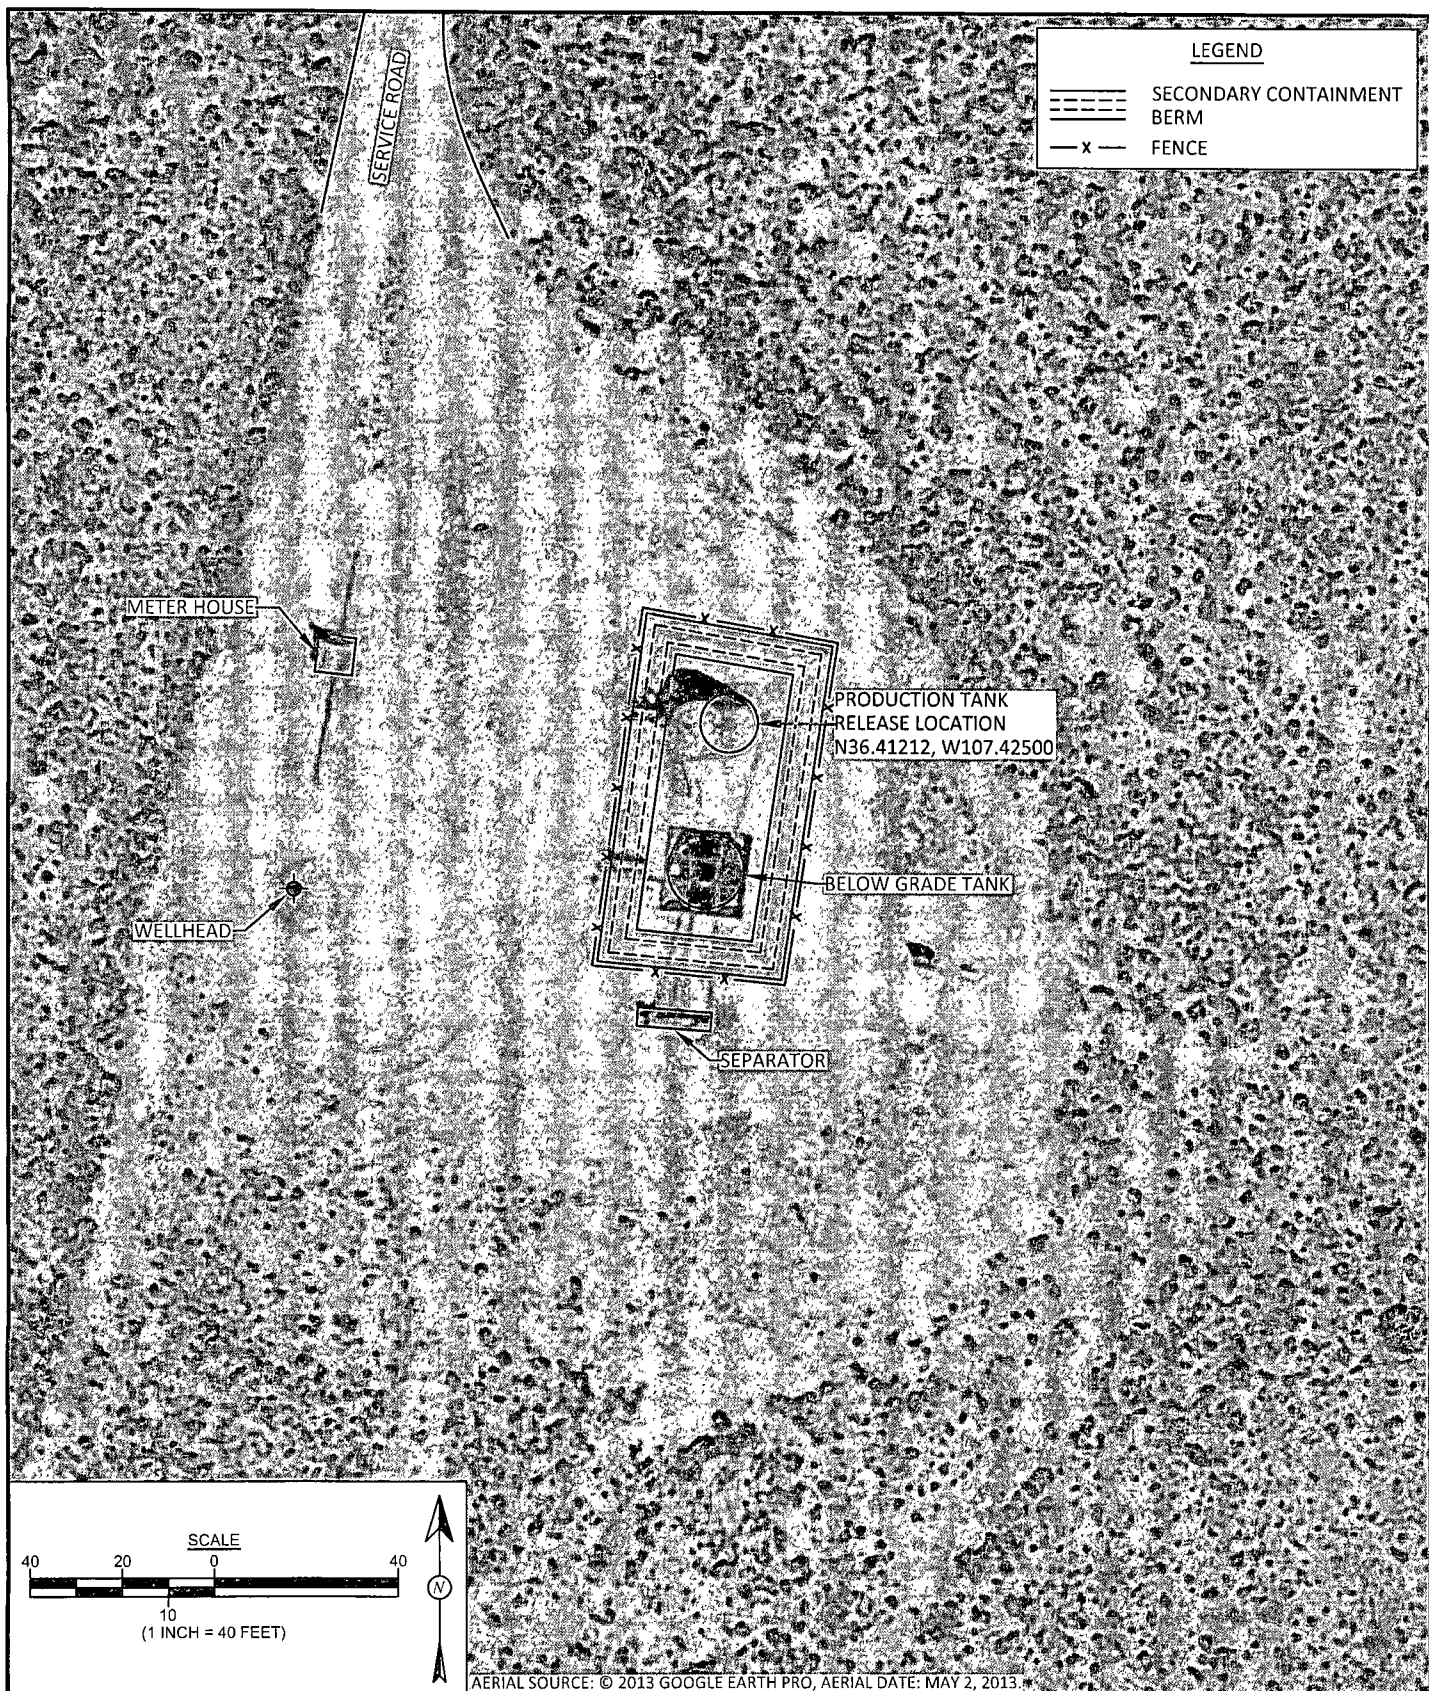
## FIGURE 2

### AERIAL SITE MAP FEBRUARY 2014

ConocoPhillips  
CANYON LARGO #240  
NW¼ SW¼, SECTION 12, T25N, R6W  
RIO ARriba COUNTY, NEW MEXICO  
N36.41203, W107.42529

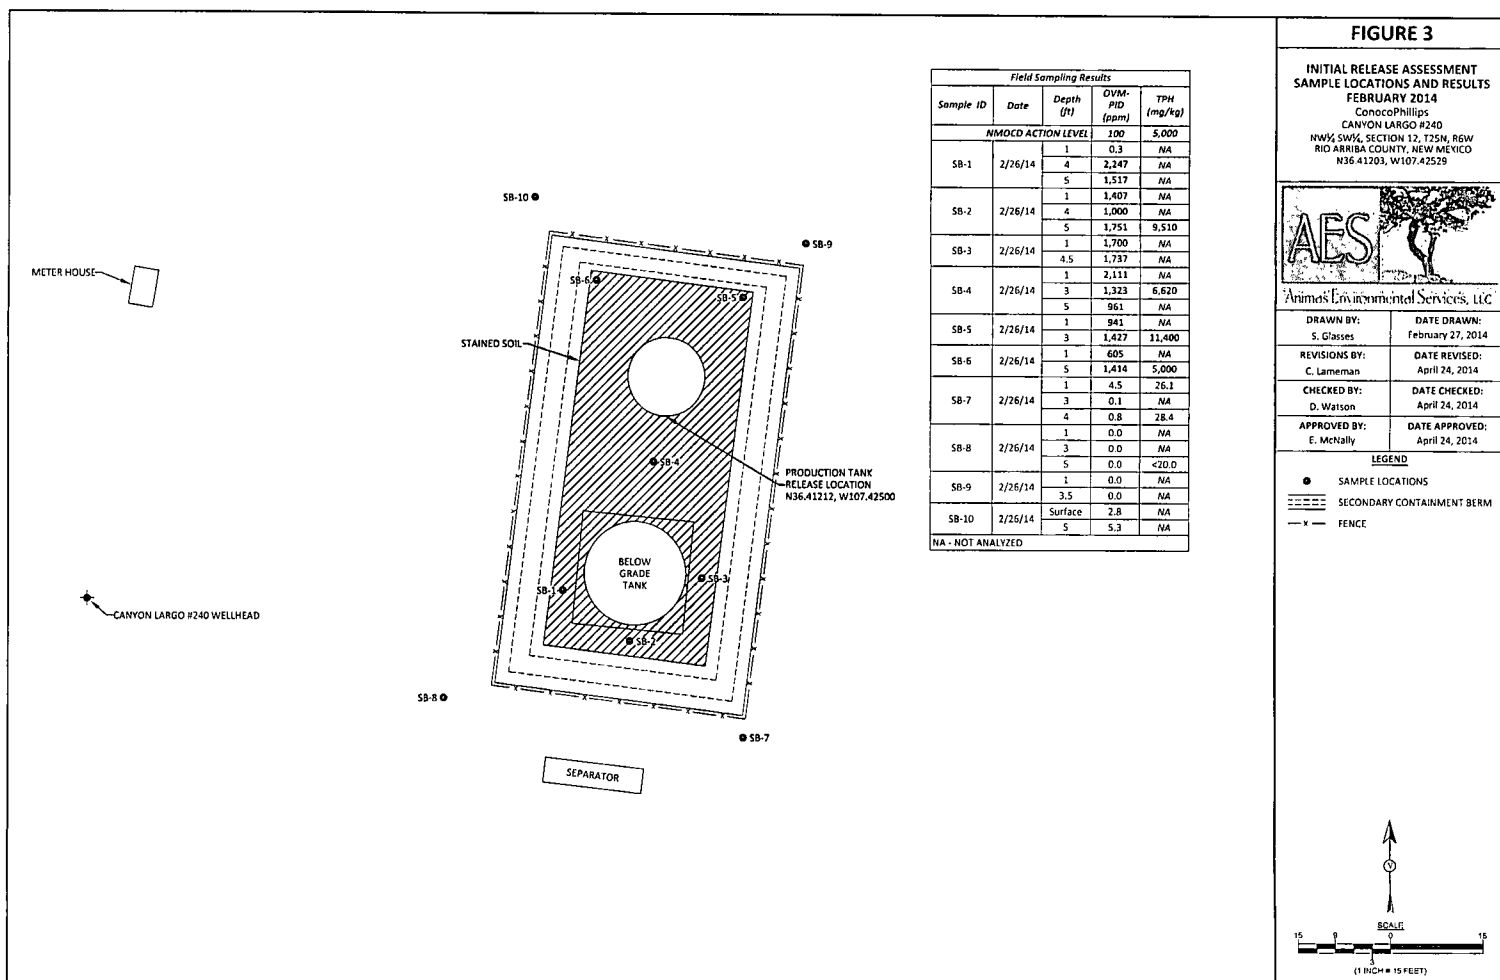
AES was initially contacted by Lindsay Dumas of CoP on February 24, 2014, and on February 26, 2014, Stephanie Lynn and Jesse Sprague of AES completed the release assessment field work. The assessment included collection and field sampling of 25 soil samples from 10 soil borings in and around the release area. Soil borings were terminated on sandstone between 3 and 5 feet. Based on the field sampling results, AES recommended further excavation of the release area. Sample locations are shown on Figure 3.

On February 26, 2014, initial assessment field screening results for VOCs via OVM showed concentrations ranging from 0.0 ppm in SB-8 and SB-9 up to 2,247 ppm in SB-1. Field TPH concentrations ranged from less than 20 mg/kg in SB-8 up to 11,400 mg/kg in SB-5.

Initial assessment field sampling results above the NMOCD action level of 100 ppm VOCs and 5,000 mg/kg TPH were reported in SB-1 through SB-6. The highest VOC concentration was reported in SB-1 with 2,247 ppm, and the highest TPH concentration was reported in SB-5 with 11,400 mg/kg.

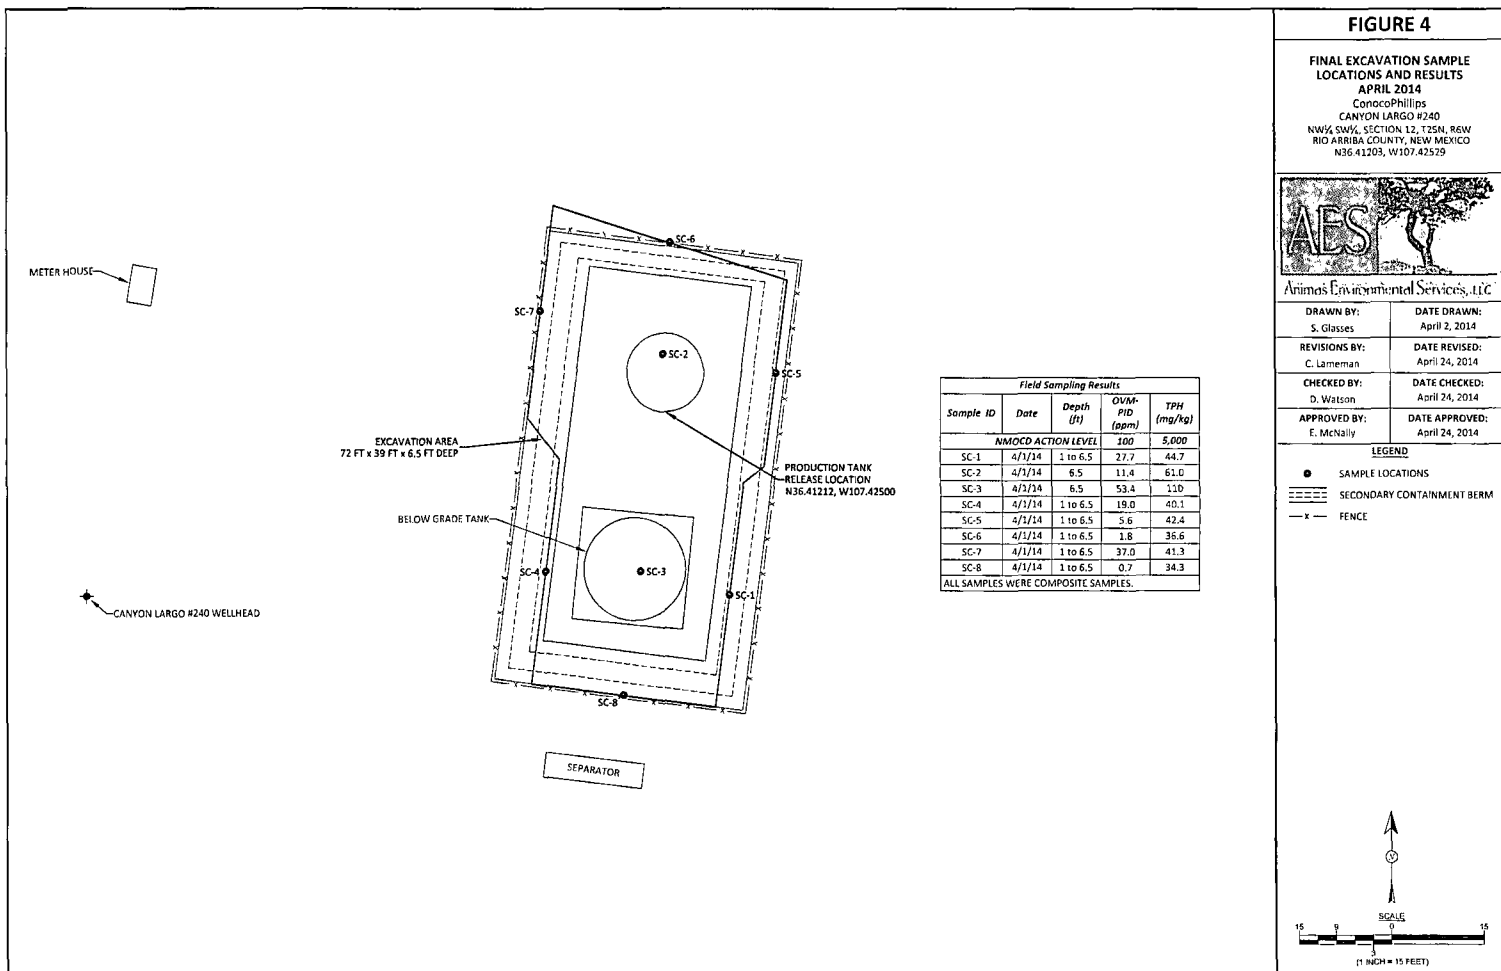
On April 1, 2014, AES returned to the location to collect confirmation soil samples of the excavation. The field sampling activities included collection of eight confirmation composite soil samples from the walls and base of the excavation. The area of the final excavation measured approximately 72 feet by 39 feet by 6.5 feet in depth. Sample locations and final excavation extents are presented on Figure 4.

On April 1, 2014, final excavation field screening results for VOCs via OVM ranged from 0.7 ppm in SC-8 up to 53.4 ppm in SC-3. Field TPH concentrations ranged from 34.3 mg/kg in SC-8 up to 110 mg/kg in SC-3. Field sampling results are included below in Table 1 and presented on Figures 3 and 4. The AES Field Sampling Reports are attached.

On April 1, 2014, final clearance of the excavation area was completed. Field sampling results of the excavation extents showed that VOC and TPH concentrations were below applicable NMOCD action levels for the final walls and base of the excavation.

Based on final field sampling results of the excavation of petroleum contaminated soils at the Canyon Largo #240, VOC and TPH concentrations were below applicable NMOCD action levels for each of the sidewalls and base of the excavation. No further work is recommended.
