**Release Notification and Corrective Action**

Name of Company <b>ConocoPhillips Company</b>	Contact <b>Lisa Hunter</b>	
Address <b>3401 East 30<sup>th</sup> St, Farmington, NM</b>	Telephone No. <b>(505) 326-9786</b>	
Facility Name: <b>San Juan 29-6 Unit 84</b>	Facility Type: <b>Gas Well</b>	
Surface Owner <b>BLM</b>	Mineral Owner <b>BLM</b>	API No. <b>3003907623</b>

**RE: Initial Release Assessment and Final Excavation Report  
San Juan 29-6 #84  
Rio Arriba County, New Mexico**

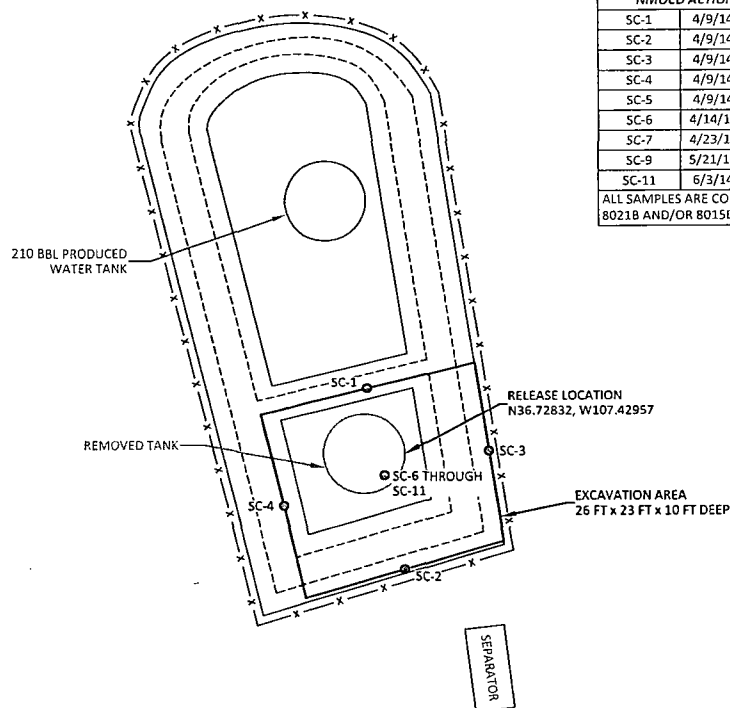
# FIGURE 4

Samples collected from the sandstone base of the excavation did not meet NMOCD action levels, and at the direction of BLM, the excavation remained open during April through early June while additional remedial activities and sampling events continued. Additional remedial activities included two applications of Quantum Growth™ (April and May 2014) and one application of potassium permanganate (June 2014). AES returned to the location in April, May, and June 2014 to resample the base and collect an additional six confirmation samples (SC-6 through SC-11). Sample locations and final excavation extents are presented on Figure 4.

**FINAL EXCAVATION SAMPLE  
LOCATIONS AND RESULTS  
APRIL THROUGH JUNE 2014**  
ConocoPhillips  
SAN JUAN 29-6 #84  
SW¼ NE¼, SECTION 14, T29N, R6W  
RIO ARriba COUNTY, NEW MEXICO  
N36.72859, W107.42938

Field Sampling Results				
Sample ID	Date	Depth (ft)	OVIM-PID (ppm)	TPH (mg/kg)
NMOC ACTION LEVEL			100	100
SC-1	4/9/14	1 to 10	407	27.8
SC-2	4/9/14	1 to 10	9.1	26.5
SC-3	4/9/14	1 to 10	1.1	<20.0
SC-4	4/9/14	1 to 10	5.1	<20.0
SC-5	4/9/14	10	3,888	NA
SC-6	4/14/14	10	2,356	2,100
SC-7	4/23/14	10	575	650
SC-8	5/7/14	10	2,506	2,210
SC-9	5/21/14	10	412	408
SC-10	5/30/14	10	843	463
SC-11	6/3/14	10	11.7	57.5

Laboratory Analytical Results						
Sample ID	Date	Depth (ft)	Benzene (mg/kg)	Total BTEX (mg/kg)	TPH - GRO (mg/kg)	TPH - DRO (mg/kg)
NMOC ACTION LEVEL			10	50		100
SC-1	4/9/14	1 to 10	<0.034	<0.17	<4.7	16
SC-2	4/9/14	1 to 10	NA	NA	<4.9	<10
SC-3	4/9/14	1 to 10	NA	NA	<4.7	<10
SC-4	4/9/14	1 to 10	NA	NA	<4.8	<10
SC-5	4/9/14	10	<0.34	111	1,500	870
SC-6	4/14/14	10	<0.79	87.4	940	800
SC-7	4/23/14	10	<0.19	1.5	130	250
SC-9	5/21/14	10	<0.039	0.21	20	260
SC-11	6/3/14	10	<0.024	0.42	12	<9.9

Based on the final field sampling and laboratory analytical results of the excavation of petroleum contaminated soils and subsequent applications of Quantum Growth™ and potassium permanganate at the San Juan 29-6 #84, VOCs, benzene, total BTEX, and TPH concentrations were below the applicable NMOCD action levels for each of the sidewalls and base of the excavation. No further work is recommended.
