Release Notification and Corrective Action

Name of Company: BP	Contact: Jeff Peace	
Address: 200 Energy Court, Farmington, NM 87401	Telephone No.: 505-326-9479	
Facility Name: Gallegos Canyon Unit 166E	Facility Type: Natural gas well	
Surface Owner: Tribal	Mineral Owner: Federal	API No. 3004524429

Gallegos Canyon Unit 166E  
(E) Sec 34 – T28N – R12W  
API: 30-045-24429  
San Juan County, New Mexico

## Summary Record of Impacted Soil Remediation

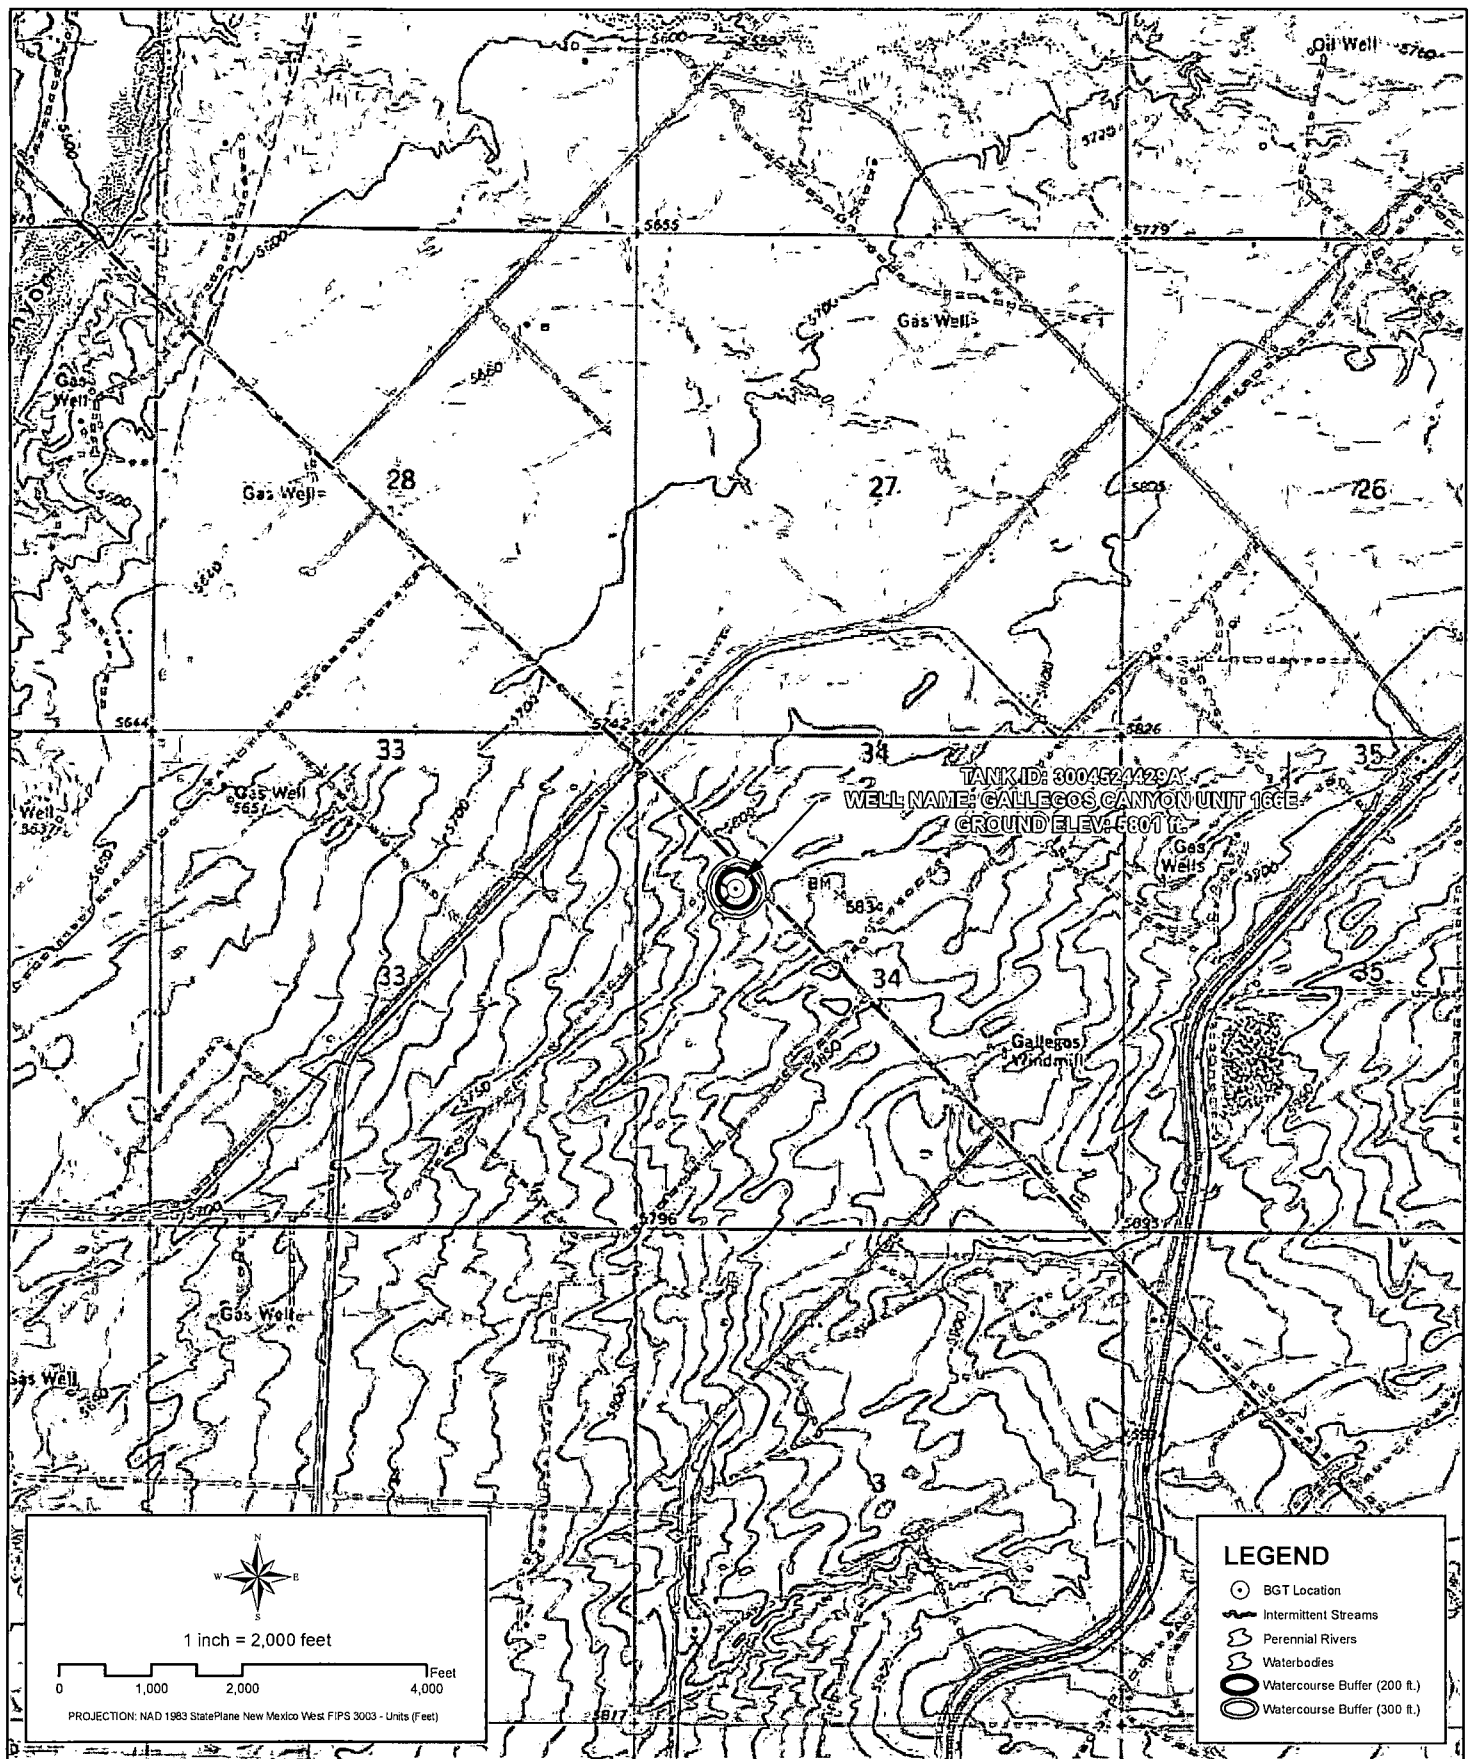
FIGURE 1

bgt relative position  
according to field  
report distance and  
bearing info.

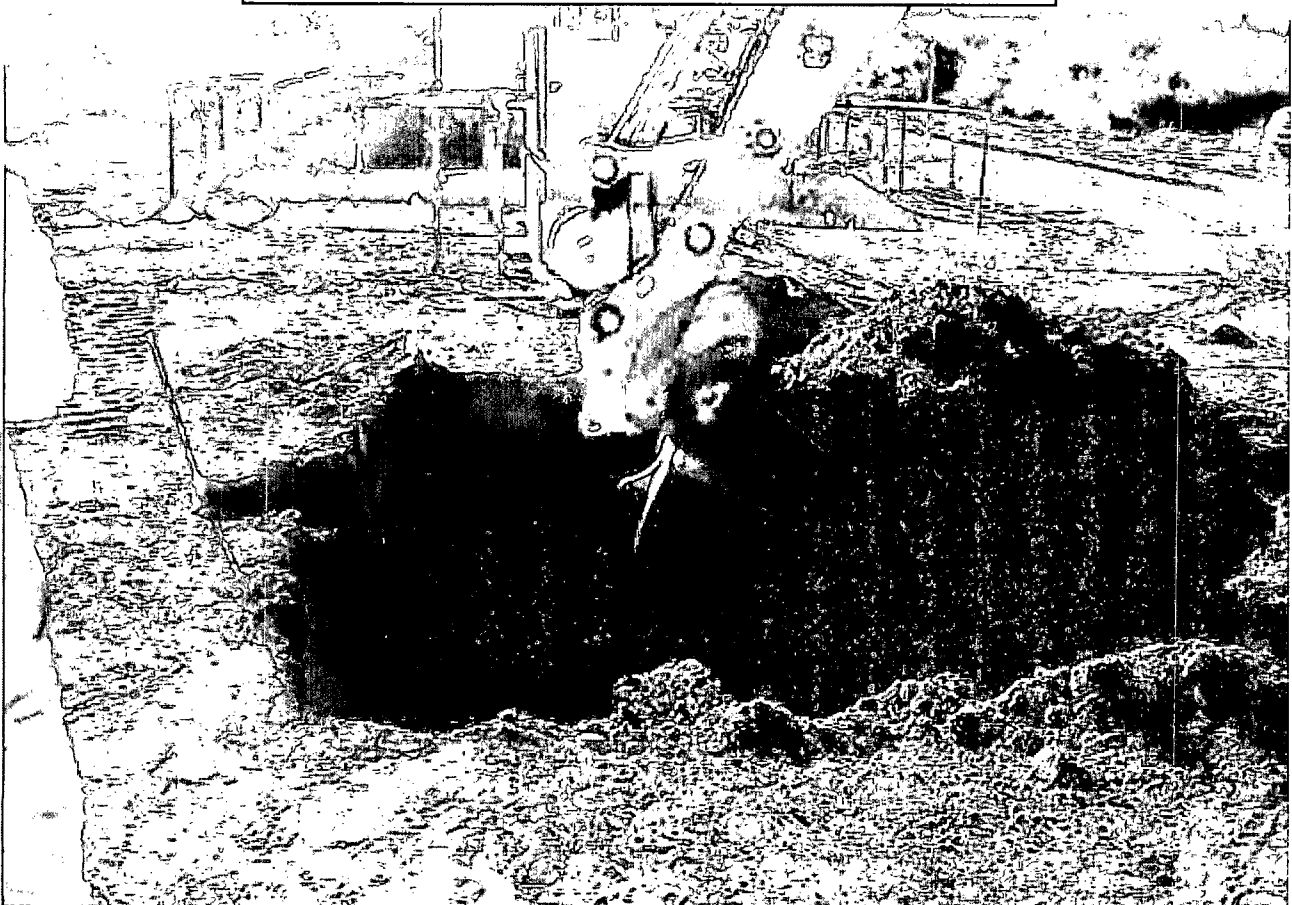
**10/02/2014 - Excavation initiated & viewing eastward**

October 2, 2014 Initiated site remediation by excavation with trackhoe. Evaluation of NMOCD's "Guidelines for Remediation of Leaks, Spills and Releases", dated August 13, 1993, for site ranking criteria indicated a closure standard of 100 mg/Kg for TPH based on groundwater depth estimated at less than 50' from the known impacted soil vertical depth. Final dimensions of the excavation was 15 ft. x 15 ft. x 8-8.5 ft. depth.
