Proposed Alternative Method Permit or Closure Plan Application

Burlington Resources Oil Gas Company, LP
San Juan Basin
Below Grade Tank Closure Report

Lease Name: Canyon Largo Unit 16
API No.: 3003960052

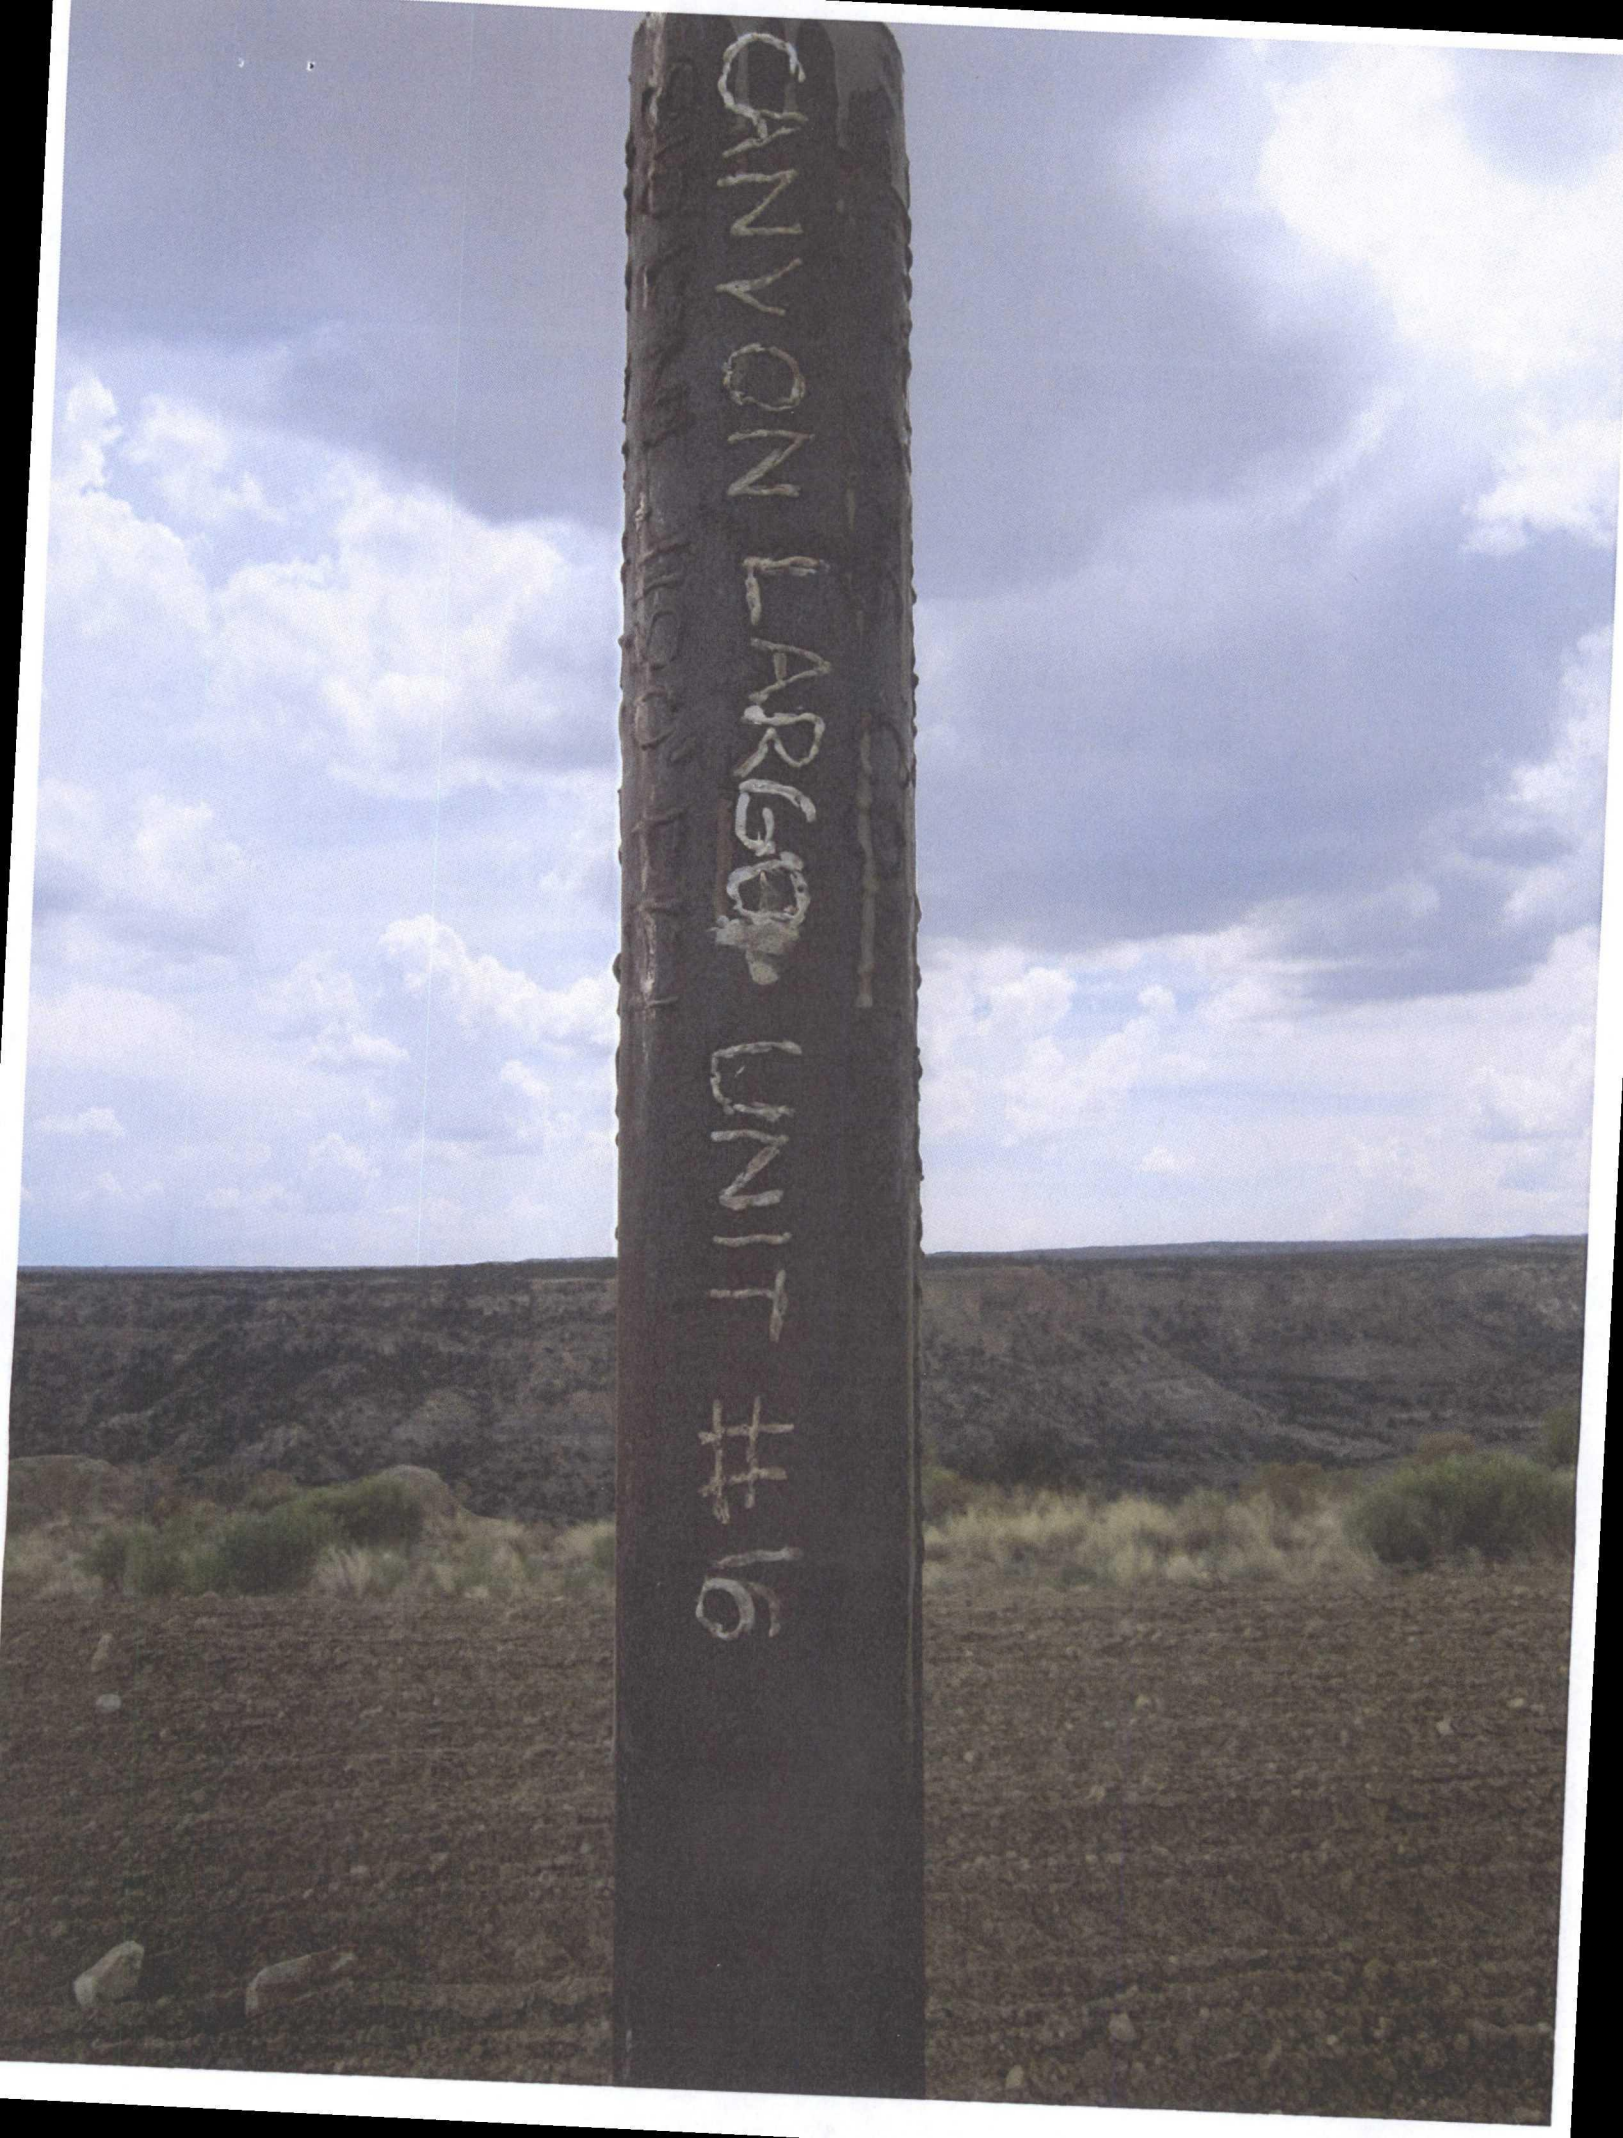
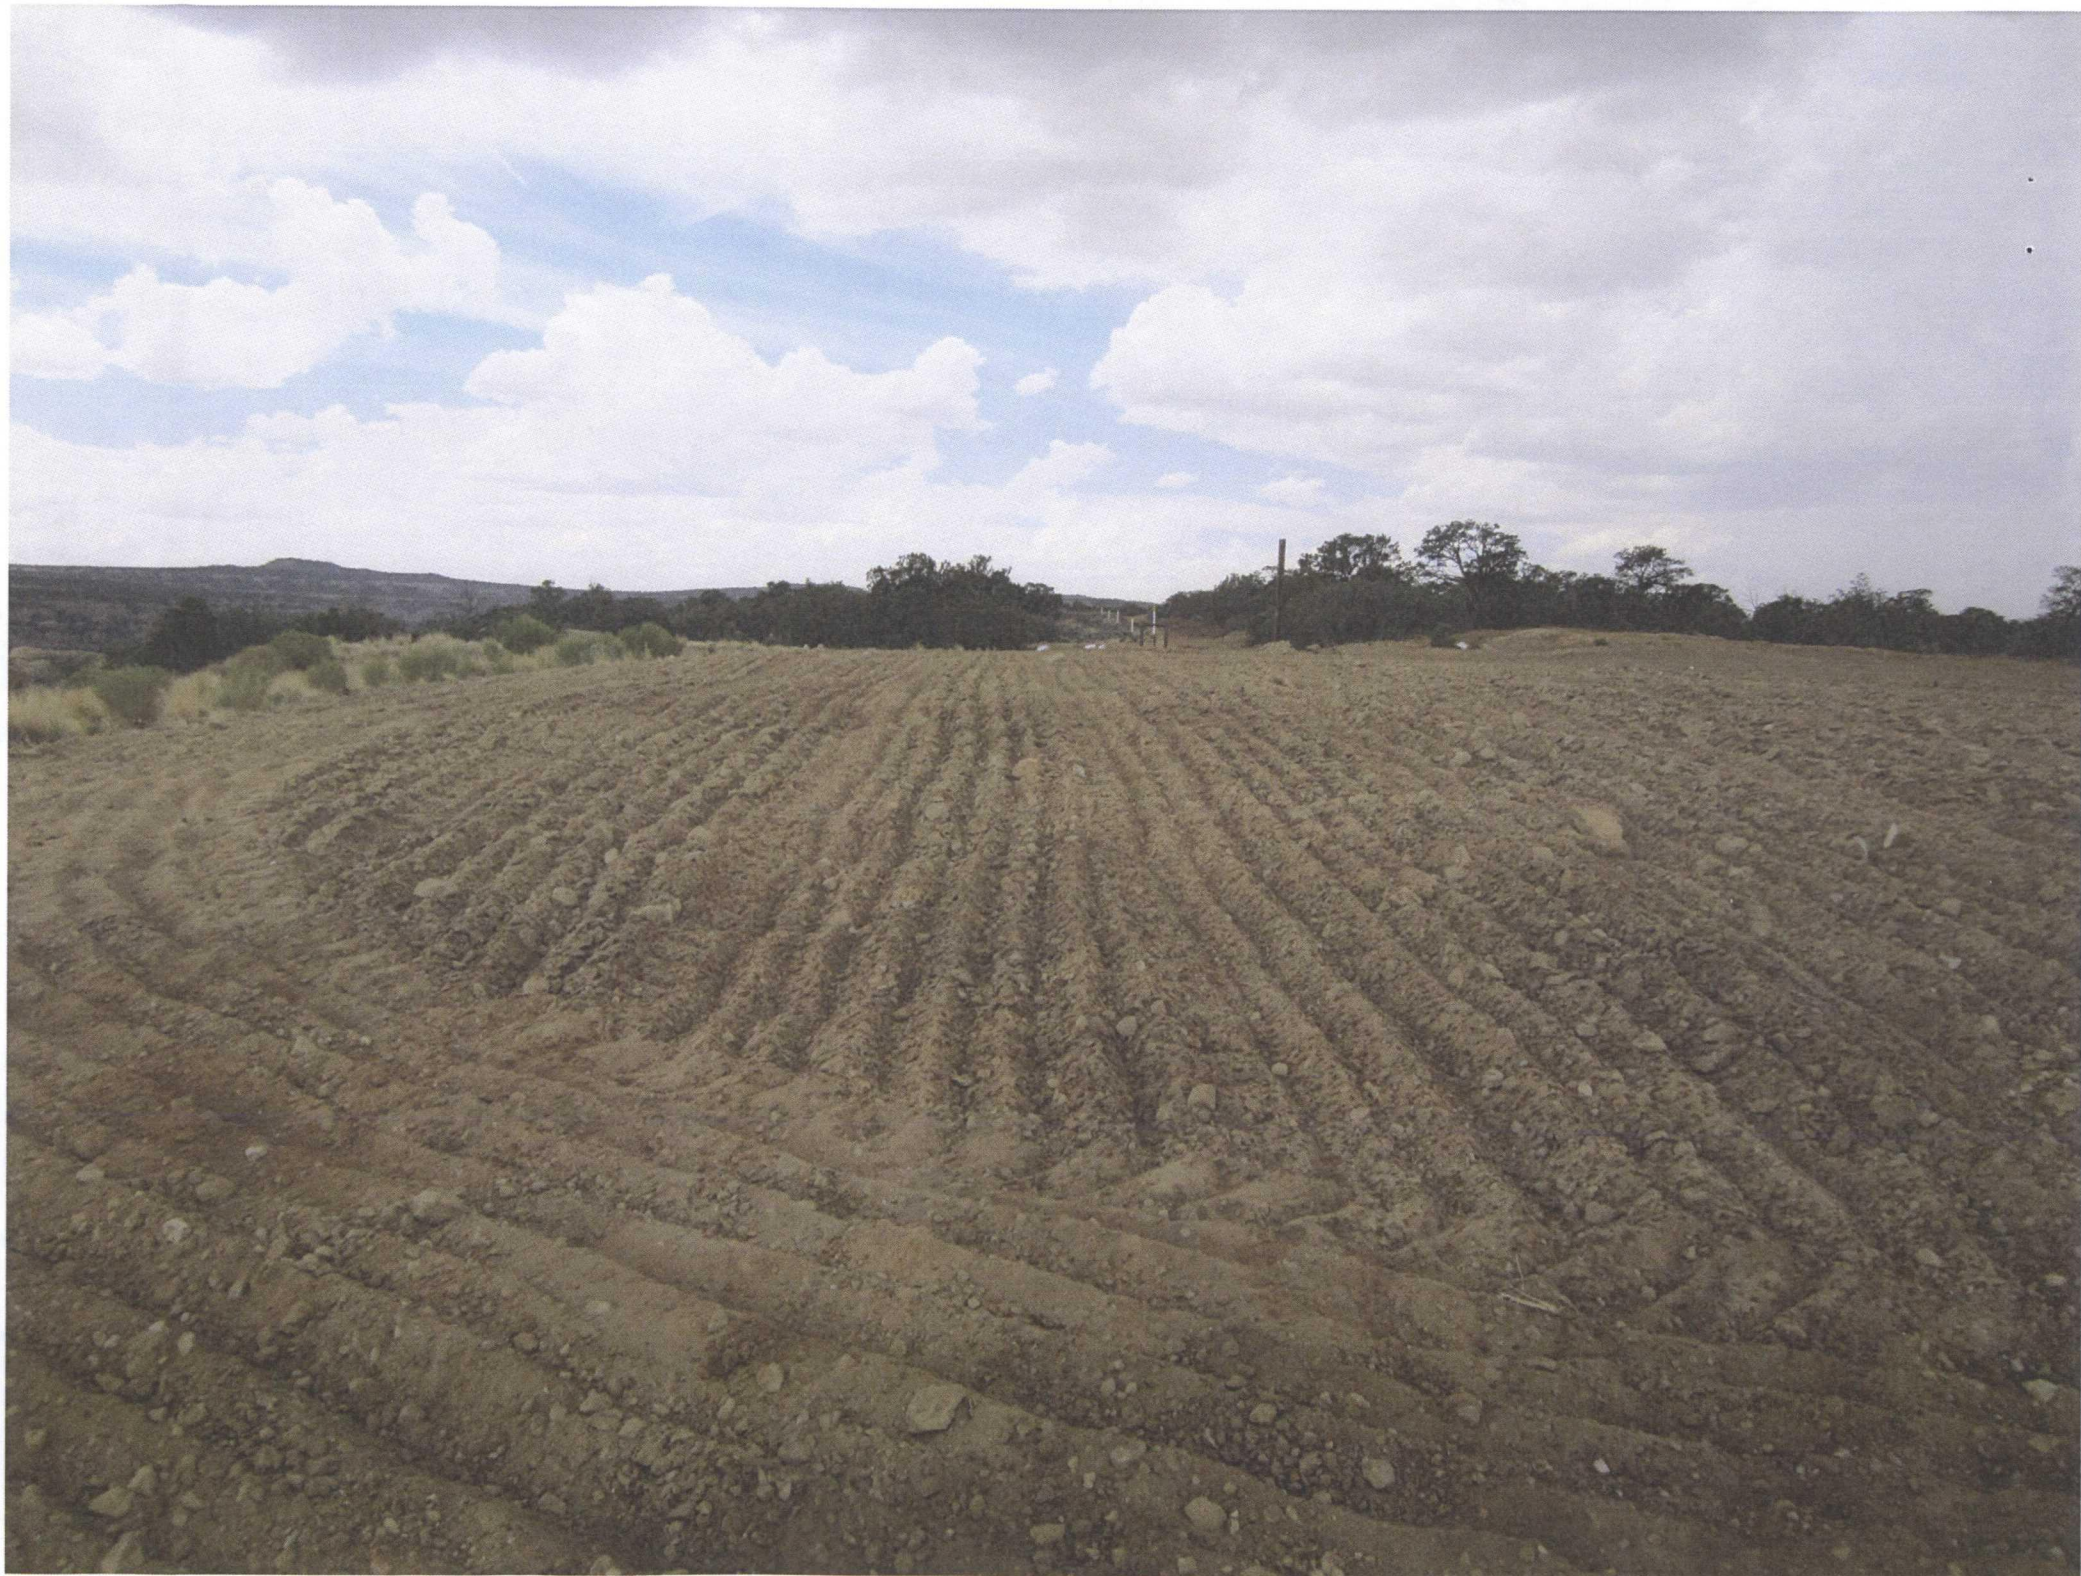
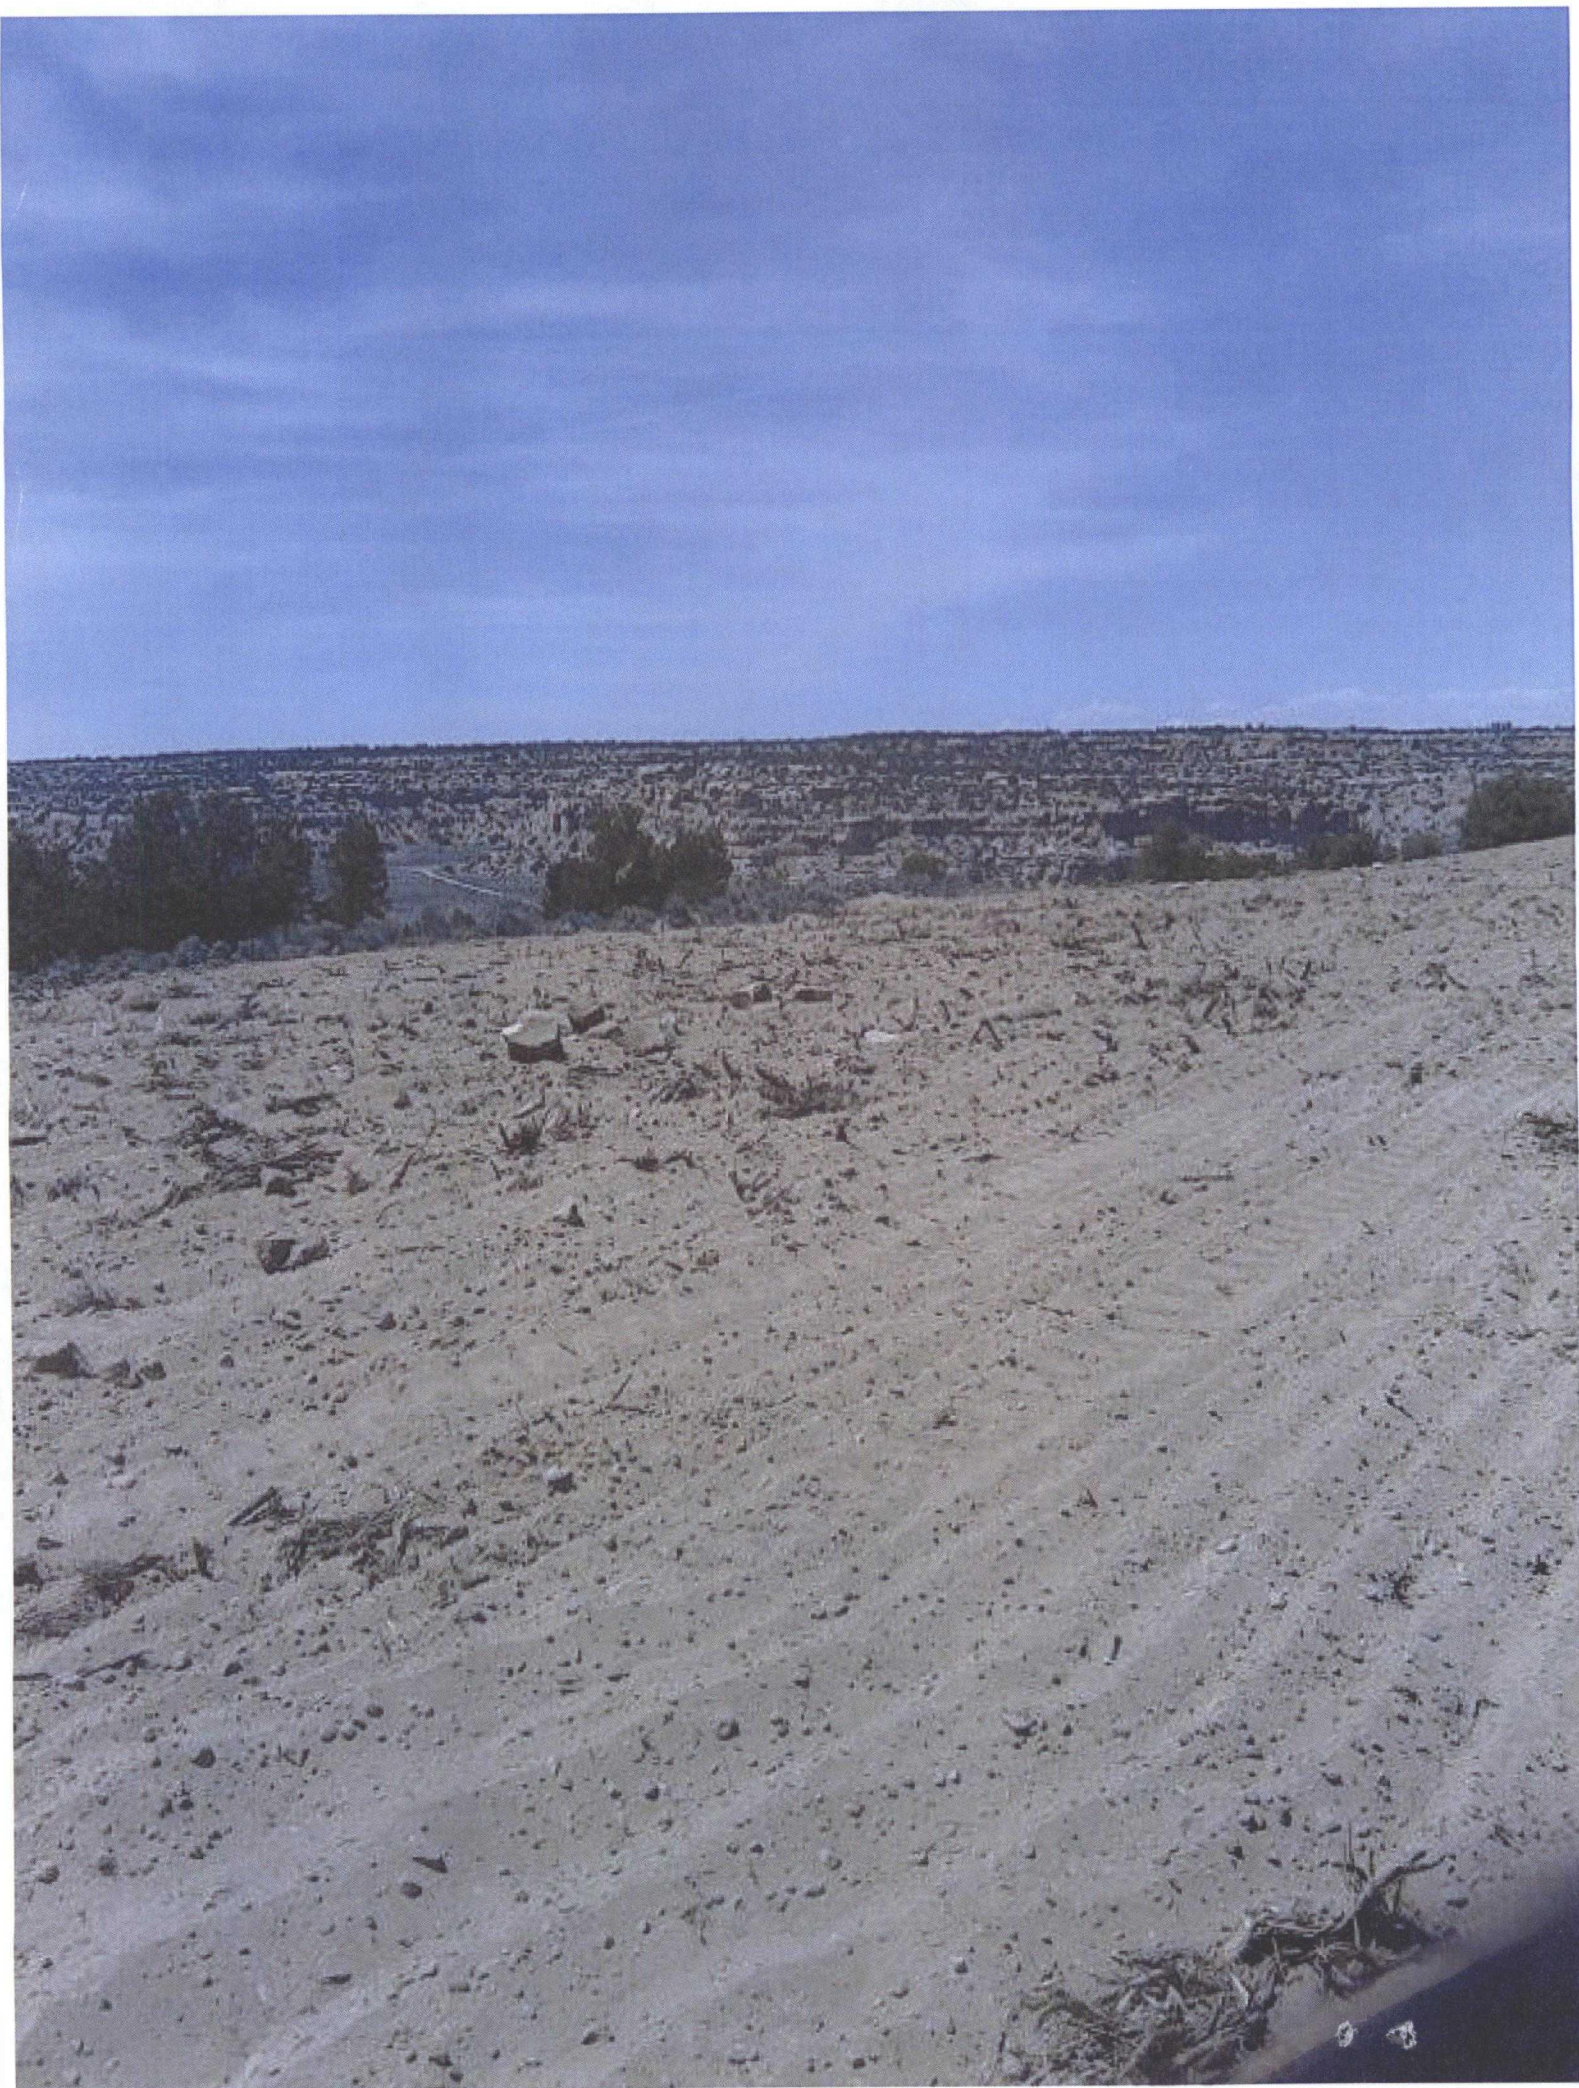
CANYON LARGO UNIT #16

The below-grade tank area was re-contoured to match fit, shape, line, form and texture of the surrounding area. Re-shaping, including drainage control, to prevent ponding and erosion. Natural drainages were unimpeded and water bars and/or silt traps were placed in areas where needed to prevent erosion on a large scale. Final recontour has a uniform appearance with smooth surface, fitting the natural landscape.
