13085 Proposed Alternative Method Permit or Closure Plan Application

Burlington Resources Oil Gas Company, LP
San Juan Basin
Below Grade Tank Closure Report

Lease Name: Crandell SRC 2
API No.: 30-045-10472

ConocoPhillips
CRANDELL SRC #2
SW¼ SW¼, SECTION 19, T31N, R10W
SAN JUAN COUNTY, NEW MEXICO
N36.87949, W107.92940

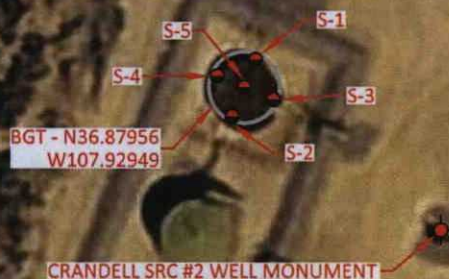
NMOCD action levels for BGT closures are specified in New Mexico Administrative Code (NMAC) 19.15.17.13E. Field TPH concentrations were below the NMOCD action level of 100 mg/kg, with the highest concentration reported in S-1, S-2, and S-4 with 20.0 mg/kg. Benzene and total BTEX concentrations in SC-1 were below the NMOCD action levels of 0.2 mg/kg and 50 mg/kg, respectively. Chloride concentrations in SC-1 were below the NMOCD action level of 250 mg/kg. Based on field sampling and laboratory analytical results for benzene, total BTEX, TPH, and chlorides, no further work is recommended at Crandell SRC #2.

Field Sampling Results				
Sample ID	Date	OVM-PID (ppm)	TPH (mg/kg)	Chlorides (mg/kg)
NMOCD ACTION LEVEL		--	100	250
S-1	10/28/14	1.0	20.0	NA
S-2	10/28/14	12.8	20.0	NA
S-3	10/28/14	1.8	<20.0	NA
S-4	10/28/14	0.1	20.0	NA
S-5	10/28/14	0.8	<20.0	NA
SC-1	10/28/14	0.4	NA	40
SC-1 IS A 5-POINT COMPOSITE SAMPLE OF S-1 THROUGH S-5. NA - NOT ANALYZED

Laboratory Analytical Results						
Sample ID	Date	Benzene (mg/kg)	Total BTEX (mg/kg)	TPH - GRO (mg/kg)	TPH - DRO (mg/kg)	Chlorides (mg/kg)
NMOCD ACTION LEVEL		0.2	50	100		250
SC-1	10/28/14	<0.027	<0.135	<2.7	<9.9	<30
SAMPLE WAS ANALYZED PER USEPA METHOD 8021B, 8015D AND 300.0.
