Pit, Below-Grade Tank, or
Proposed Alternative Method Permit or Closure Plan Application

1. Operator: WPX Energy Production, LLC OGRID #: 120782
Address: PO Box 640/ 721 S Main, Aztec, New Mexico 87410
Facility or well name: Rosa Unit #165A
API Number: 30-039-26150 OCD Permit Number: _____
U/L or Qtr/Qtr B Section 25 Township 31N Range 06W County: Rio Arriba
Center of Proposed Design: Latitude N36.8743 36.87470 N Longitude W107.41 107.41066 W NAD: ☐ 1927 ☒ 1983
Surface Owner: ☒ Federal ☐ State ☐ Private ☐ Tribal Trust or Indian Allotment
JK off of C-141 10/20/2015

Photograph Log
Rosa Unit 165A BGT Closure
WPX Energy

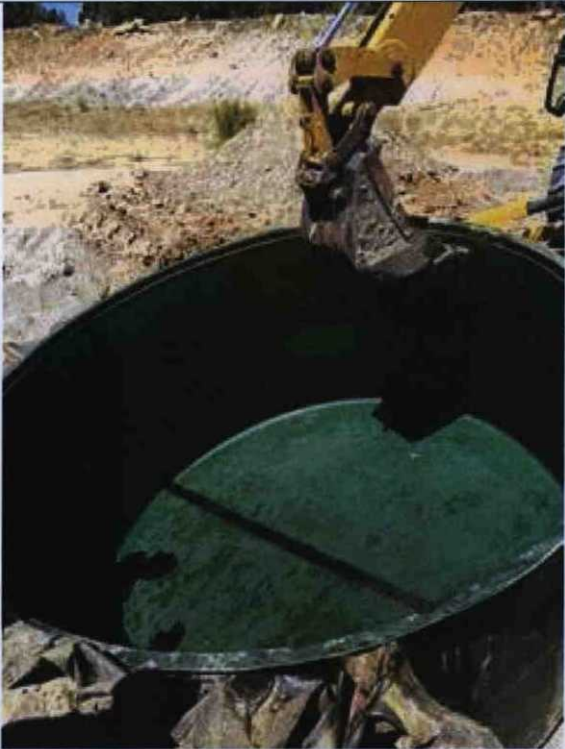
Photograph 1	
Site Name: Rosa Unit 165A BGT Closure	
Date Photo Taken: August 14, 2015	
Location: N36.87460, W107.41050 B-25-31N-06W Rio Arriba County, New Mexico	
Photo Taken by: Deborah Watson	Description: Facing NW, BGT being removed from location. All fluids have been removed from the tank.

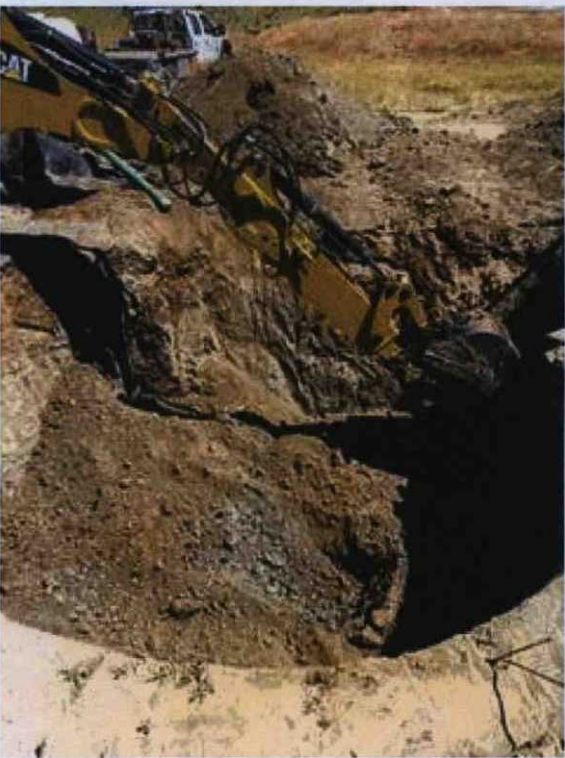
Photograph 2	
Site Name: Rosa Unit 165A BGT Closure	
Date Photo Taken: August 14, 2015	
Location: N36.87460, W107.41050 B-25-31N-06W Rio Arriba County, New Mexico	
Photo Taken by: Deborah Watson	Description: Facing NE, BGT and liner have been removed from containment. Sampling in progress.

A five point composite sample (SC-1) was collected from beneath the BGT following BGT removal on August 14, 2015. No obvious stained soils were observed below the BGT. The sample was submitted to Hall Environmental Analysis Laboratory, Albuquerque, NM, for analysis of benzene, BTEX, TPH, and chlorides. Attached is Form C-141 and laboratory analytical report.

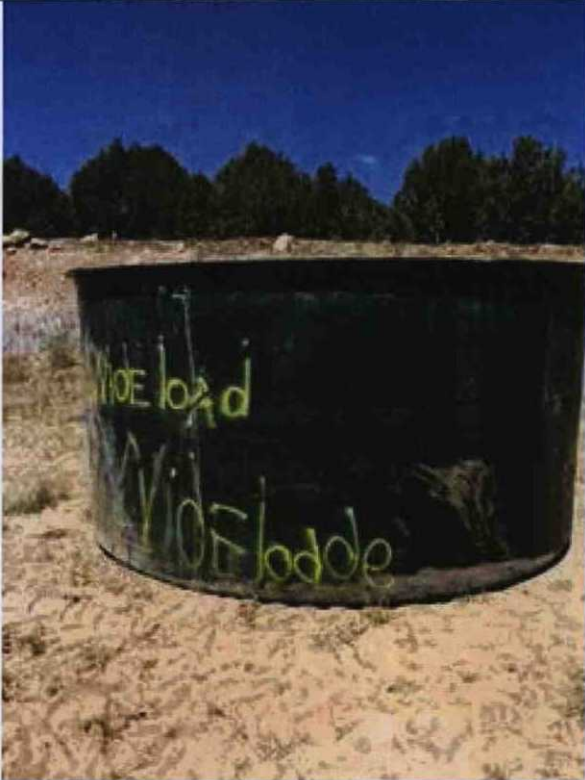
Photograph 3	
Site Name: Rosa Unit 165A BGT Closure	
Date Photo Taken: August 14, 2015	
Location: N36.87460, W107.41050 B-25-31N-06W Rio Arriba County, New Mexico	
Photo Taken by: Deborah Watson	Description: Facing NW, BGT following removal from containment.

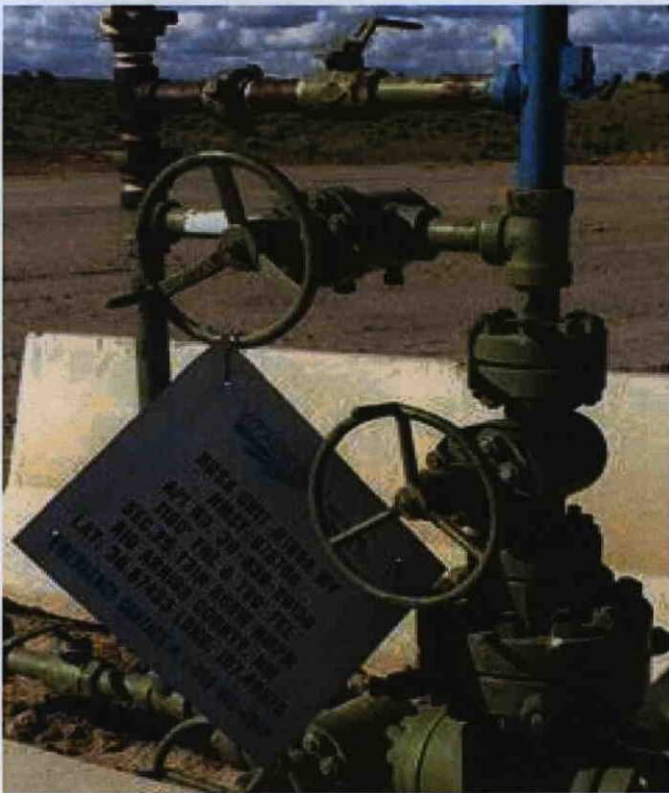
Photograph 4	
Site Name: Rosa Unit 165A BGT Closure	
Date Photo Taken: September 3, 2015	
Location: N36.87460, W107.41050 B-25-31N-06W Rio Arriba County, New Mexico	
Photo Taken by: Deborah Watson	Description: Facing NE, Rosa Unit #165A wellhead.

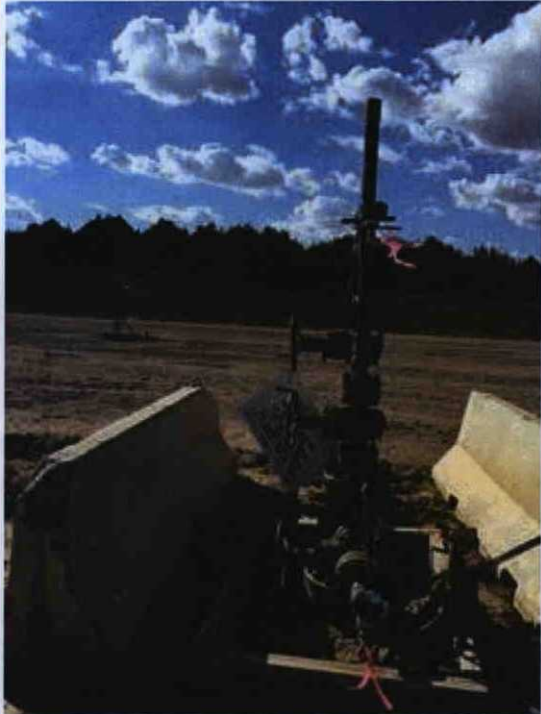
Photograph 5	
Site Name: Rosa Unit 165A BGT Closure	
Date Photo Taken: September 3, 2015	
Location: N36.87460, W107.41050 B-25-31N-06W Rio Arriba County, New Mexico	
Photo Taken by: Deborah Watson	Description: Facing N, looking at former BGT location. Area has been backfilled with clean fill dirt and compacted.

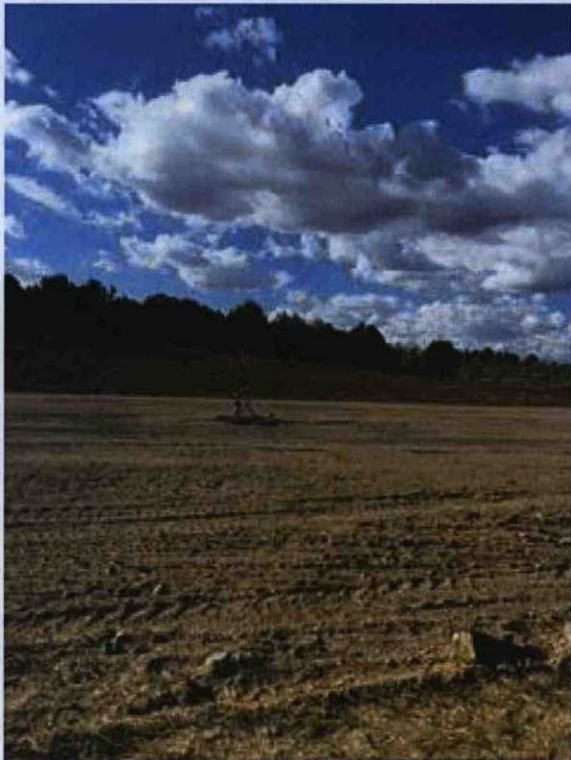
Photograph 6	
Site Name: Rosa Unit 165A BGT Closure	
Date Photo Taken: September 3, 2015	
Location: N36.87460, W107.41050 B-25-31N-06W Rio Arriba County, New Mexico	
Photo Taken by: Deborah Watson	Description: Facing N, looking at former BGT location. BGT location will be reclaimed once the area is no longer needed for production operations.
