ConocoPhillips Company
BGT Size Clarification

**ConocoPhillips Company
San Juan Basin
Below Grade Tank Closure Report
(Without Reclamation)**

Lease Name: San Juan 29-5 Unit 55

API No.: 30-039-20458

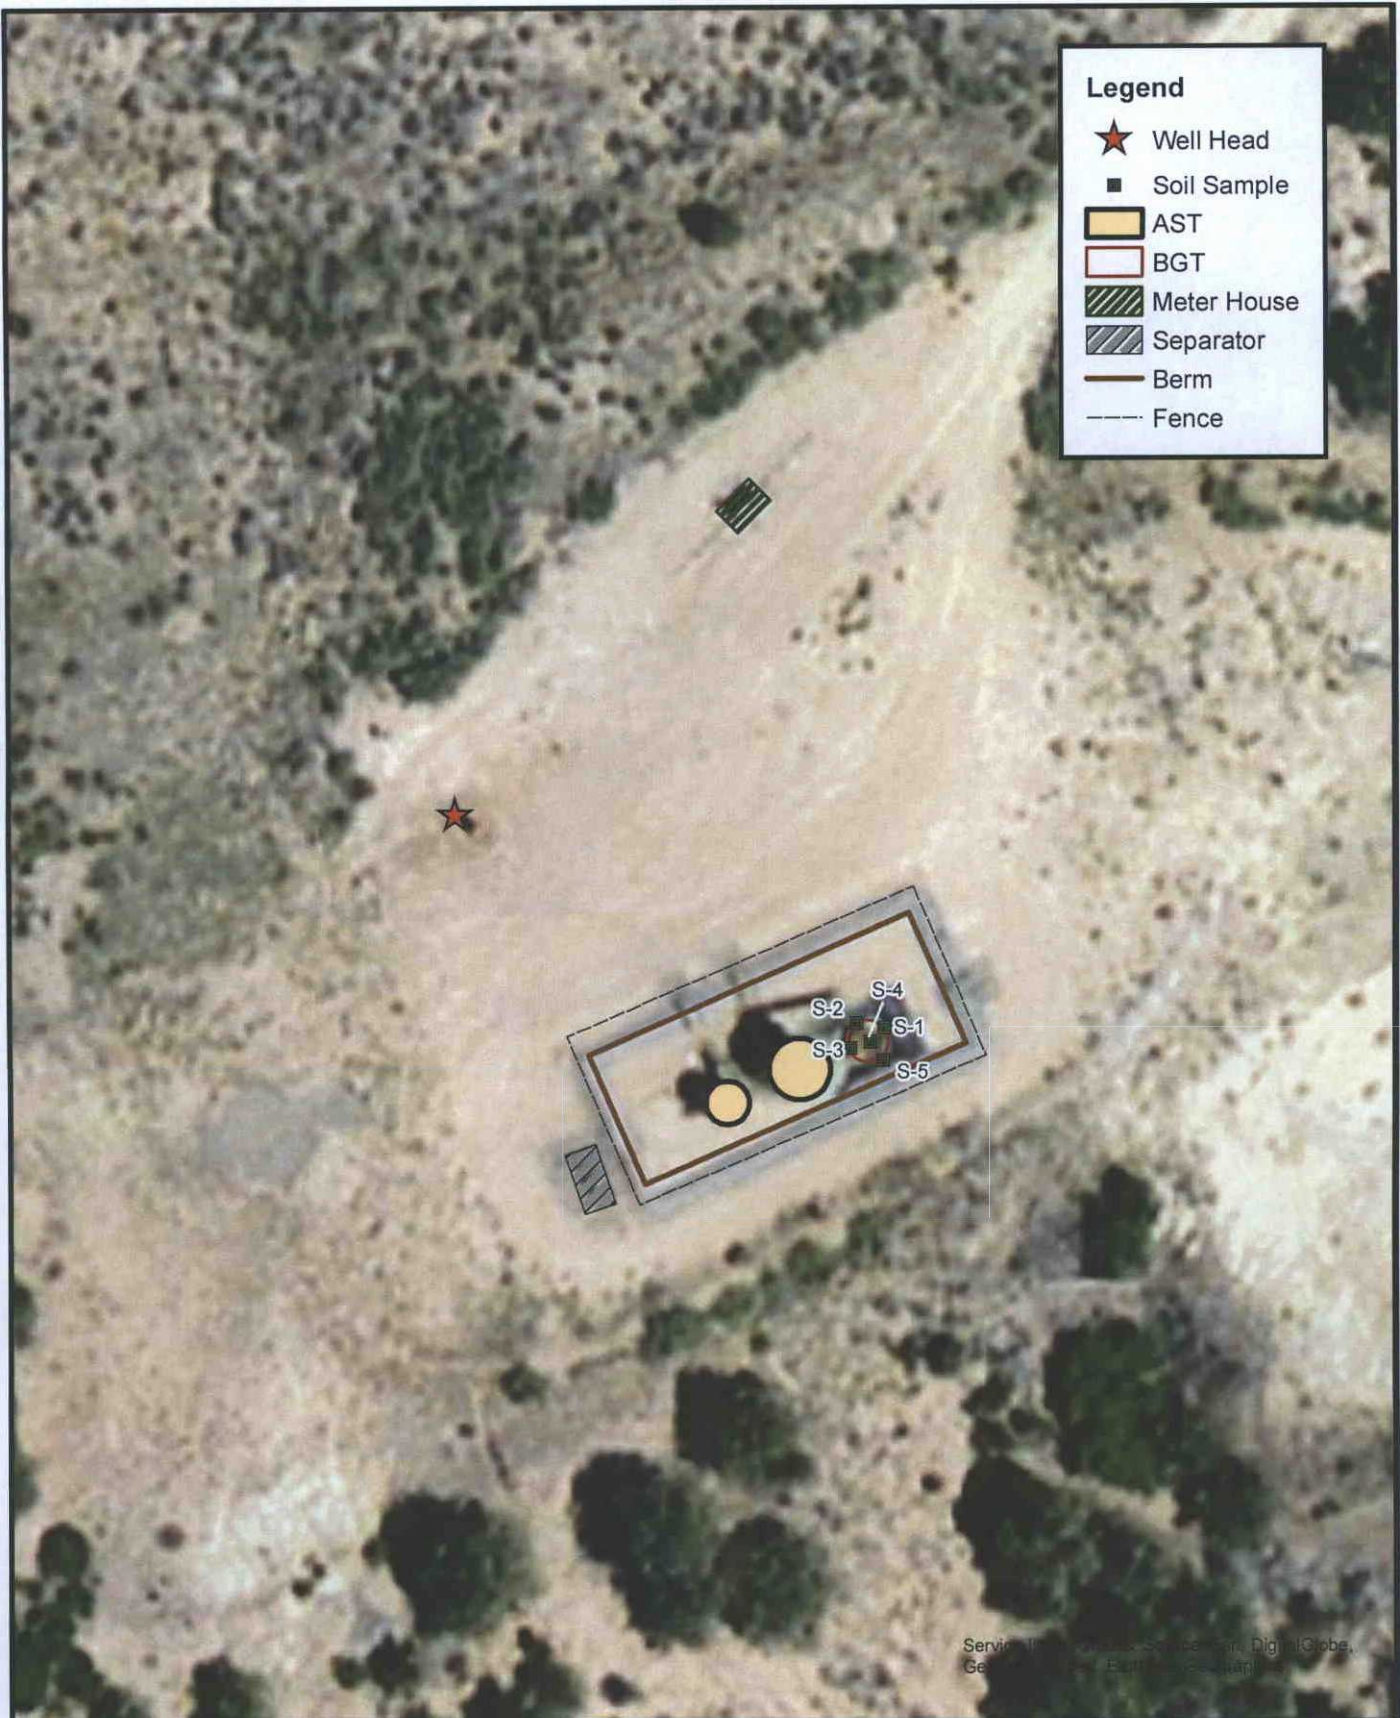
Observations: No staining or indication of a release.

SC-1 is a 5-point composite of S-1 through S-5, collected 0.5 ft below tank liner.

On July 22, 2015, following removal of the BGT tank and gravel, Rule personnel conducted a visual inspection for surface/subsurface indications of a release. No evidence of a release was observed. Rule personnel then collected five soil samples (S-1 through S-5) from 0.5 feet beneath the BGT liner. Figure 2 provides the location of the soil samples collected from below the BGT. The field work summary sheet is attached.
