# ConocoPhillips Company San Juan Basin Below Grade Tank Closure Report

Lease Name: San Juan 29-6 Unit 247R

API No.: 30-039-25414

RE: Below Grade Tank Closure Report

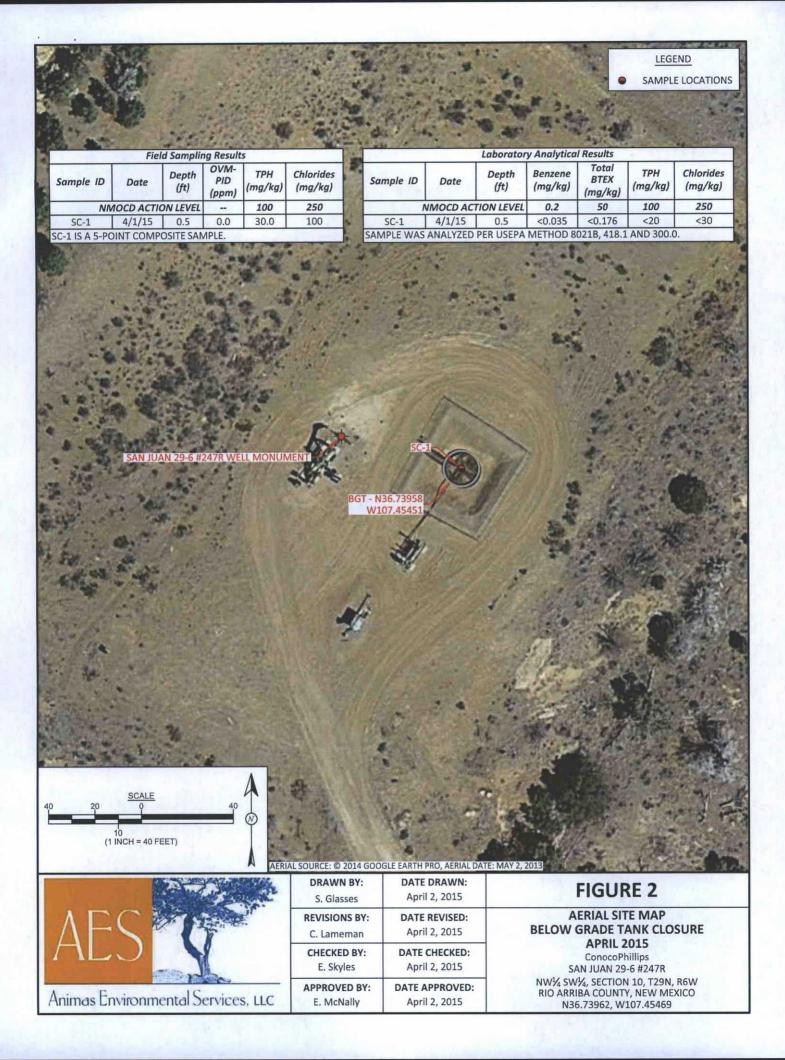
On April 1, 2015, AES personnel conducted field sampling and collected one 5-point composite (SC-1) from below the BGT. Soil was collected from approximately 0.5 feet below the former BGT. Soil sample SC-1 was field screened for volatile organic compounds (VOCs), total petroleum hydrocarbon (TPH), and chloride, and was submitted for confirmation laboratory analysis. Soil sample locations are included on Figure 2.

Field screening readings for VOCs via OVM were measured at 0.0 ppm in SC-1. Field TPH concentrations were reported at 30.0 mg/kg. The field chloride concentration was 100 mg/kg. Field sampling results are summarized in Table 1 and presented on Figure 2. The AES Field Sampling Report is attached.

Laboratory analytical results reported benzene and total BTEX concentrations in SC-1 as less than 0.035 mg/kg and 0.176 mg/kg, respectively. TPH concentrations were reported at less than 20 mg/kg. The laboratory chloride concentration was reported below the laboratory detection limit of 30 mg/kg. Laboratory analytical results are summarized in Table 2 and included on Figure 2. The laboratory analytical report is attached.
