Burlington Resources Oil Gas Company, LP San Juan Basin Below Grade Tank Closure Report (Without Reclamation)

Lease Name: San Juan 29-6 Unit 15C

API No.: 30-039-26704

RE: Below Grade Tank Closure Report

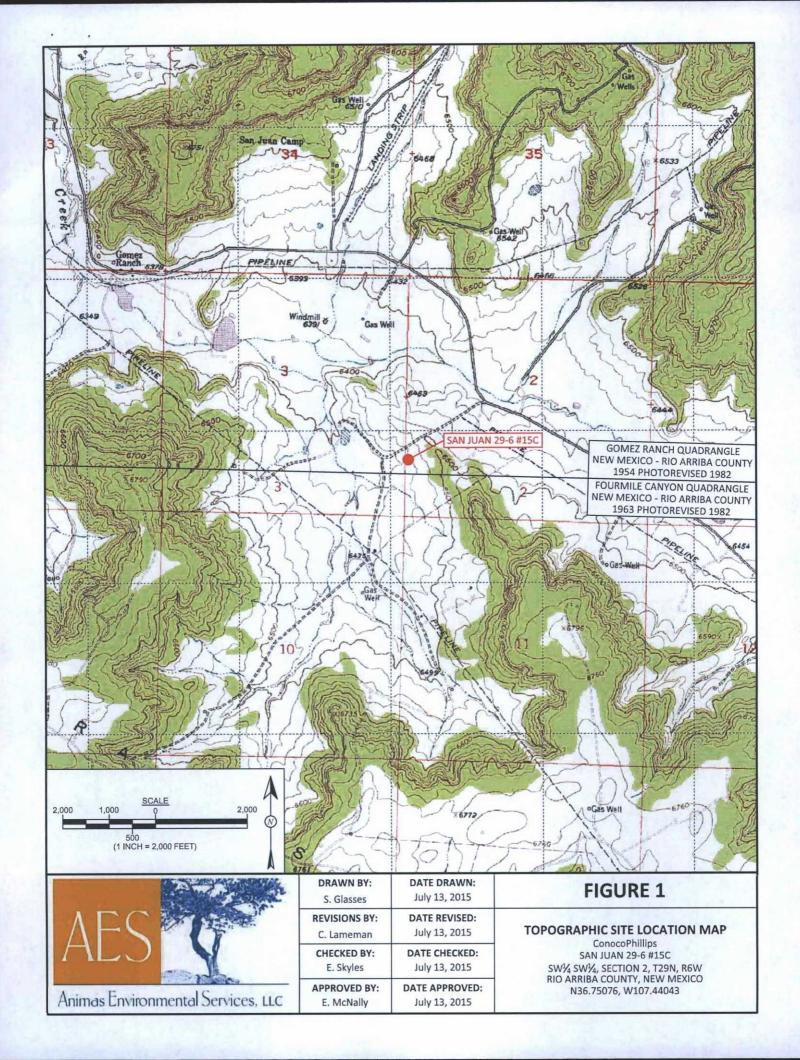
Site Name – San Juan 29-6 #15C
Legal Description – SW¼ SW¼, Section 2, T29N, R6W, Rio Arriba County, New Mexico
Well Latitude/Longitude – N36.75076 and W107.44043, respectively
BGT Latitude/Longitude – N36.75084 and W107.44025, respectively
Land Jurisdiction – State of New Mexico
Figure 1. Topographic Site Location Map
Figure 2. Aerial Site Map, July 2015

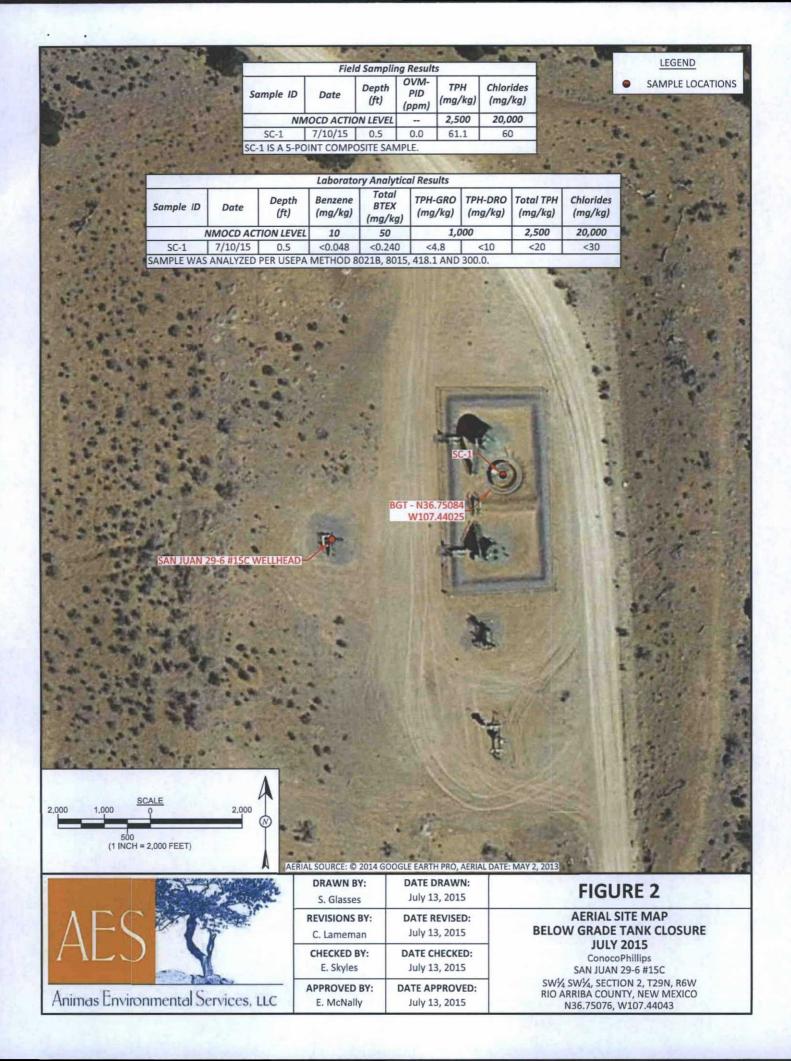
On July 10, 2015, AES personnel conducted field sampling and collected one 5-point composite (SC-1) from below the BGT. Soil was collected from approximately 0.5 feet below the former BGT. Soil sample SC-1 was field screened for volatile organic compounds (VOCs), total petroleum hydrocarbon (TPH), and chloride, and was submitted for confirmation laboratory analysis. Soil sample locations are included on Figure 2.

Field screening readings for VOCs via OVM were measured at 0.0 ppm in SC-1. Field TPH concentrations were reported at 61.1 mg/kg. The field chloride concentration was 60 mg/kg. Field sampling results are summarized in Table 1 and presented on Figure 2. The AES Field Sampling Report is attached.

Laboratory analytical results reported benzene and total BTEX concentrations in SC-1 as less than 0.048 mg/kg and 0.240 mg/kg, respectively. TPH (as GRO and DRO were reported at less than 4.8 mg/kg and 10 mg/kg, respectively. Total TPH concentrations were reported at less than 20 mg/kg. The laboratory chloride concentration was reported below the laboratory detection limit of 30 mg/kg. Laboratory analytical results are summarized in Table 2 and included on Figure 2. The laboratory analytical report is attached.

NMOCD action levels for BGT closures are specified in New Mexico Administrative Code (NMAC) 19.15.17.13 Table 1. Field TPH concentrations were below the NMOCD action level of 2,500 mg/kg, with a reported concentration of 61.1 mg/kg. Laboratory analytical results in SC-1 for TPH as GRO and DRO were reported below the NMOCD action level of 1,000 mg/kg, and total TPH results were reported below the NMOCD action level of 2,500 mg/kg. Benzene and total BTEX concentrations were below the NMOCD action levels of 10 mg/kg and 50 mg/kg, respectively. Chloride concentrations in SC-1 were below the NMOCD action level of 20,000 mg/kg. Based on field sampling and laboratory analytical results for benzene, total BTEX, TPH, and chlorides, no further work is recommended at San Juan 29-6 #15C.
