Form C-144
Revised June 6, 2013

**Burlington Resources Oil Gas Company, LP
San Juan Basin
Below Grade Tank Closure Report**

Lease Name: Crandell SRC 2

API No.: 30-045-10472

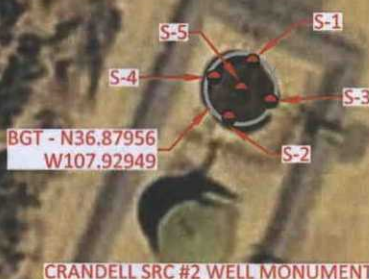
Sample ID	Date	Benzene (mg/kg)	Total BTEX (mg/kg)	TPH - GRO (mg/kg)	TPH - DRO (mg/kg)	Chlorides (mg/kg)
NMOCD ACTION LEVEL		0.2	50	100		250
SC-1	10/28/14	<0.027	<0.135	<2.7	<9.9	<30

SAMPLE WAS ANALYZED PER USEPA METHOD 8021B, 8015D AND 300.0.

AERIAL SOURCE: © 2014 GOOGLE EARTH PRO, AERIAL DATE: APRIL 4, 2013

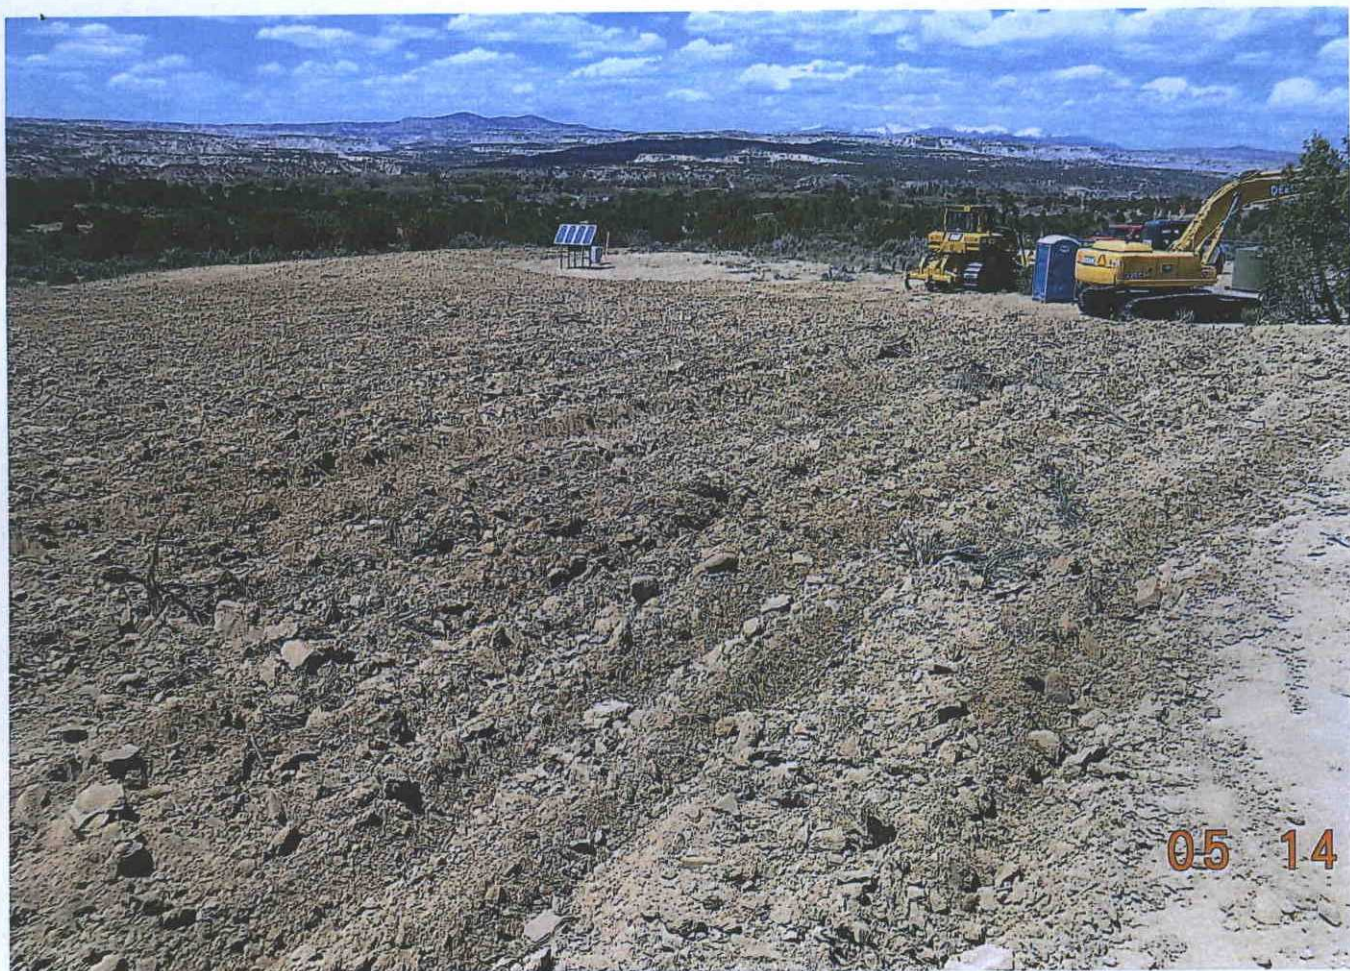
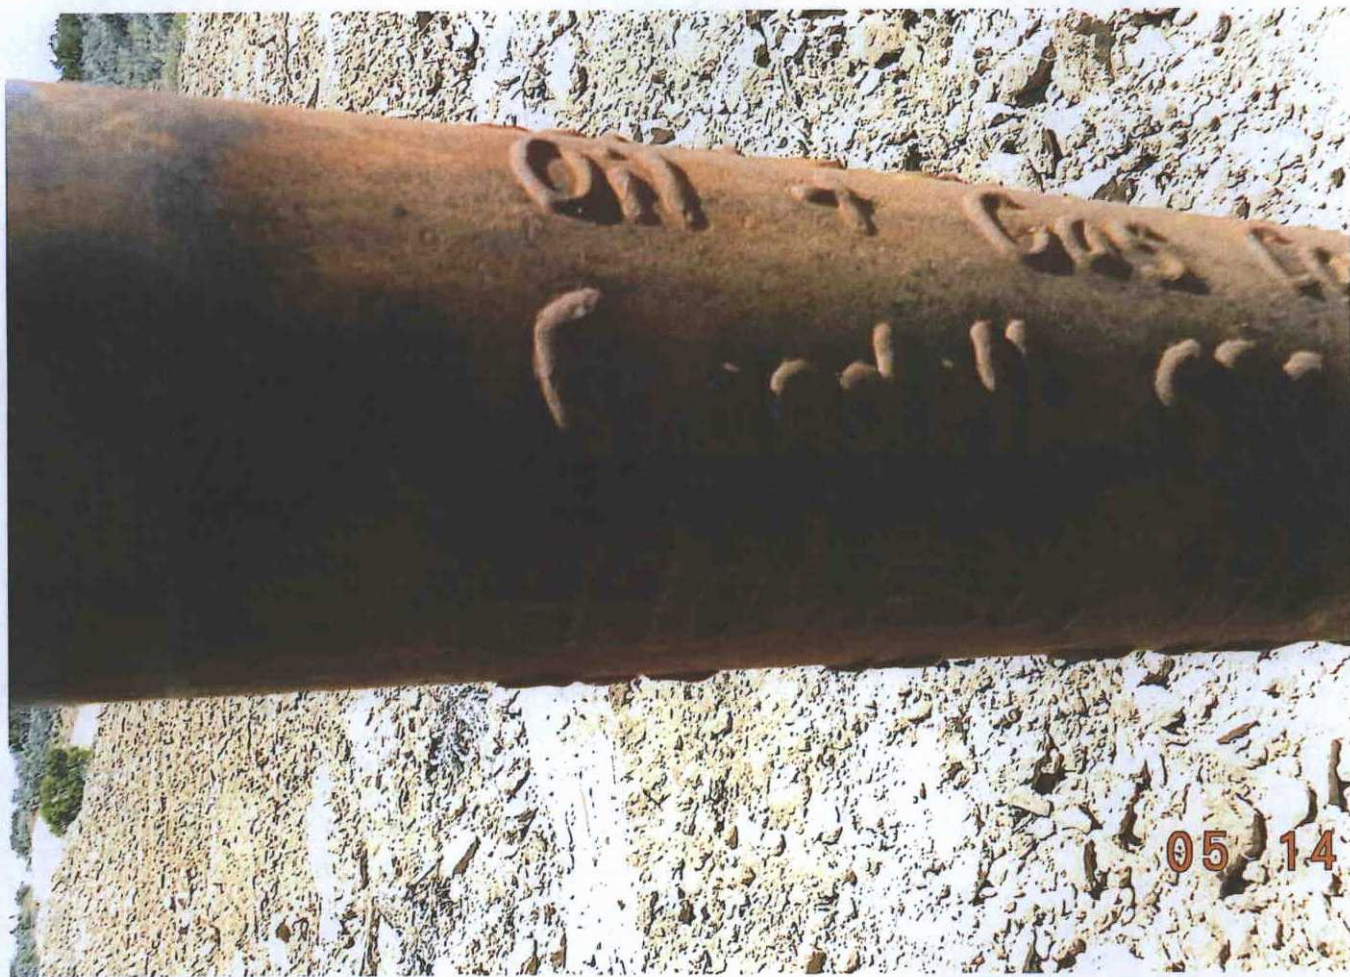
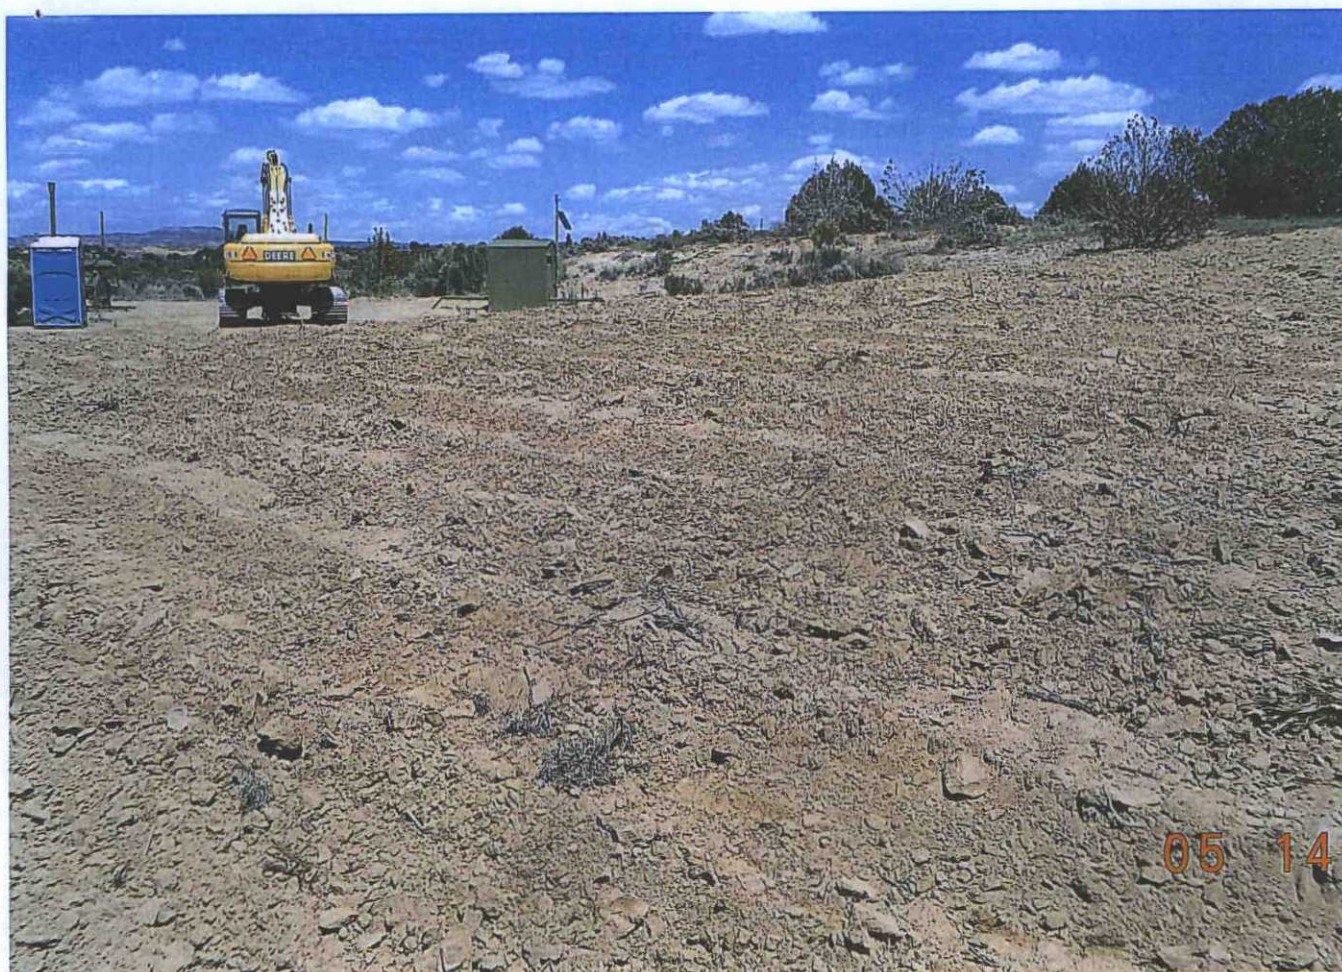
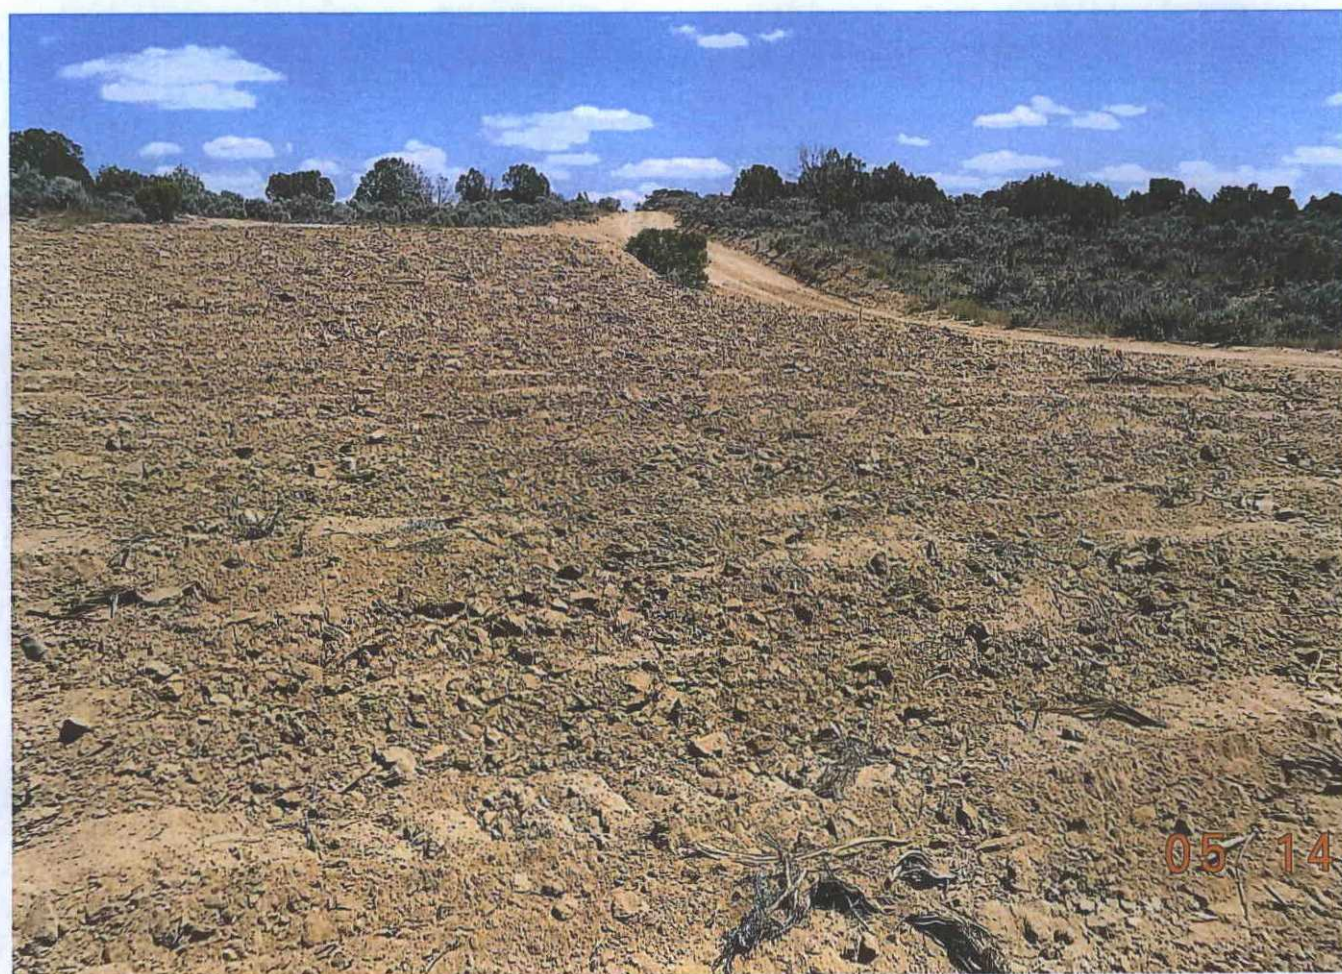
- ☒ Proof of Closure Notice (surface owner and division)
☐ Proof of Deed Notice (required for on-site closure for private land only)
☐ Plot Plan (for on-site closures and temporary pits)
☒ Confirmation Sampling Analytical Results (if applicable)
☐ Waste Material Sampling Analytical Results (required for on-site closure)
☐ Disposal Facility Name and Permit Number
☒ Soil Backfilling and Cover Installation
☒ Re-vegetation Application Rates and Seeding Technique
☒ Site Reclamation (Photo Documentation)
