13154 Proposed Alternative Method Permit or Closure Plan Application

Operator: Burlington Resources OGRID #: 14538
Address: PO BOX 4289, Farmington, NM 87499
Facility or well name: HUBBARD 2A
API Number: 30-045-22870 OCD Permit Number: _____
U/L or Qtr/Qtr O Section 11 Township 32N Range 12W County: San Juan
Center of Proposed Design: Latitude 36.99609°N Longitude -108.06177°W NAD: ☐ 1927 ☒ 1983
Surface Owner: ☐ Federal ☐ State ☒ Private ☐ Tribal Trust or Indian Allotment

Burlington Resources Oil & Gas Company, LP
San Juan Basin
Below Grade Tank Closure Report

Lease Name: Hubbard 2A
API No.: 30-045-22870

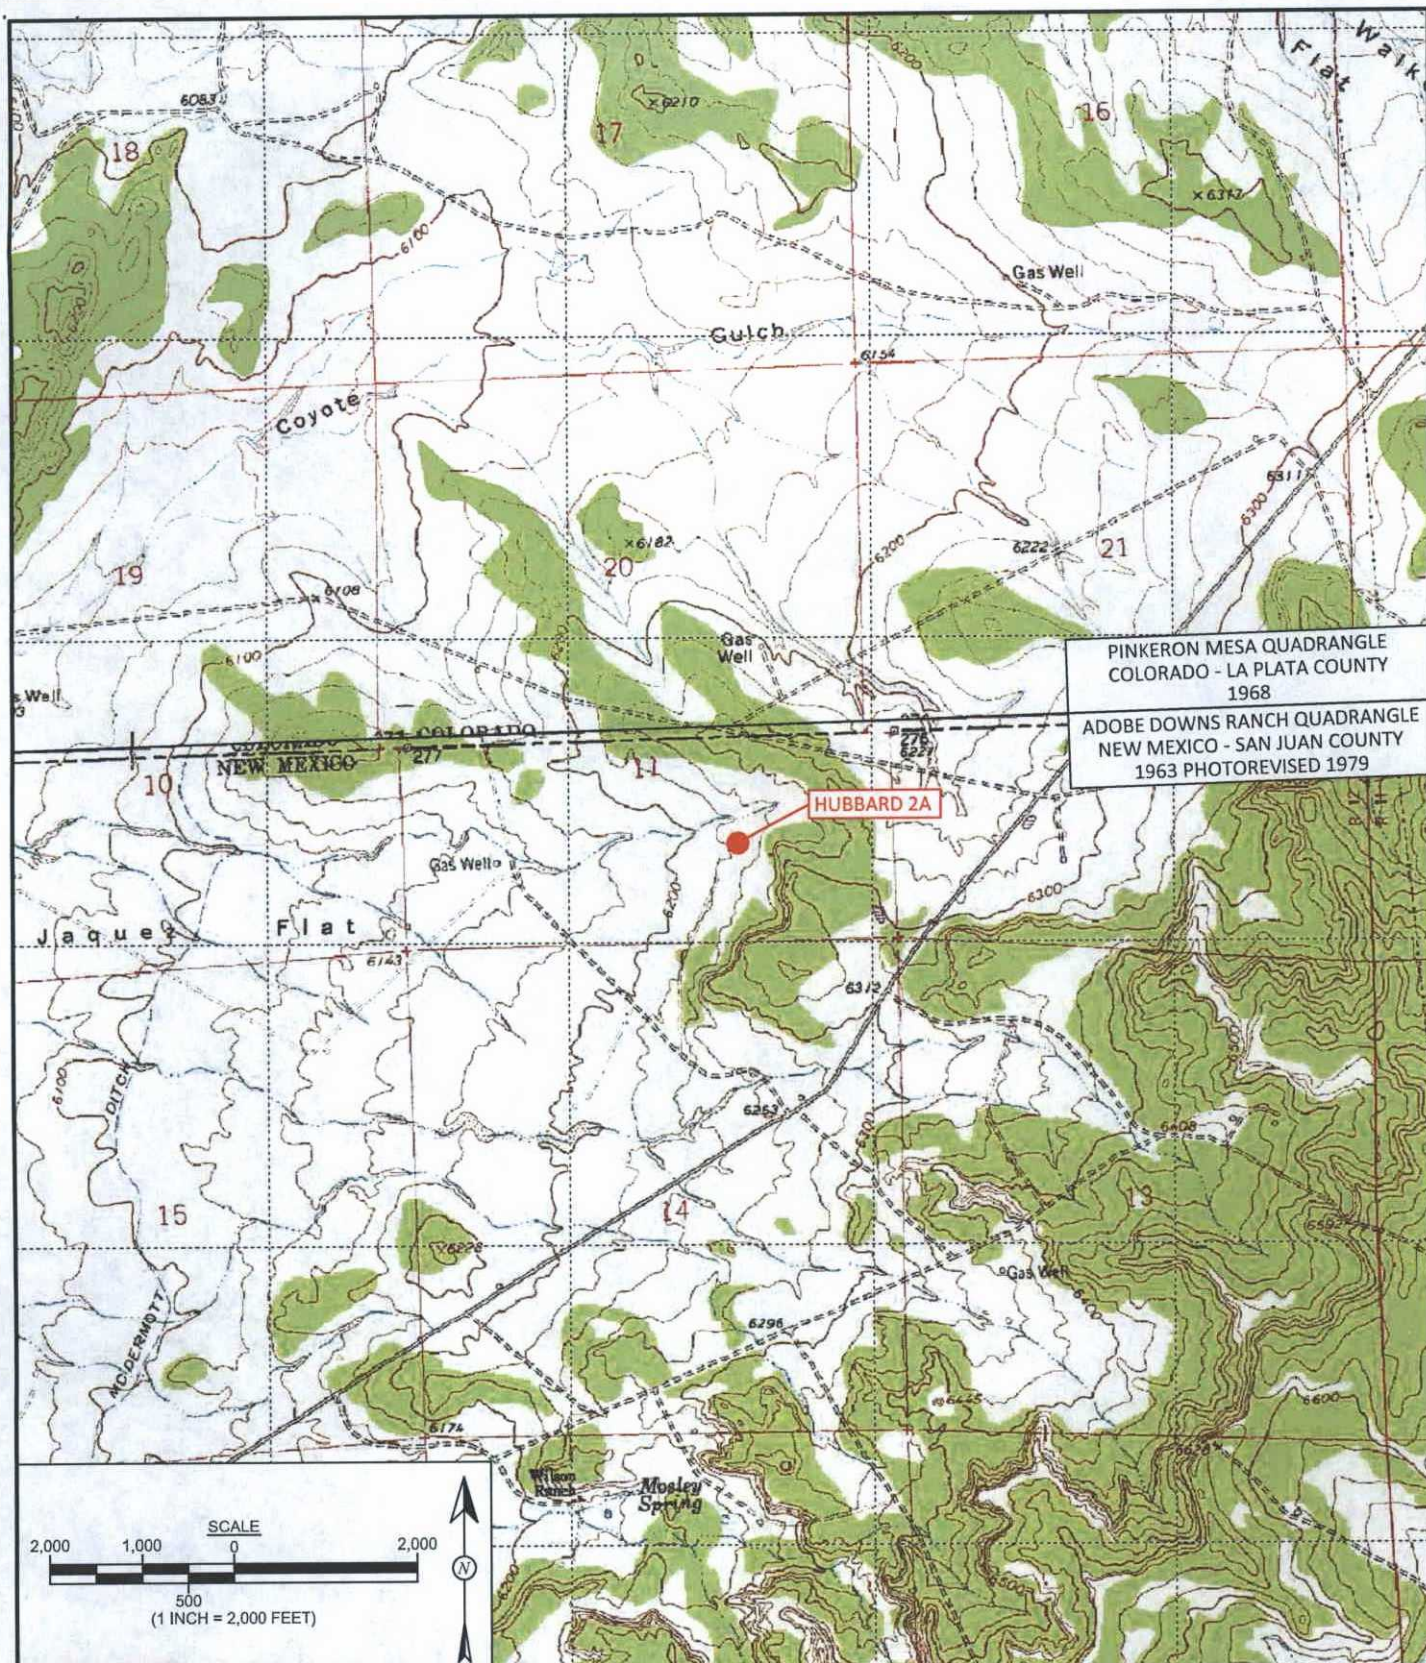
FIGURE 1

TOPOGRAPHIC SITE LOCATION MAP

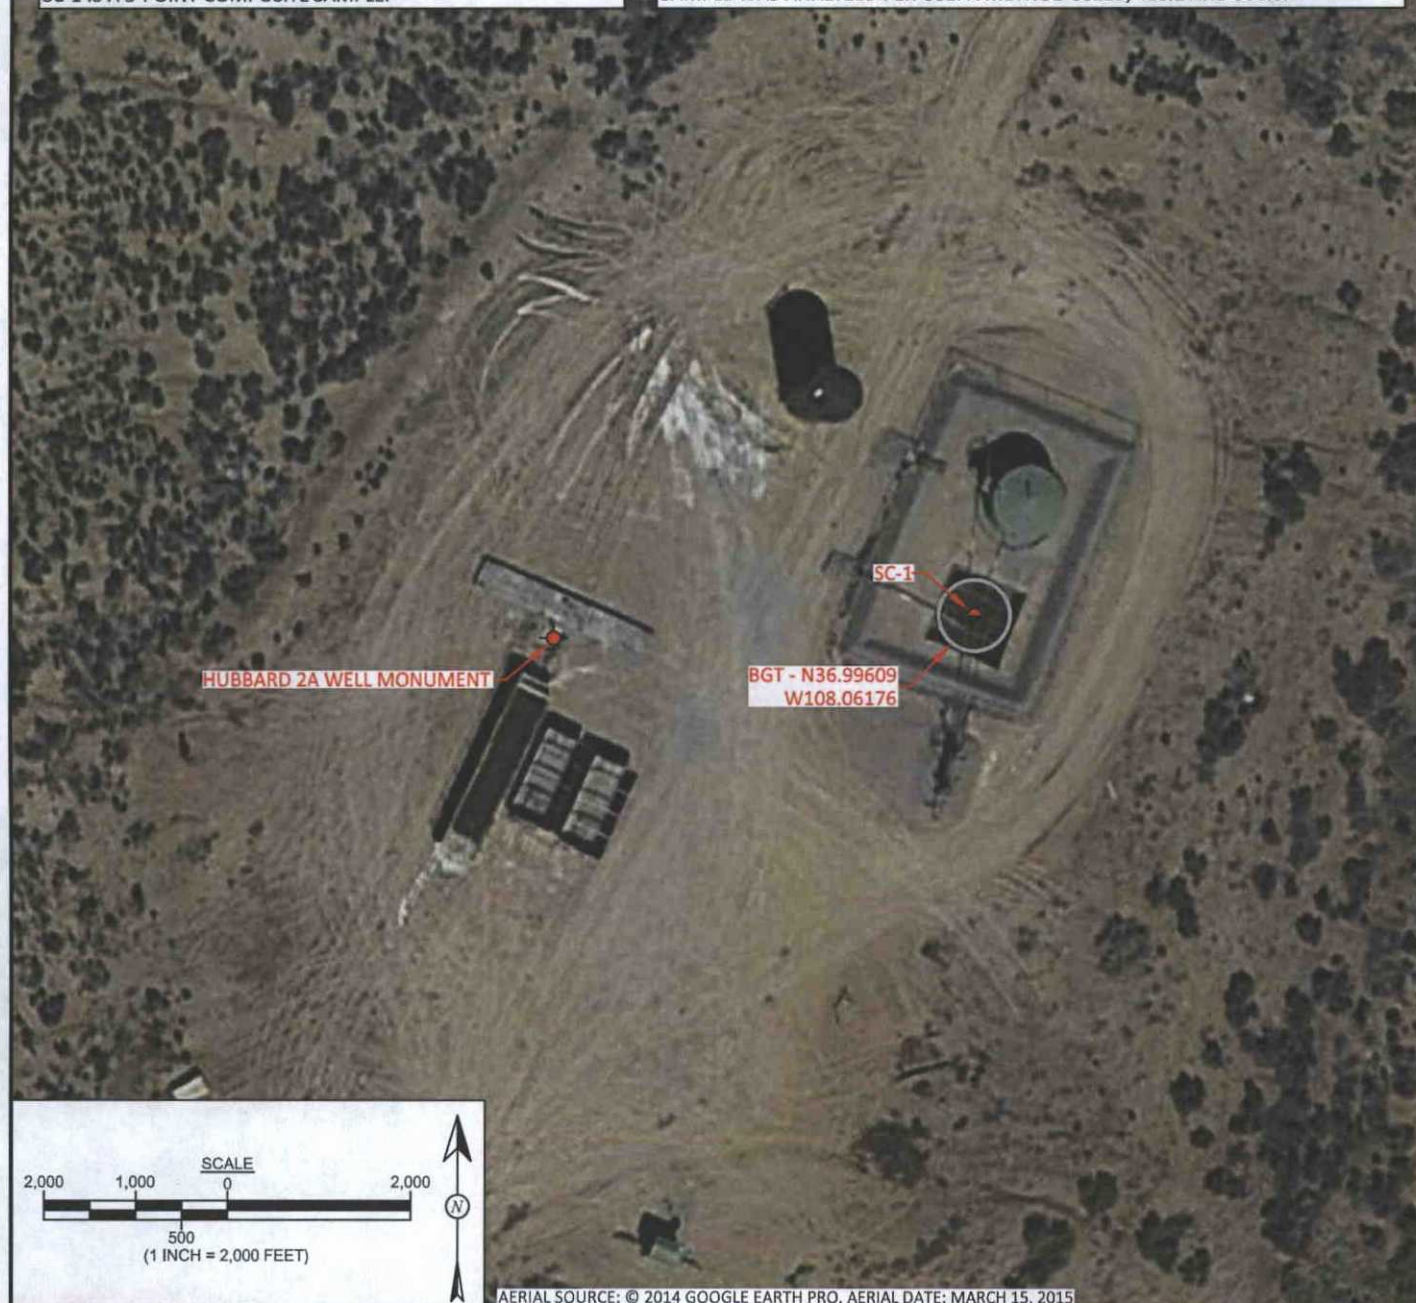
Sample ID	Date	Depth (ft)	Benzene (mg/kg)	Total BTEX (mg/kg)	TPH (mg/kg)	Chlorides (mg/kg)
NMOCD ACTION LEVEL			0.2	50	100	250
SC-1	6/23/15	0.5	<0.048	<0.241	<20	1,200

SAMPLE WAS ANALYZED PER USEPA METHOD 8021B, 418.1 AND 300.0.

NMOCD action levels for BGT closures are specified in New Mexico Administrative Code (NMAC) 19.15.17.13E. Field TPH concentrations in SC-1 were below the NMOCD action level of 100 mg/kg, with a concentration reported at 24.6 mg/kg. Benzene and total BTEX concentrations were below the NMOCD action levels of 0.2 mg/kg and 50 mg/kg, respectively. In contrast, chloride concentrations in SC-1 exceeded the NMOCD action level of 250 mg/kg with 1,200 mg/kg. As per Cory Smith of the NMOCD, due to no risk to groundwater or surface impact, no further work is recommended for the Hubbard 2A.
