Release Notification and Corrective Action

Name of Company	Burlington Resources Oil & Gas Co.	Contact	Lindsay Dumas
Address	3401 East 30 th St, Farmington, NM	Telephone No.	(505) 258-1643
Facility Name	Hubbard 2A	Facility Type	Gas

**RE: Below Grade Tank Closure Report
Hubbard 2A
San Juan County, New Mexico**

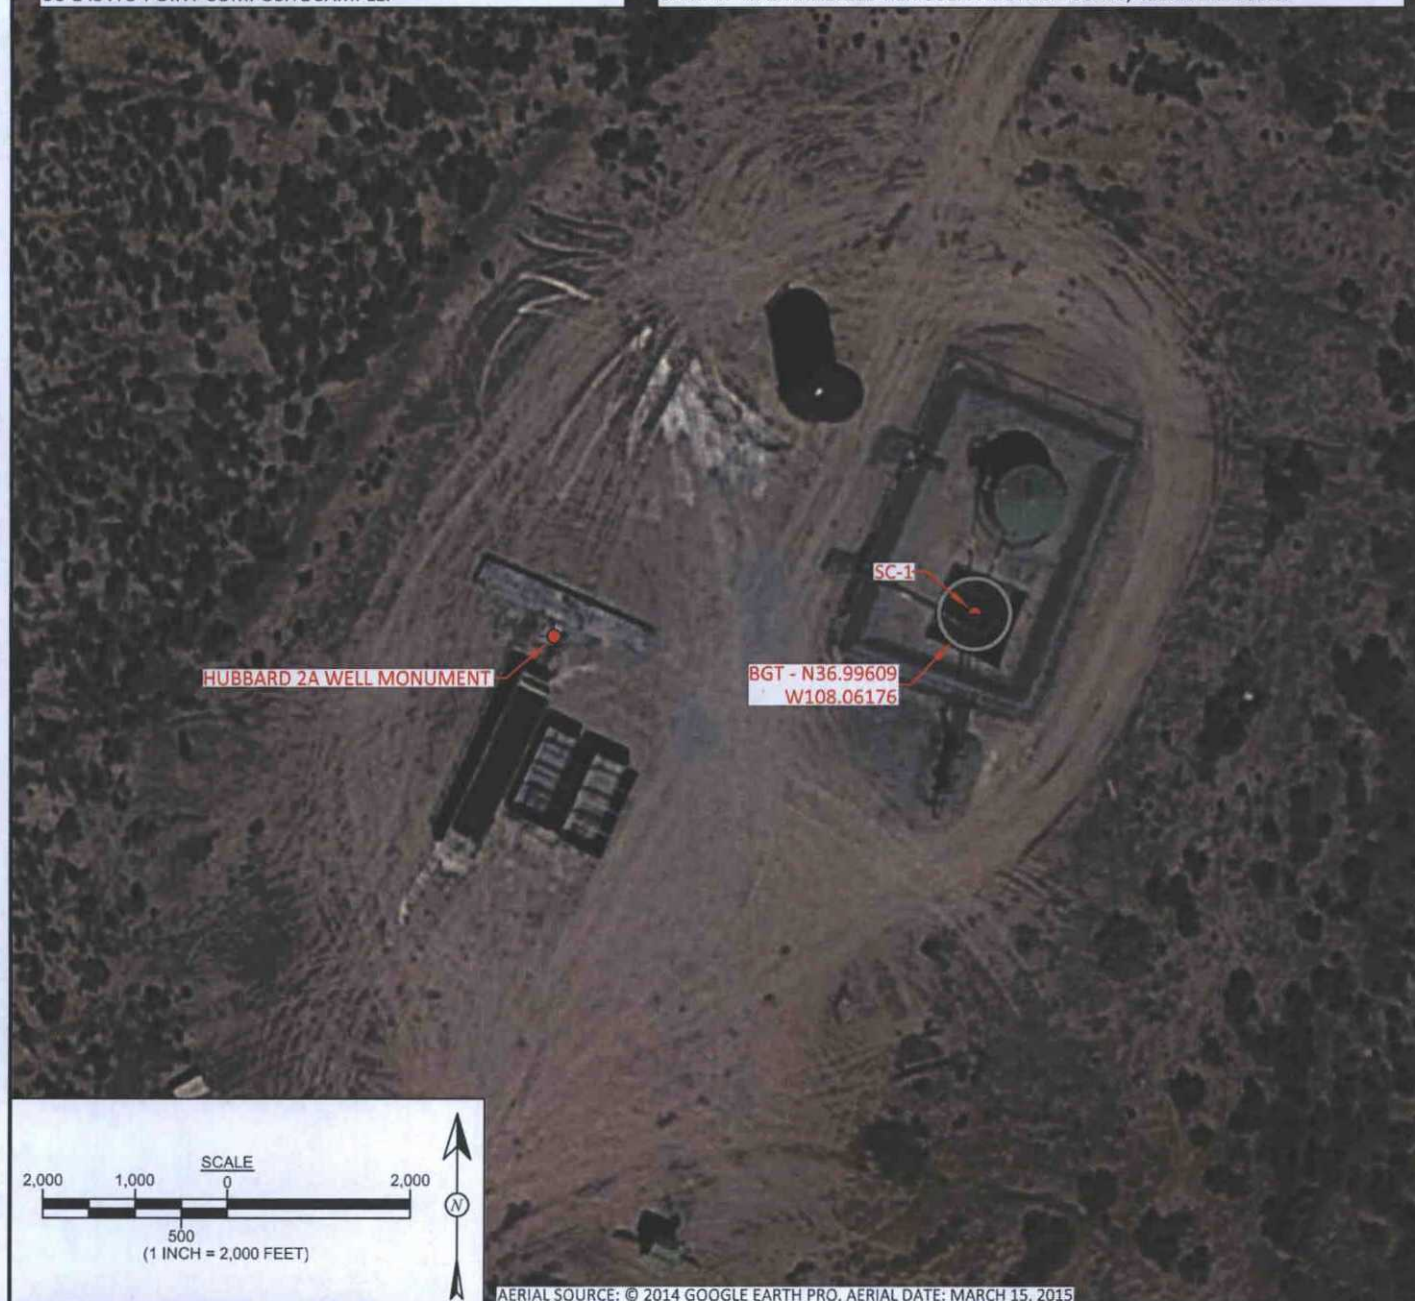
FIGURE 2

On June 23, 2015, AES personnel conducted field sampling and collected one 5-point composite (SC-1) from below the BGT. Soil was collected from approximately 0.5 feet below the former BGT. Soil sample SC-1 was field screened for volatile organic compounds (VOCs), total petroleum hydrocarbon (TPH), and chloride, and was submitted for confirmation laboratory analysis. Soil sample locations are included on Figure 2.

Sample ID	Date	Depth (ft)	OVM-PID (ppm)	TPH (mg/kg)	Chlorides (mg/kg)
NMOCD ACTION LEVEL			--	100	250
SC-1	6/23/15	0.5	0.0	24.6	240

SC-1 IS A 5-POINT COMPOSITE SAMPLE.

Sample ID	Date	Depth (ft)	Benzene (mg/kg)	Total BTEX (mg/kg)	TPH (mg/kg)	Chlorides (mg/kg)
NMOCD ACTION LEVEL			0.2	50	100	250
SC-1	6/23/15	0.5	<0.048	<0.241	<20	1,200

AERIAL SITE MAP
BELOW GRADE TANK CLOSURE
JUNE 2015
ConocoPhillips
HUBBARD 2A
SW¼ SE¼, SECTION 11, T32N, R12W
SAN JUAN COUNTY, NEW MEXICO
N36.99608, W108.06208
