Pit, Below-Grade Tank, or
13262 Proposed Alternative Method Permit or Closure Plan Application
Type of action: Below grade tank registration OIL CONS. DIV DIST. 3
Permit of a pit or proposed alternative method X Closure of a pit, below-grade tank, or proposed alternative method NOV 1 3 2015
☐ Modification to an existing permit/or registration ☐ Closure plan only submitted for an existing permitted or non-permitted pit, below-grade tank,
or proposed alternative method
Instructions: Please submit one application (Form C-144) per individual pit, below-grade tank or alternative request
Please be advised that approval of this request does not relieve the operator of liability should operations result in pollution of surface water, ground water or the nvironment. Nor does approval relieve the operator of its responsibility to comply with any other applicable governmental authority's rules, regulations or ordinances.

Burlington Resources Oil Gas Company, LP San Juan Basin Closure Report

Lease Name: Roelofs A 2B API No.: 30-045-35193

In accordance with Rule 19.15.17.13 NMAC the following information describes the closure of the temporary pit referenced above. All proper documentation re

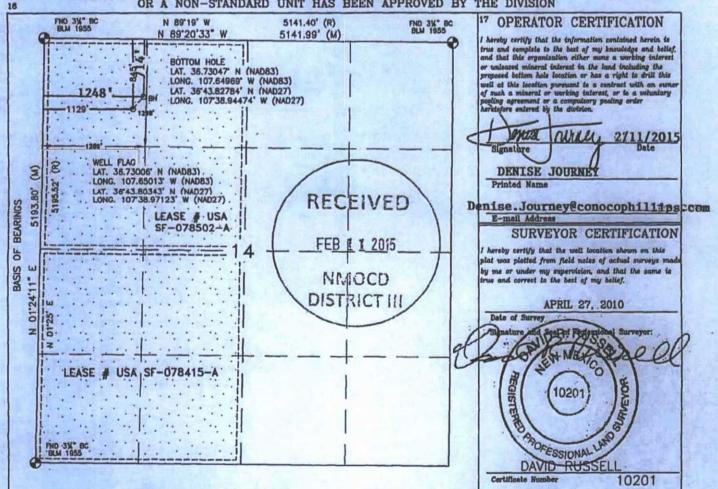
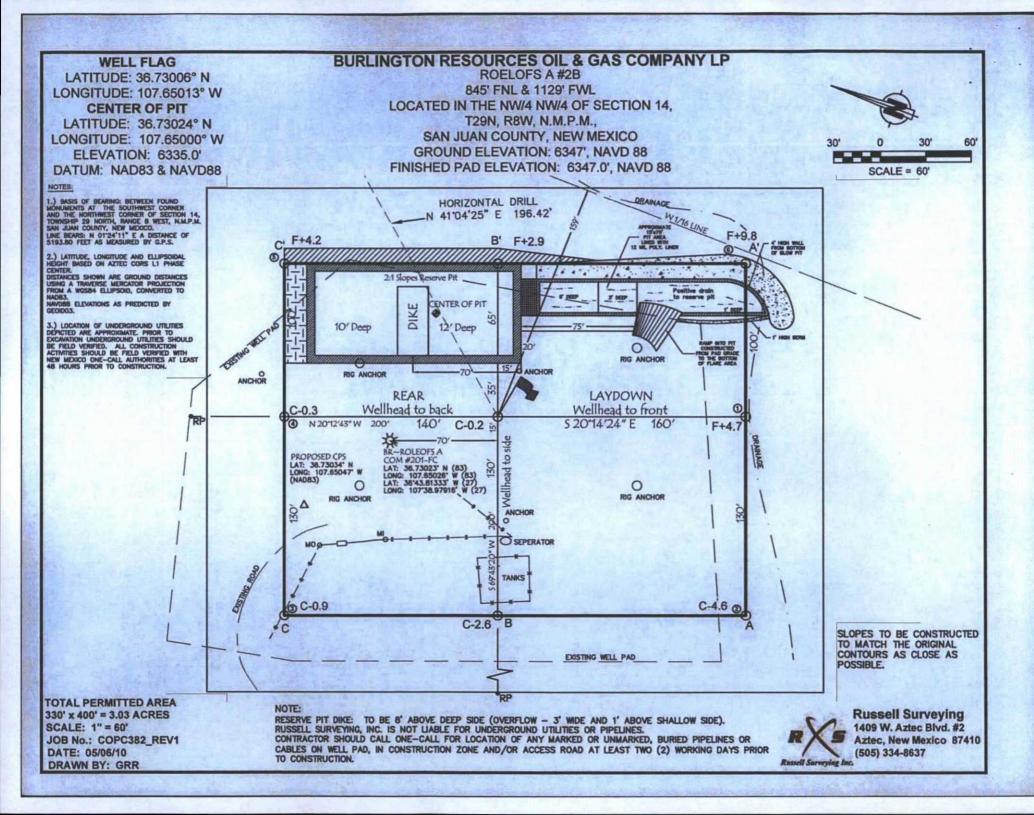
WELL LOCATION AND ACREAGE DEDICATION PLAT

"AS DRILLED PLAT"

During Doubles										
UL or lot no.	THE REST OF THE PARTY.	Township 29N			Feet from the 845'	North/South line NORTH	Feet from the 1129'	East/West line WEST	County SAN JUAN	1
	THE RESERVE AND ADDRESS.					And the second of the second o	A STATE OF THE PARTY OF THE PAR	The second secon	THE RESIDENCE OF THE PARTY OF T	6

UL or lot no.	Section 14	Township 29N	Range 8W	Lot Idn	Feet from the 714	North/South line NORTH	Feet from the	East/West line WEST	County SAN JUAN
Mary Property Control of the Control		18 Joint or	Joint or Infill 14 Consolidat		ode	18 Order No.

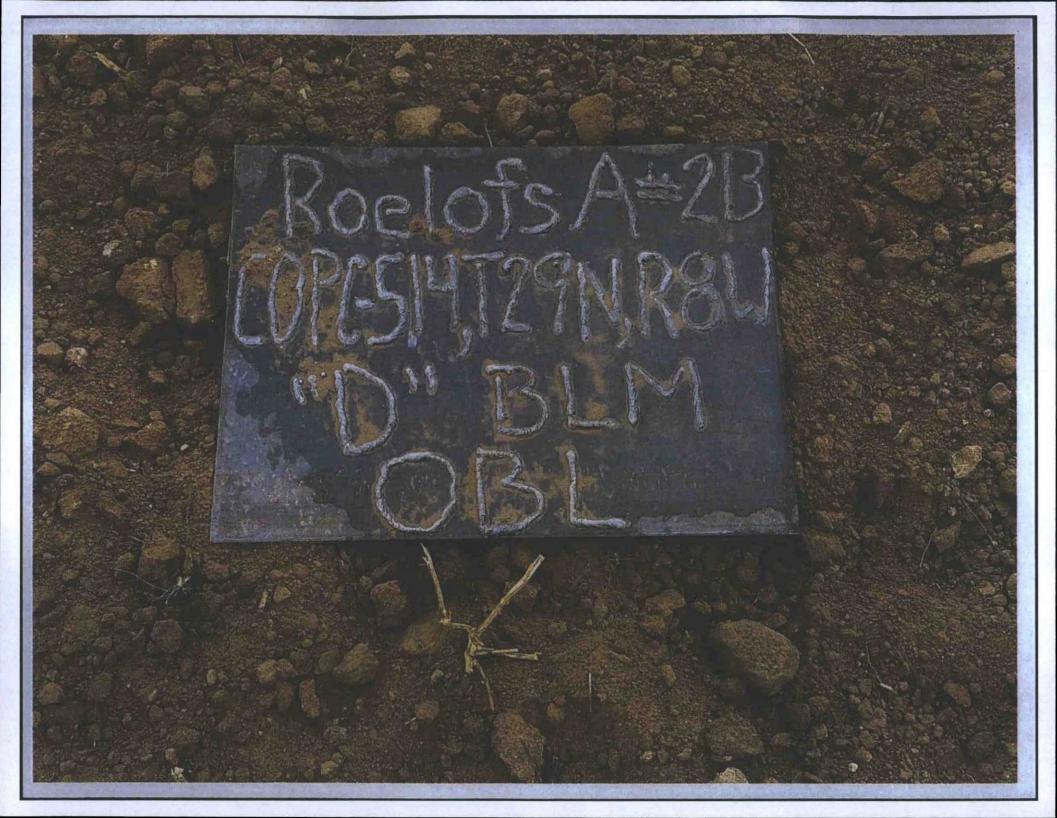
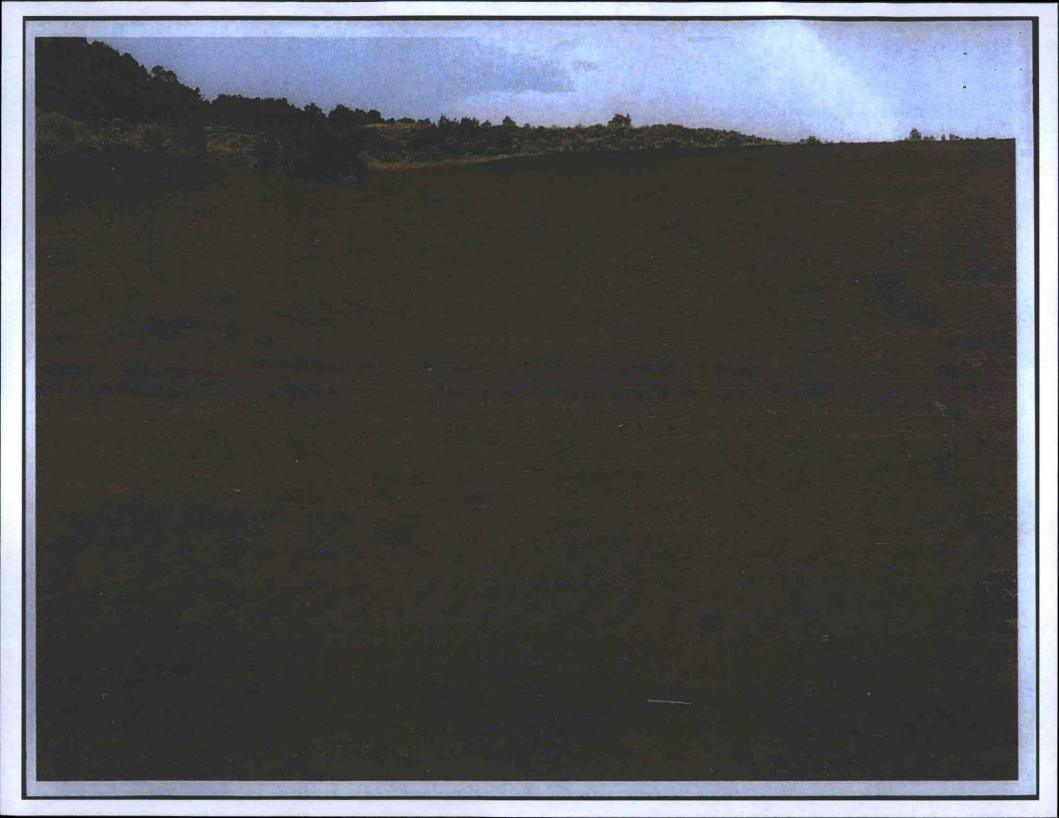
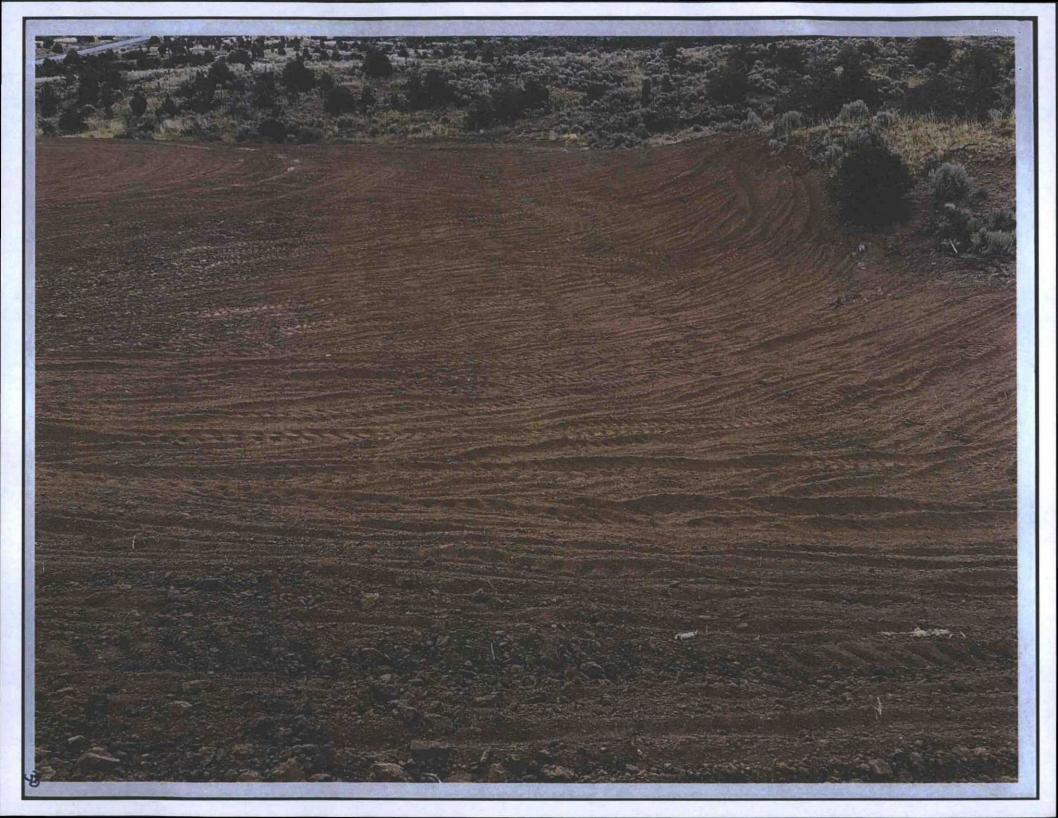
Reclamation Form:
Date: 9/30/15
Well Name: ROBLOFS A # 2B
Footages: 545 FNL + 1129 FWL Unit Letter: D
Section: 14 , T-29 -N, R- 8 -W, County: San Jun State: NM
Reclamation Contractor: ACE SERVICES
Reclamation Start Date: 6/29/15
Reclamation Complete Date: 7/22/15
Road Completion Date: 7/20/5
Seeding Date: 7/27/15 - ACE
**PIT MARKER STATUS (When Required): Picture of Marker set needed
MARKER PLACED: 7/30/15 (DATE)
LATATUDE: N36.730120
LONGITUDE: W-107, 649 877
Pit Manifold removed 6/30/15 (DATE)
Construction Inspector: JAED CHAVEZ Date: 7/30/15
Inspector Signature:
Office Use Only: SubtaskDSNIPictures
Revised 6/14/2012
