Pit, Below-Grade Tank, or	
13261 Propo	sed Alternative Method Permit or Closure Plan Appl	ication
Type of action:	☐ Below grade tank registration	OIL CONS. DIV DIST. 3
45-35460	Permit of a pit or proposed alternative method  X Closure of a pit, below-grade tank, or proposed alternative method  Modification to an existing permit/or registration	NOV 1 3 2015
or proposed alter	Closure plan only submitted for an existing permitted or non-permitted relative method	ed pit, below-grade tank,

## ConocoPhillips Company San Juan Basin Closure Report

Lease Name: State Gas Com A 1E

API No.: 30-045-35460

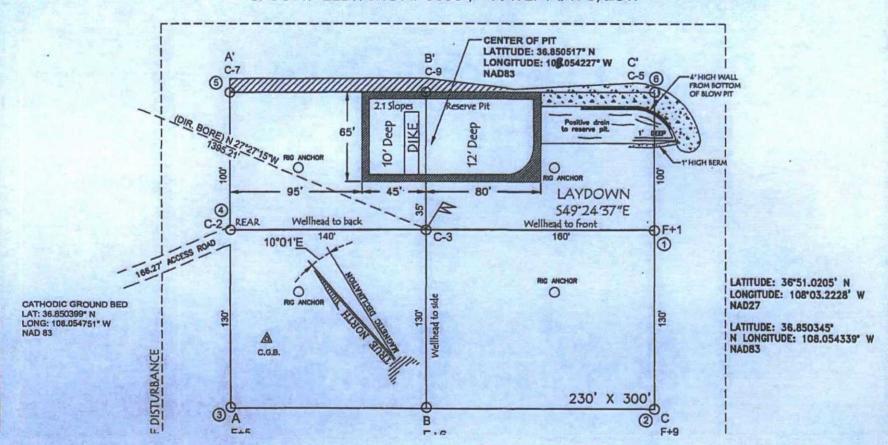
STATE GAS COM A #1E, 700' FSL & 1360' FWL
SECTION 36, T-31-N, R-12-W, NMPM, SAN JUAN COUNTY, NM
GROUND ELEVATION: 5880', DATE: MAY 5, 2011
