Form C-144
Revised June 6, 2013

13263 Proposed Alternative Method Permit or Closure Plan Application

1.
Operator: ConocoPhillips Company OGRID #: 217817
Address: PO BOX 4289, Farmington, NM 87499
Facility or well name: AXI Apache N 13A
API Number: 30-039-22288 OCD Permit Number: _____
U/L or Qtr/Qtr I (NESE) Section 2 Township 25N Range 4W County: Rio Arriba
Center of Proposed Design: Latitude 36.425251°N Longitude -107.21582°W NAD: ☐ 1927 ☒ 1983
Surface Owner: ☐ Federal ☐ State ☐ Private ☒ Tribal Trust or Indian Allotment

☒ Closure Completion Date: 6/8/2015

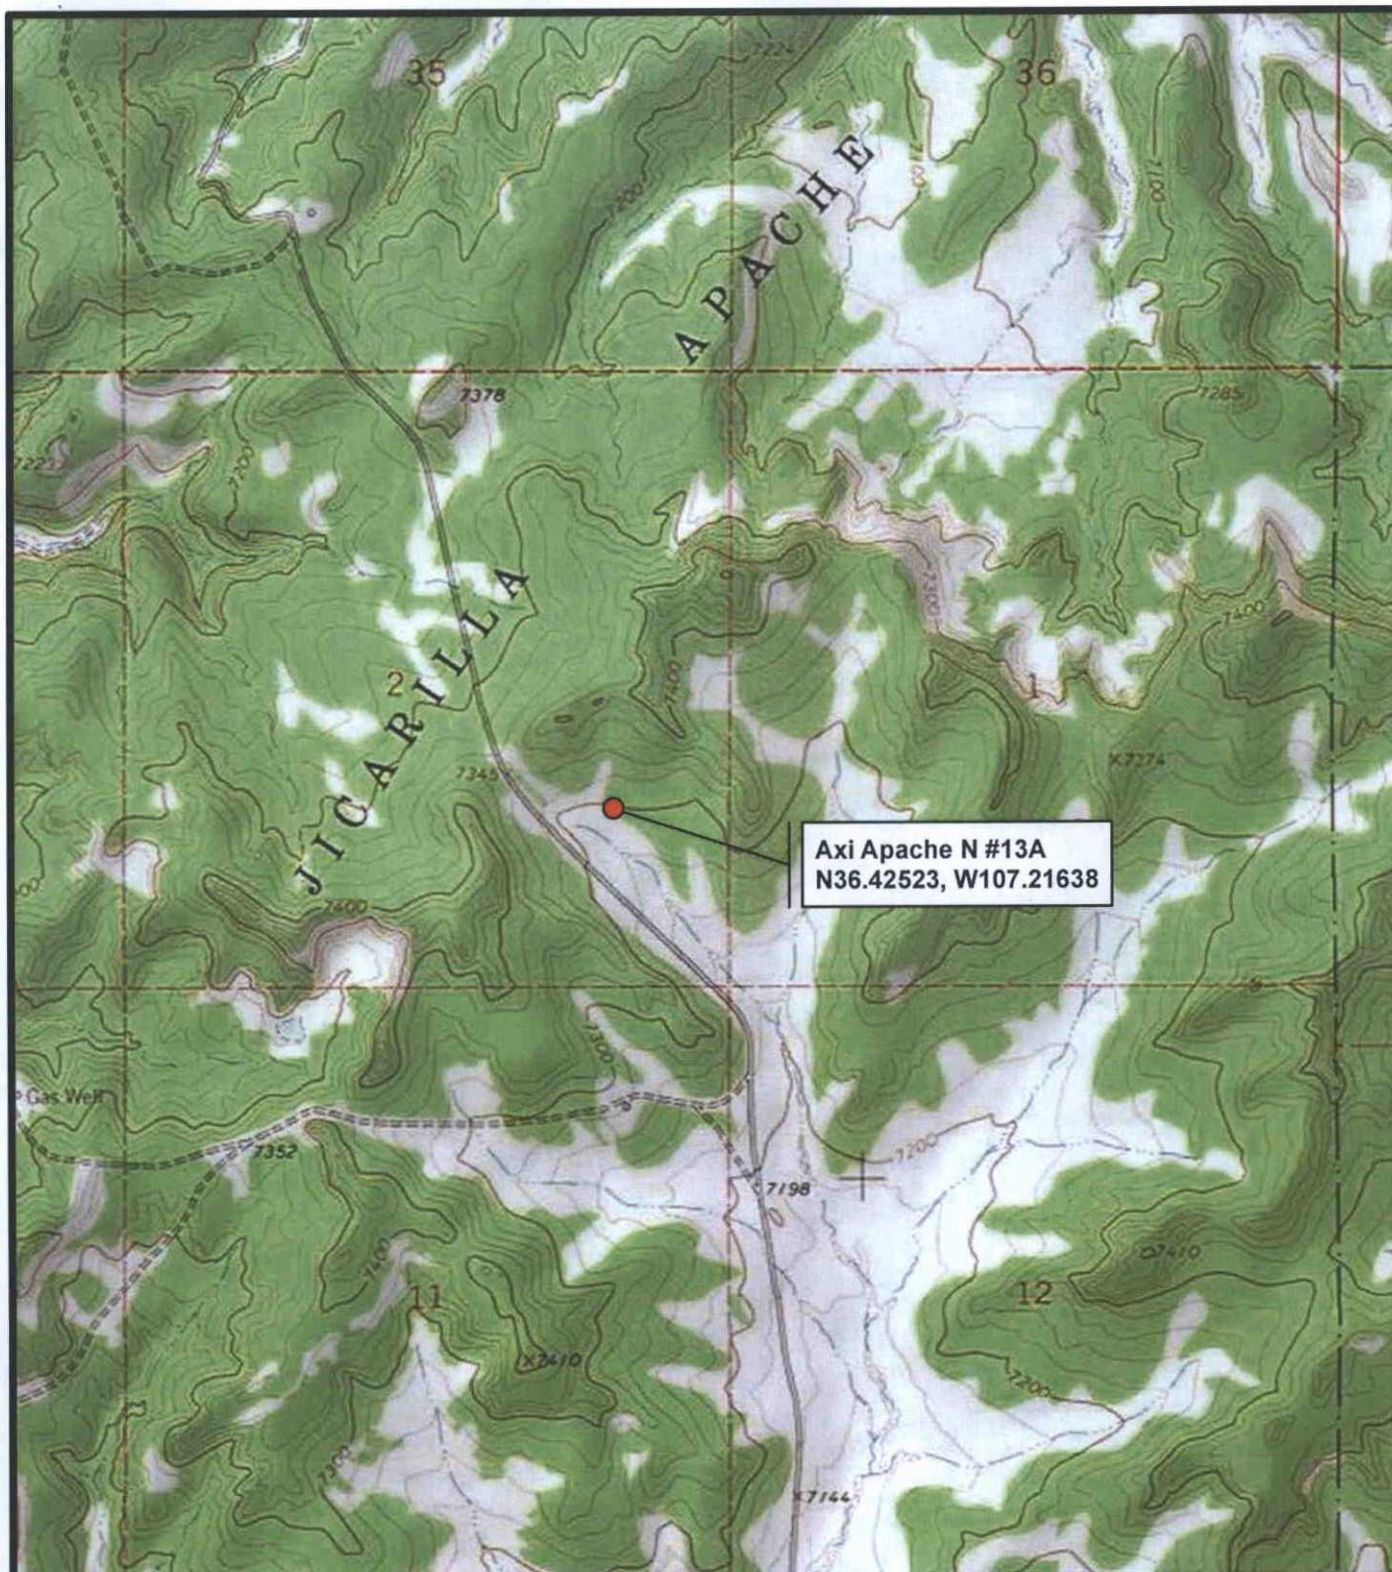
Figure 1

I-2-T25N-R04W
N36.42523, W107.21638
Schmitz Ranch Quadrangle
Rio Arriba County, New Mexico

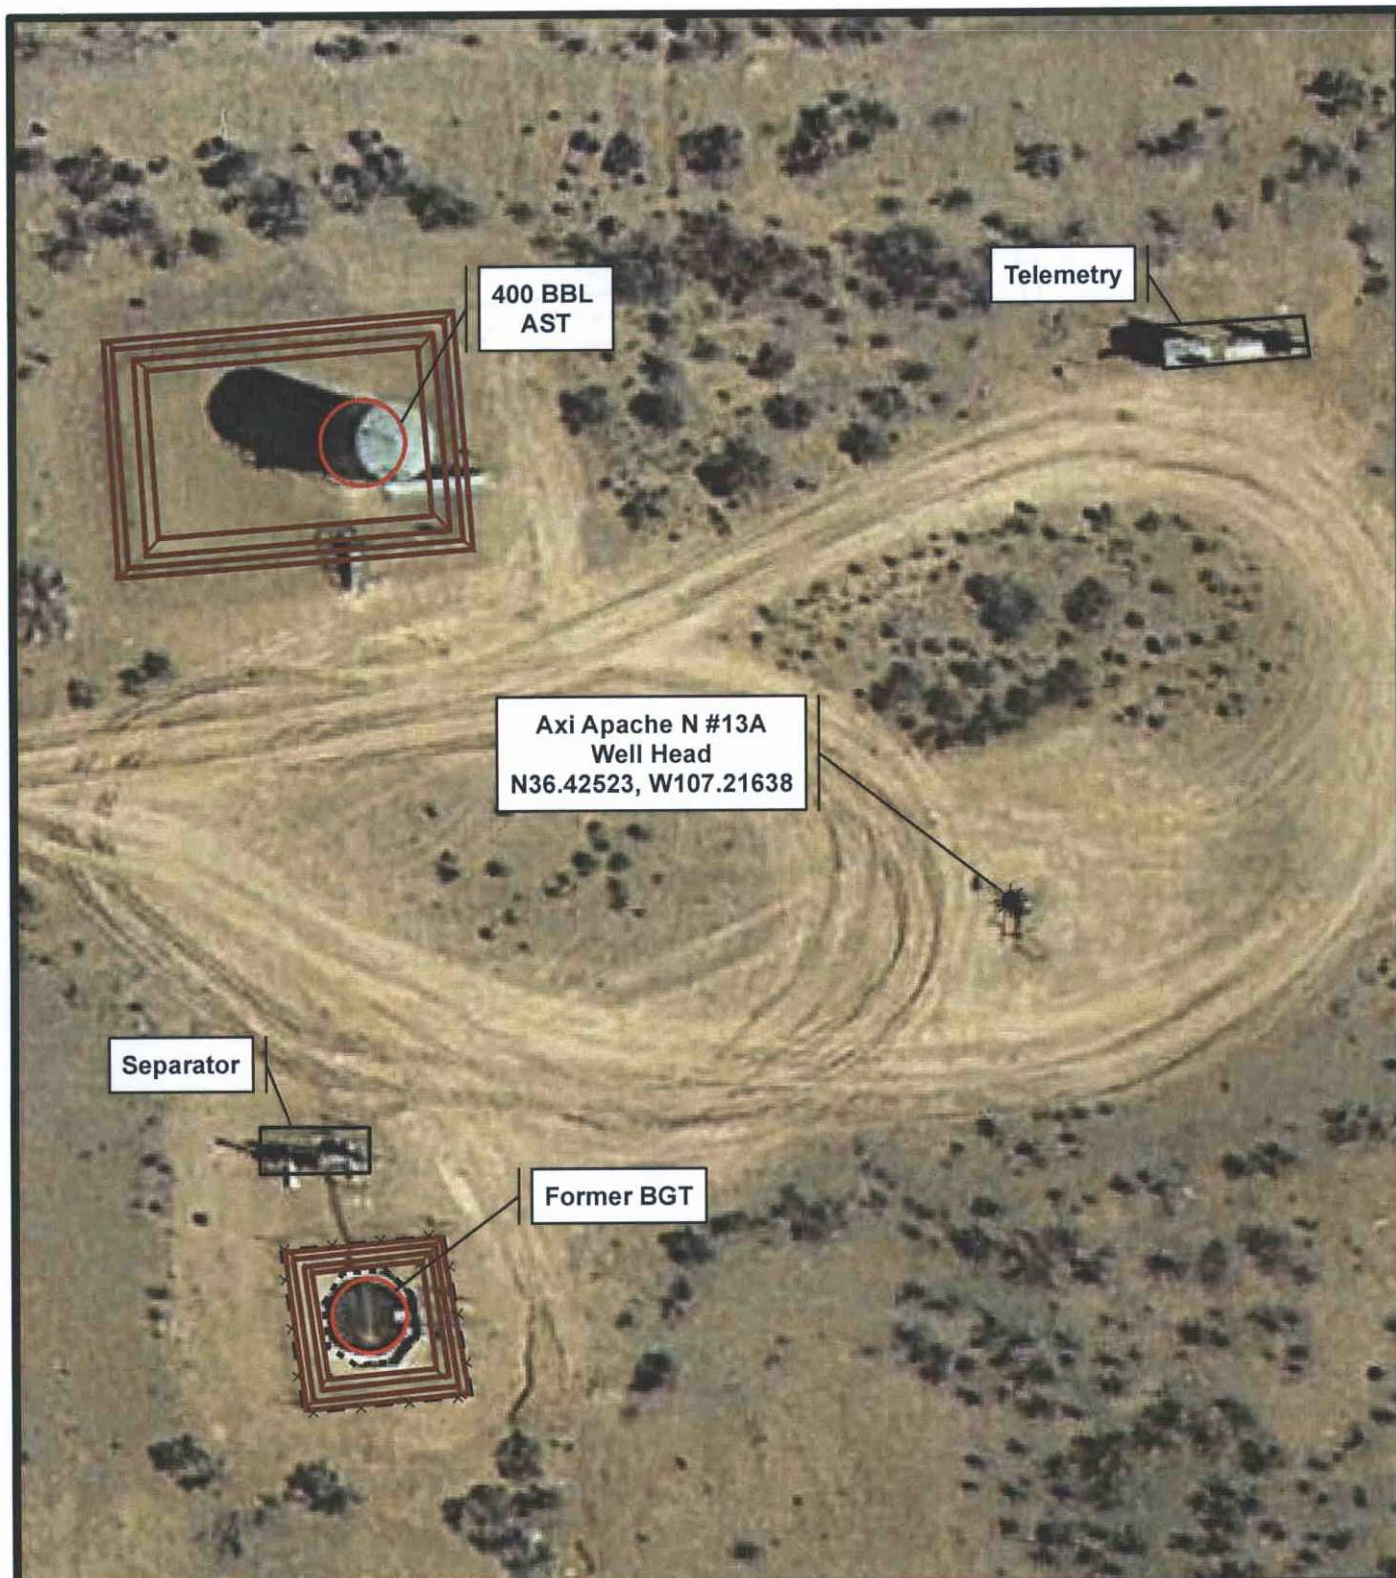
Figure 2

I-2-T25N-R04W
N36.42523, W107.21638
Rio Arriba County, New Mexico

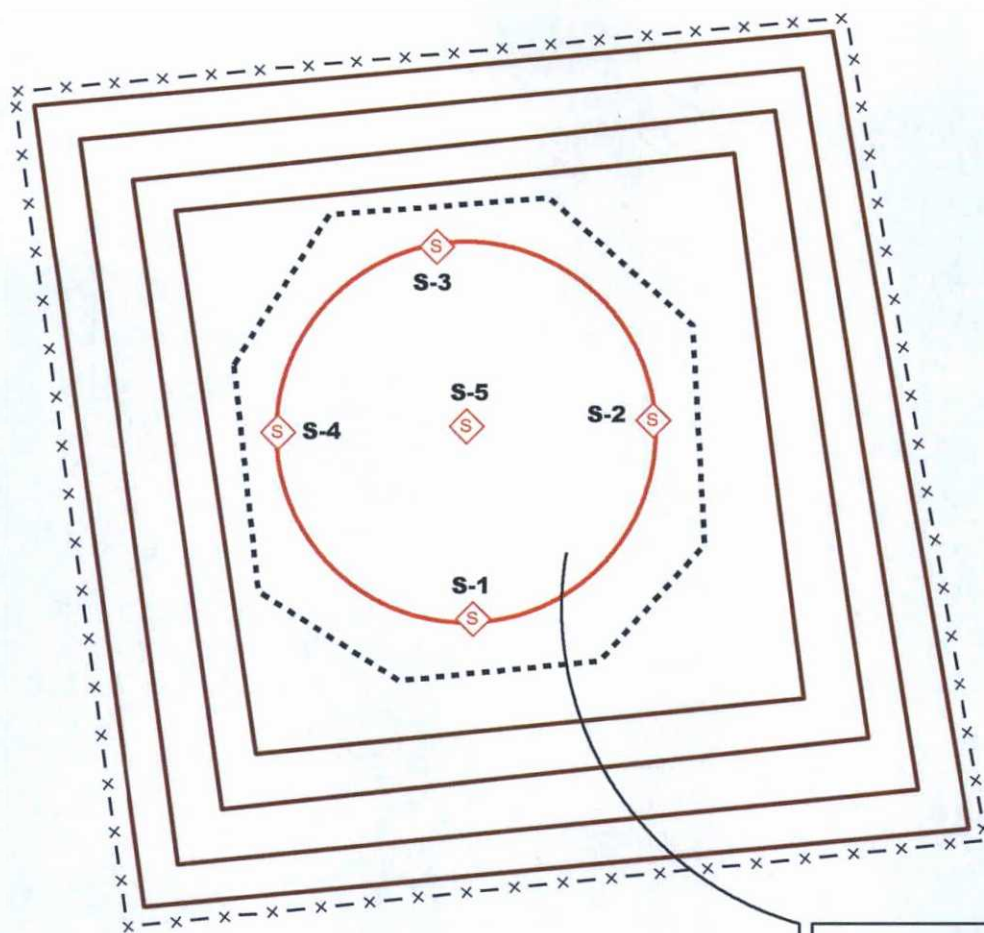
Figure 3

On June 8, 2015, Rule personnel conducted a visual inspection for surface/subsurface indications of a release. Soil discoloration and hydrocarbon odor was observed below the BGT along the eastern edge. No corrosion holes were visible in the BGT and the impacted soils were located 4 inches bgs, indicating that a historic release had occurred. Rule personnel then collected five soil samples (S-1 through S-5) from 0.5 feet beneath the BGT. The field work summary sheet is attached.

On June 8, 2015, BGT closure sampling activities were conducted at the ConocoPhillips Axi Apache N 13A. Field and laboratory results for sample SC-1 BGT were reported below the BGT closure standards for benzene, total BTEX, and chlorides as outlined in 19.15.17.13.NMAC, but exceeded the BGT closure standard of 100 mg/kg for TPH. Based on field screening results a historic release was noted along the eastern portion of the BGT location.

SC-1
 6/8/2015
 Benzene <0.005 mg/kg
 Total BTEX 0.17 mg/kg
 Chloride 170 mg/kg
 TPH 480 mg/kg

NOTES: SC-1 is a five part composite comprised of aliquots taken from S-1 through S-5
 BTEX= benzene, toluene, ethylbenzene, and xylenes
 TPH= total petroleum hydrocarbons

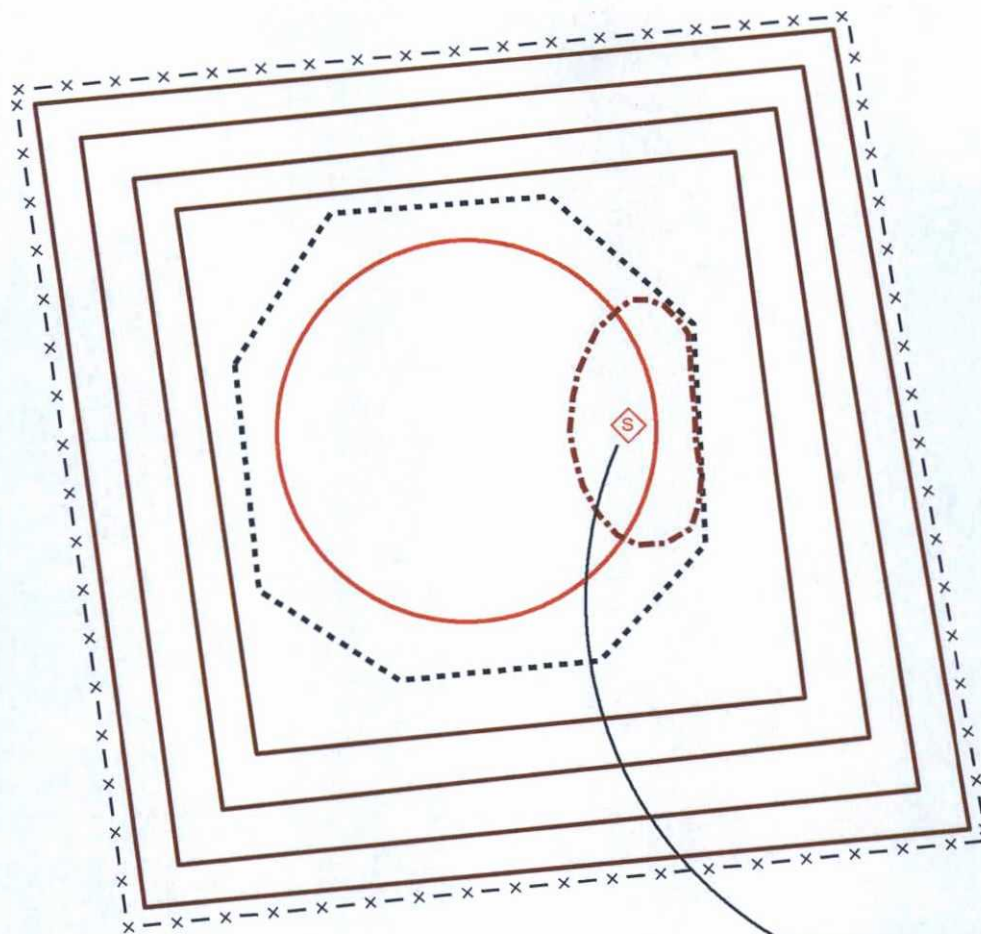
Excavation Composite

Laboratory analytical results for soil confirmation sample, Excavation Composite, reported benzene and total BTEX concentrations below the NMOCD action levels of 10 mg/kg and 50 mg/kg, respectively. The field and laboratory TPH concentrations were both reported below the NMOCD action level of 100 mg/kg. Based on the field screening results, Hobson Sandoval, EPO representative, approved backfilling of the excavation on June 12, 2015. Based on laboratory analytical results, no further work is recommended.

7/12/2015

Benzene <0.049 mg/kg
Total BTEX <0.245 mg/kg
TPH-GRO <4.9 mg/kg
TPH-DRO 50 mg/kg

NOTES: Excavation composite is a five point composite
BTEX= benzene, toluene, ethylbenzene, and xylenes
TPH= total petroleum hydrocarbons
GRO= gasoline range organics
DRO= diesel range organics

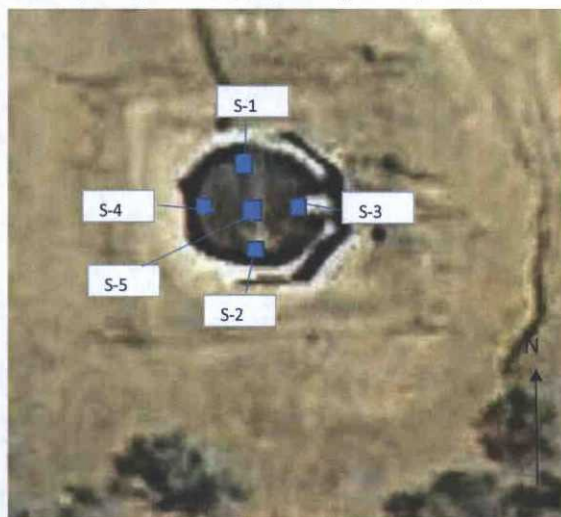
Observations: Staining observed along east portion of BGT. Stained soil included in sample.

SC-1 is a 5-point composite of S-1 through S-5, collected 0.5 ft below BGT.

Sample SC-1 was laboratory analyzed for TPH (418.1), BTEX (8021) and chlorides (300.0).
