**Release Notification and Corrective Action**

## SPILL CLEANUP REPORT

LOCATED AT:  
**JICARILLA OTERO #5**  
**SECTION 28, TOWNSHIP 24 NORTH, RANGE 5 WEST**  
**RIO ARRIBA COUNTY, NEW MEXICO**

**RE: SPILL CLEANUP REPORT JICARILLA OTERO #5 WELL SITE, RIO ARRIBA  
COUNTY, NEW MEXICO**

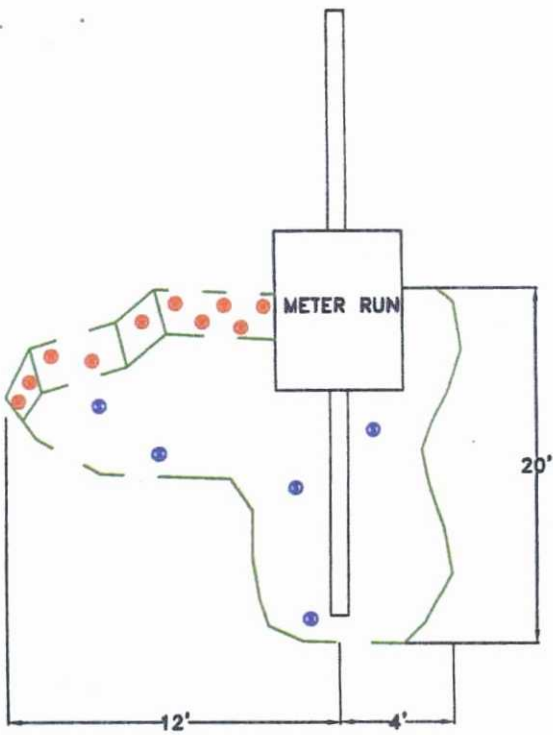
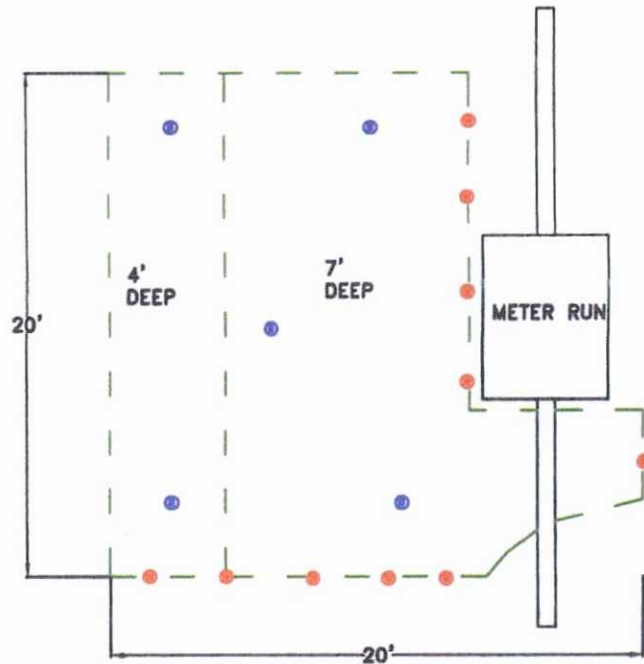
**Site Map**

**NOTE:**  
EXCAVATION COMPLETED AND SAMPLES  
COLLECTED ON AUGUST 16, 2013

**NOTE:**  
EXCAVATION COMPLETED AND SAMPLES  
COLLECTED ON AUGUST 19, 2013

- SURFACE SAMPLE LOCATION
- WALL SAMPLE LOCATION
- BOTTOM SAMPLE LOCATION
- EXCAVATION DELINEATION

The hydrocarbon impacted area was then excavated to the approximate dimensions of 20 feet by 16 feet by seven (7) feet below ground surface (BGS); see enclosed *Appendix B, Site Photography*. Two (2) additional five (5)-point composite samples were then collected. One (1) sample was collected from the north wall and one (1) sample was collected from the west wall; see enclosed *Figure 2, Site Map* for sample locations. The samples were analyzed in the field for TPH using USEPA Method 418.1 and for organic vapor using a photoionization detector (PID). Both samples returned results above the regulatory standard for TPH, but below the regulatory standard for organic vapor; see enclosed *Table 1, Summary of Analytical Results* and *Appendix A, Analytical Results*. Additionally, the two (2) samples were placed into four (4)-ounce glass jars, capped head space free, and transported on ice, under chain of custody, to Envirotech's Analytical Laboratory to be analyzed for TPH using USEPA Method 8015 and for Benzene and total BTEX using USEPA Method 8021. Both samples returned results below the regulatory standard for all constituents analyzed; see enclosed *Table 1, Summary of Analytical Results* and *Appendix A, Analytical Results*.

Envirotech personnel returned to the site on August 19, 2013, to finish spill cleanup activities. The excavation was extended to 20 feet by 20 feet with a varying depth between four (4) feet to seven (7) feet; see enclosed *Figure 2, Site Map*. Three (3) five (5)-point composite samples were collected from the final excavation. One (1) sample was collected from the south wall, one (1) sample was collected from the east wall and one (1) sample was collected from the bottom of the excavation. The bottom composite sample was collected from seven (7) feet BGS. All three (3) samples were analyzed in the field for TPH using USEPA Method 418.1 and for organic

vapors using a PID. The south wall composite sample returned a result below the regulatory standard for TPH and organic vapor. The east wall and bottom composite samples returned results above the regulatory standard for TPH, but below the regulatory standard for organic vapors; see enclosed *Table 1, Summary of Analytical Results* and *Appendix A, Analytical Results*. Additionally, the east wall and bottom composite samples were placed into four (4)-ounce glass jars, capped head space free, and transported on ice, under chain of custody, to Envirotech's Analytical Laboratory to be analyzed for TPH using USEPA Method 8015. Both samples returned results below the regulatory standard for all constituents analyzed; see enclosed *Table 1, Summary of Analytical Results* and *Appendix A, Analytical Results*.

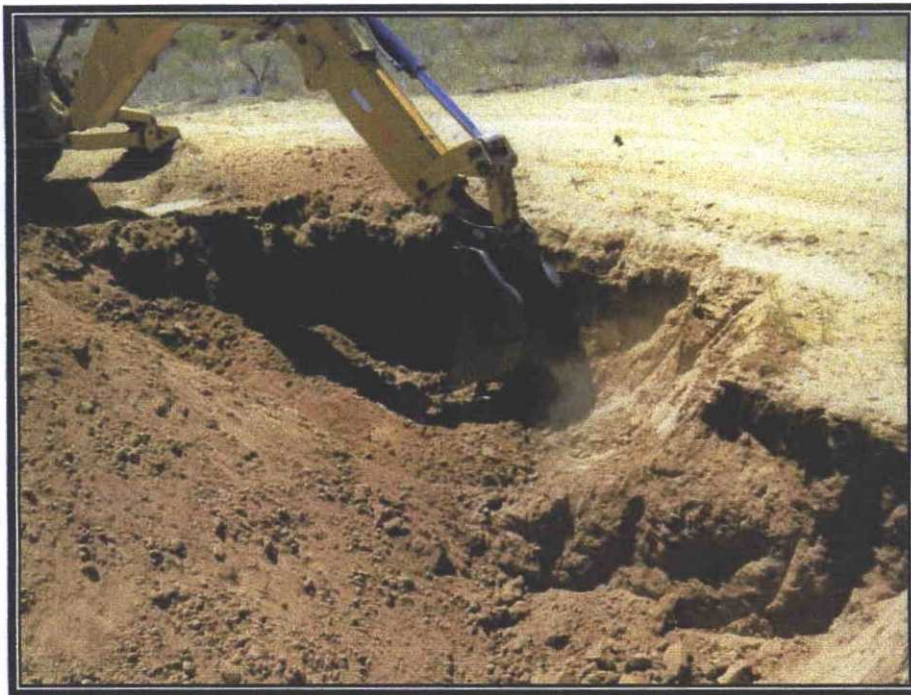
Picture 1: Excavation Activities

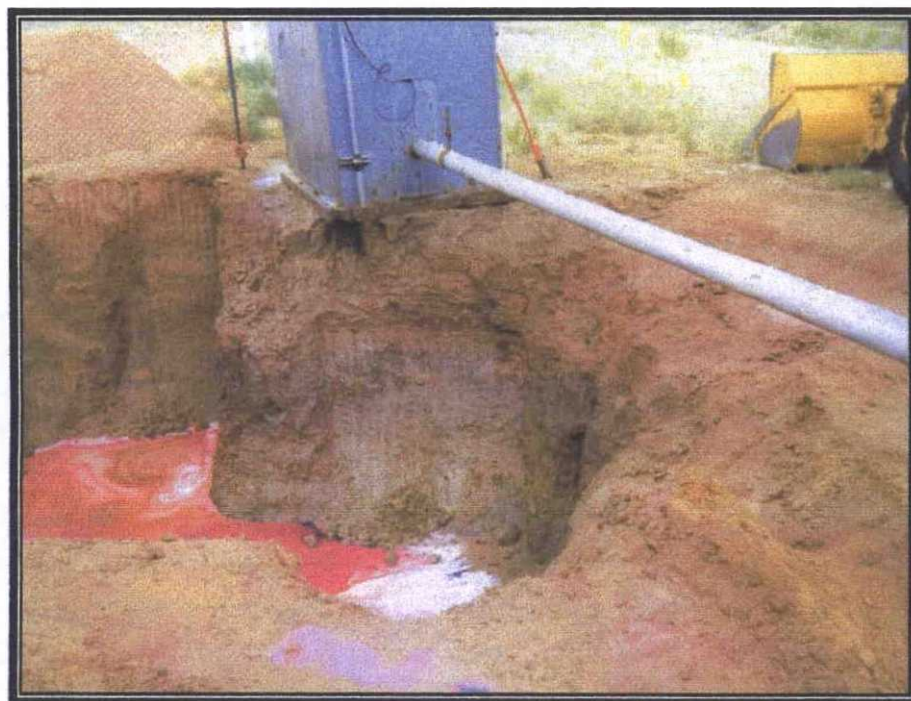
Picture 2: Potassium Permanganate Spraying Activities (View 1)

Mr. Hobson Sandoval, representative of the Jicarilla Apache Nation Oil and Gas Administration, requested that Envirotech treat the excavation with potassium permanganate, an oxidizer which degrades hydrocarbons.

On August 19, 2013, Envirotech Inc. personnel proceeded to apply the potassium permanganate solution. Upon completion of the application of the potassium permanganate to the excavation, the area was backfilled using soil collected from near the Enterprise plant, as directed by Mr. Hobson Sandoval. The site near the meter run at the above referenced well site was re-contoured and returned to pre-incident surface conditions; see enclosed *Appendix B, Site Photography*.

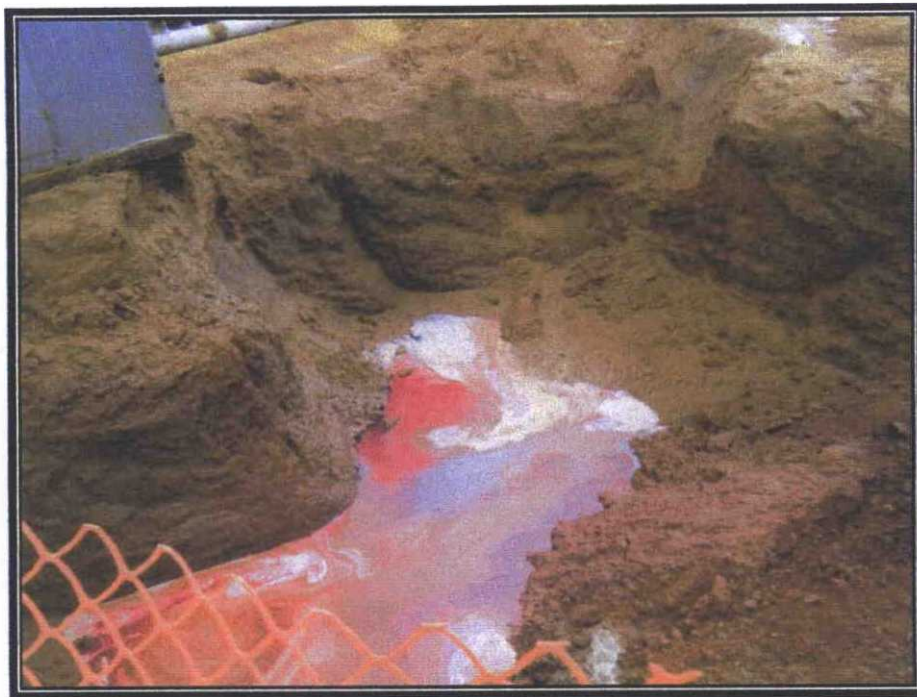
Picture 3: Potassium Permanganate Spraying Activities (View 2)

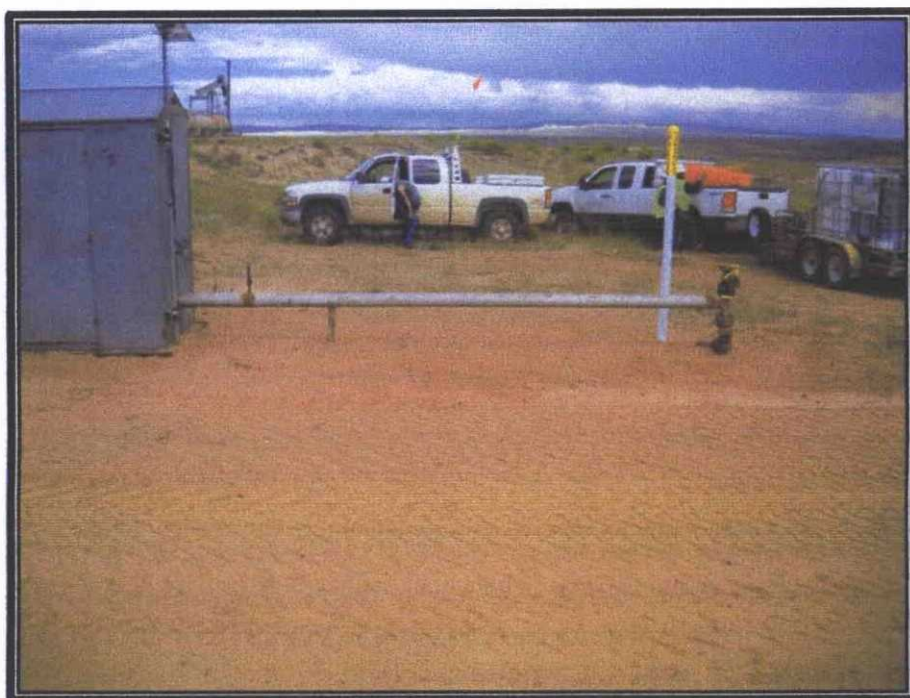
Picture 4: Post Backfilling and Re-contouring
