Proposed Alternative Method Permit or Closure Plan Application

**Burlington Resources Oil Gas Company, LP
San Juan Basin
Below Grade Tank Closure Report**

Lease Name: HARVEY STATE 11

API No.: 30-039-05988

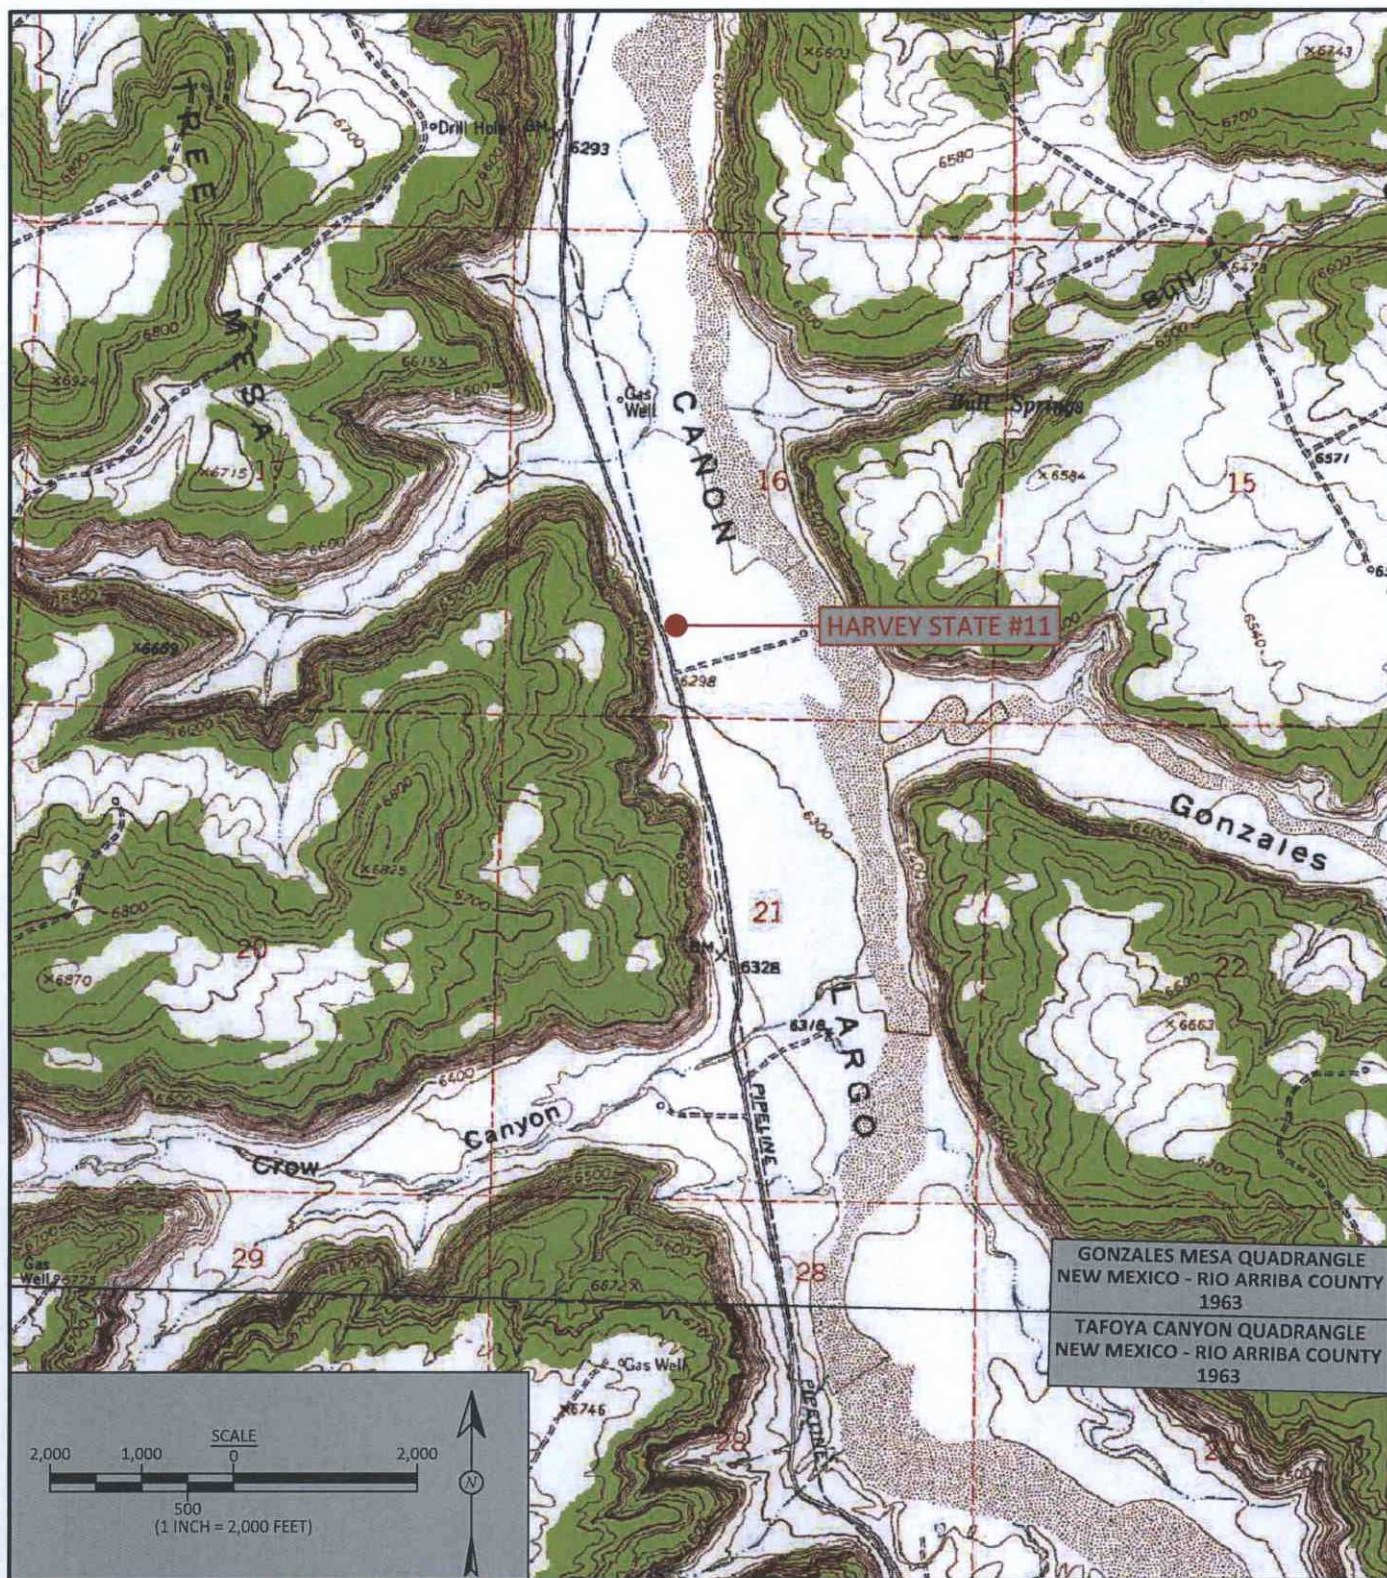
FIGURE 1

TOPOGRAPHIC SITE LOCATION MAP

ConocoPhillips
 HARVEY STATE #11
 RIO ARRIBA COUNTY, NEW MEXICO
 SE¼, SW¼, SECTION 16, T25N, R6W
 N36.39505°, W107.47475°

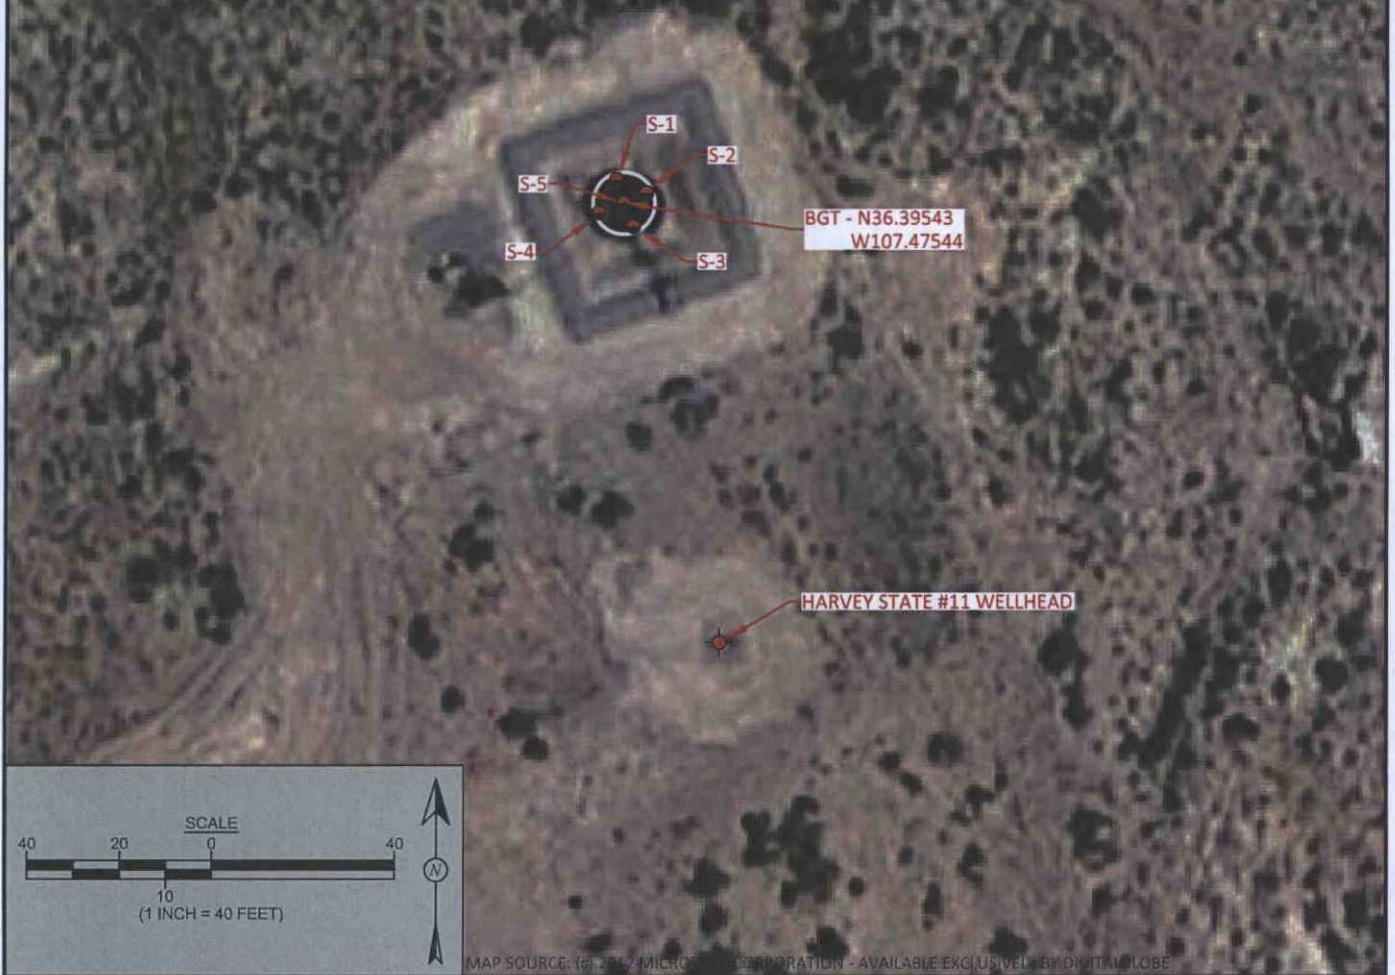
SAMPLE ID	OVM-PID (ppm)	FIELD		LABORATORY
		AES		HALL
		TPH (mg/kg)	CHLORIDES (mg/kg)	CHLORIDES (mg/kg)
S-1	0.0	<20.0	60	<30
S-2	0.0	<20.0	40	<30
S-3	0.0	37.1	40	<30
S-4	0.0	<20.0	40	<30
S-5	0.0	<20.0	40	<30

NOTE: ALL SAMPLES WERE COLLECTED ON JANUARY 16, 2012.

- Figure 1. Topographic Site Location Map
- Figure 2. General Site Plan, January 2012
- AES Field Screening Report 011612
- Hall Analytical Report 1201431
