Proposed Alternative Method Permit or Closure Plan Application

**Burlington Resources Oil & Gas Company, LP
San Juan Basin
Below Grade Tank Closure Report**

Lease Name: RHODES C 101

API No.: 30-045-28964

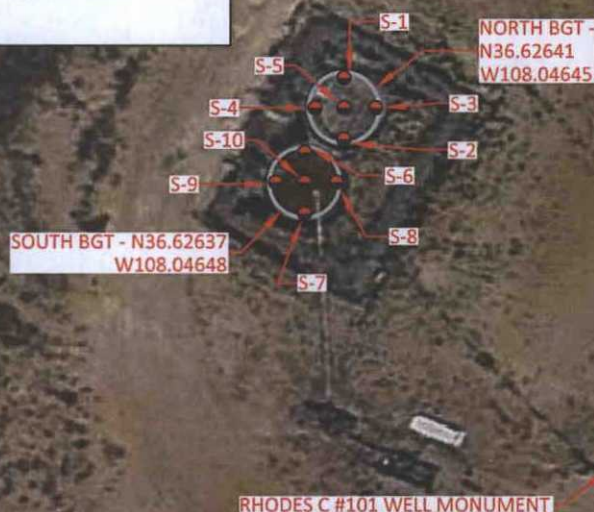
Sample ID	Date	Benzene (mg/kg)	Total BTEX (mg/kg)	TPH - GRO (mg/kg)	TPH - DRO (mg/kg)	Chlorides (mg/kg)
NMOCD ACTION LEVEL		0.2	50	100		250
SC-1	12/31/13	<0.035	<0.175	<3.5	<9.9	270
SC-2	12/31/13	<0.035	<0.176	NA	NA	660

SC-1 WAS ANALYZED PER EPA METHOD 8021B, 8015D AND 300.0.
SC-2 WAS ANALYZED PER EPA METHOD 8021B AND 300.0.

AERIAL SOURCE: © 2013 GOOGLE EARTH, AERIAL DATE: JUNE 10, 2011

Chloride concentrations in SC-1 and SC-2 were reported above the NMOCD action level of 250 mg/kg; however, on January 2, 2014, CoP received approval to backfill the BGTs from Brandon Powell of the NMOCD. Based on field screening and laboratory analytical results for benzene, total BTEX, TPH, and chlorides, no further work is recommended at Rhodes C #101.
