13690 Proposed Alternative Method Permit or Closure Plan Application

Facility or well name: GALT A 1R

Burlington Resources Oil & Gas Company
San Juan Basin: New Mexico Assets
Below Grade Tank Closure Report

Lease Name: GALT A 1R
API No.: 30-045-30499

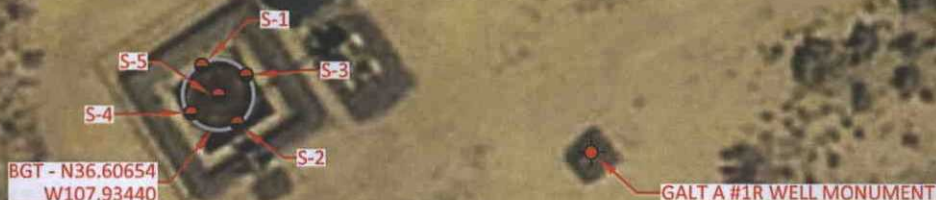
FIGURE 2

AERIAL SOURCE: © 2013 PICTOMETRY INTERNATIONAL CORP. ONLINE, AERIAL DATE: APRIL 2, 2013
