San Juan Basin: New Mexico Assets Below Grade Tank Closure Report

Lease Name: Hancock B 9R API No.: 30-045-30928

RE: Below Grade Tank Closure Report

FIGURE 2 AERIAL SITE MAP BELOW GRADE TANK CLOSURE JULY 2013 ConocoPhillips

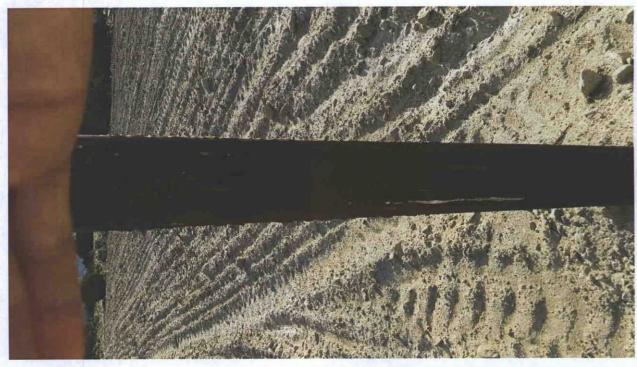
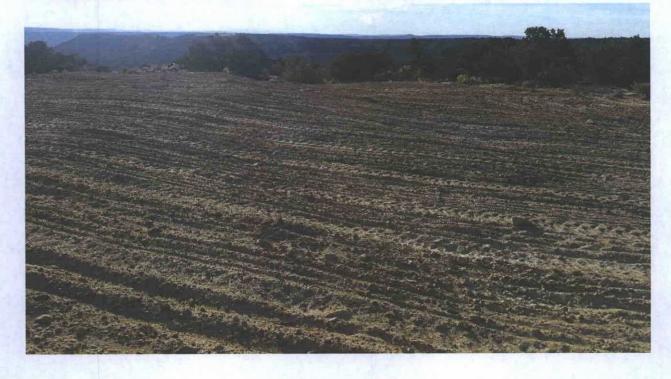
Hancock B 9R

- Proof of Closure Notice (surface owner and District Division) (Missing)
- Backfilling & cover installation (See Report)
- Confirmation Sampling Analytical Results (Attached)
- Application Rate & Seeding techniques (See Report)
- Photo Documentation of Reclamation (Attached)
