ConocoPhillips Company San Juan Basin Below Grade Tank Closure Report

Lease Name: Mudge B 100S API No.: 30-045-34876

RE: **Below Grade Tank Closure Report**

Mudge B #100S

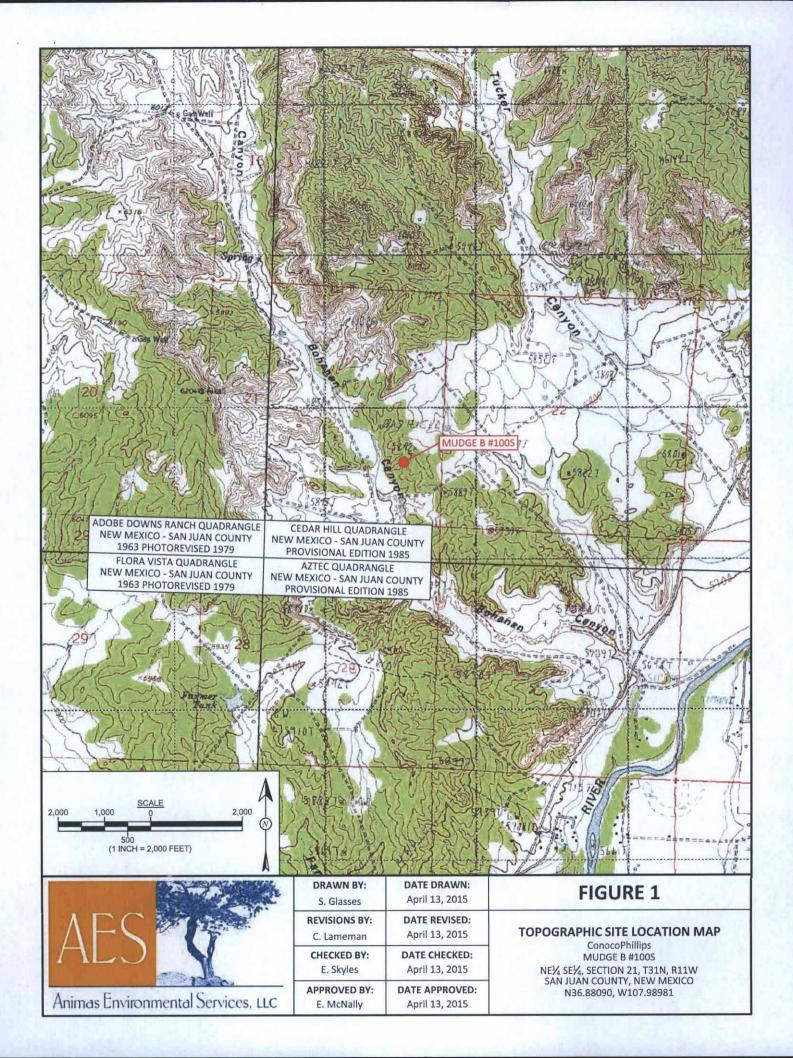
Site Name - Mudge B #100S Legal Description - NE¼ SE¼, Section 21, T31N, R11W, San Juan County, New Mexico Well Latitude/Longitude - N36.88090 and W107.98981, respectively BGT Latitude/Longitude - N36.88093 and W107.99004, respectively Land Jurisdiction - Bureau of Land Management (BLM) Figure 1. Topographic Site Location Map

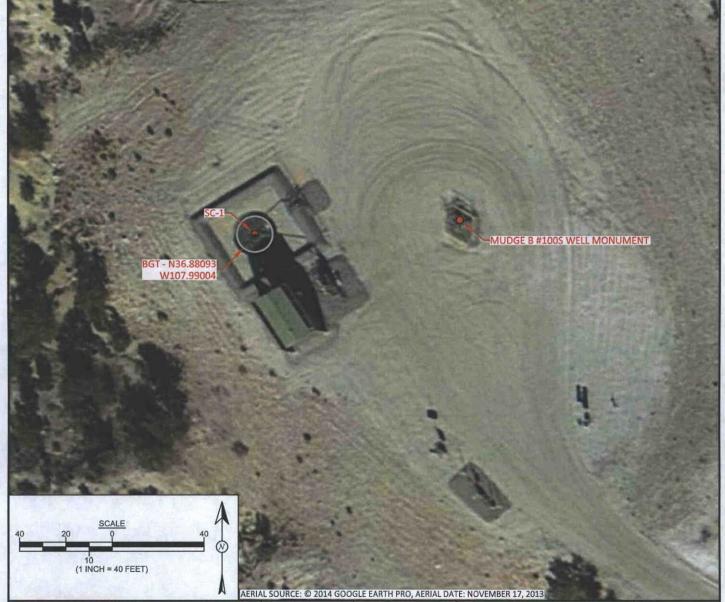
FIGURE 2

On April 8, 2015, AES personnel conducted field sampling and collected one 5-point composite (SC-1) from below the BGT. Soil was collected from approximately 0.5 feet below the former BGT. Soil sample SC-1 was field screened for volatile organic compounds (VOCs), total petroleum hydrocarbon (TPH), and chloride, and was submitted for confirmation laboratory analysis. Soil sample locations are included on Figure 2.

Field screening readings for VOCs via OVM were measured at 0.4 ppm in SC-1. Field TPH concentrations were reported at 26.6 mg/kg. The field chloride concentration was 80 mg/kg. Field sampling results are summarized in Table 1 and presented on Figure 2. The AES Field Sampling Report is attached.

Laboratory analytical results reported benzene and total BTEX concentrations in SC-1 as less than 0.050 mg/kg and 0.249 mg/kg, respectively. TPH concentrations were reported at less than 20 mg/kg. The laboratory chloride concentration was reported below the laboratory detection limit of 30 mg/kg. Laboratory analytical results are summarized in Table 2 and included on Figure 2. The laboratory analytical report is attached.

AERIAL SITE MAP
BELOW GRADE TANK CLOSURE
APRIL 2015
ConocoPhillips

NMOCD action levels for BGT closures are specified in New Mexico Administrative Code (NMAC) 19.15.17.13E. Field TPH concentrations in SC-1 were below the NMOCD action level of 100 mg/kg, with a concentration reported at 26.6 mg/kg. Benzene and total BTEX concentrations were below the NMOCD action levels of 0.2 mg/kg and 50 mg/kg, respectively. Chloride concentrations in SC-1 were below the NMOCD action level of 250 mg/kg. Based on field sampling and laboratory analytical results for benzene, total BTEX, TPH, and chlorides, no further work is recommended at the Mudge B #100S.
