**Release Notification and Corrective Action**

**RE: SPILL ASSESSMENT AND CLOSURE REPORT AT THE NELLIE PLATERO 5A WELL SITE, SAN JUAN COUNTY, NEW MEXICO**

# **SPILL ASSESSMENT AND CLOSURE REPORT**

**LOCATED AT:  
NELLIE PLATERO 5A WELL SITE  
SECTION 11, TOWNSHIP 27N, RANGE 9W  
SAN JUAN COUNTY, NEW MEXICO**

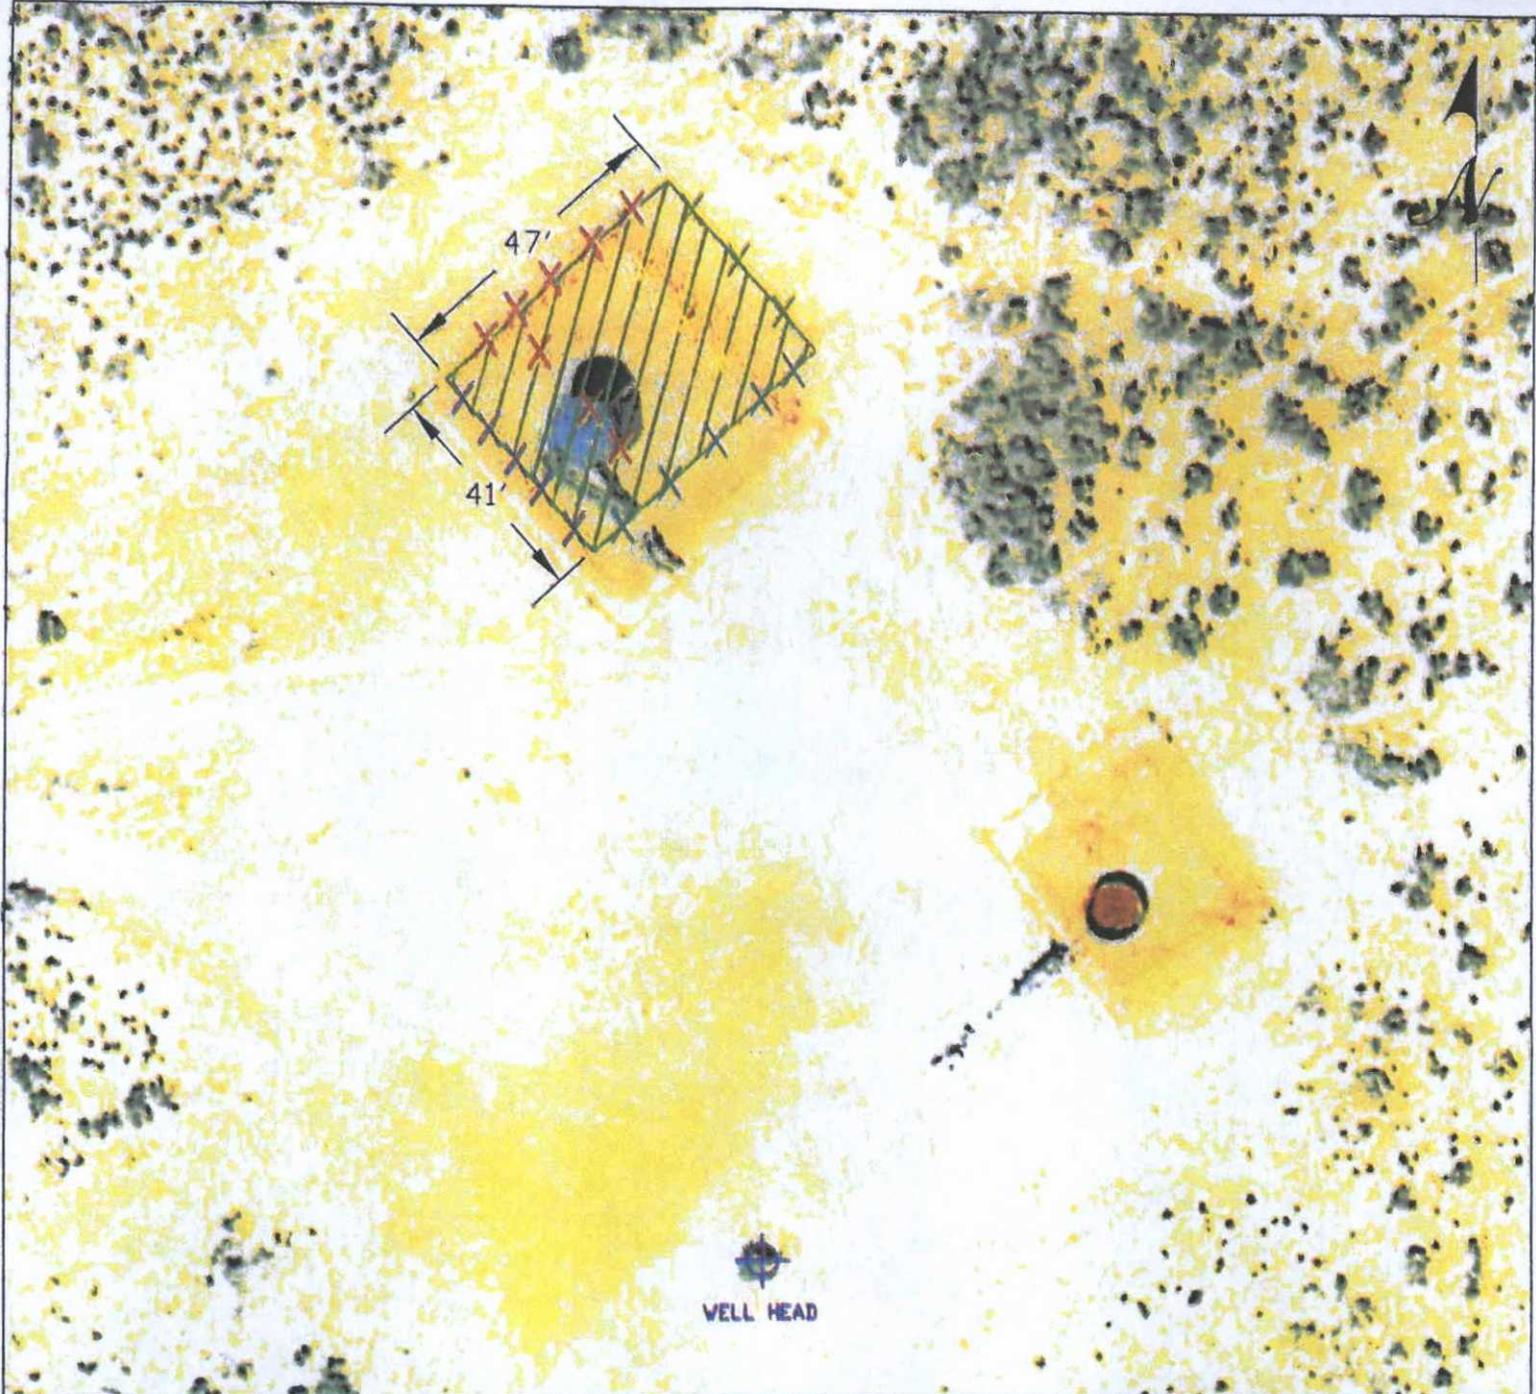
**Figure 1, Vicinity Map**  
**Figure 2, Site Map**

Upon collection of the site assessment the impacted surface area was determined to be approximately five (5) feet by five (5) feet on the north side of the AST. Samples were collected in the center and around the perimeter of the visual staining at six (6) inches below ground surface (BGS). Samples were also collected from two (2) feet BGS and four (4) feet BGS in the center of the impacted area as well as one (1) sample collected at four (4) feet diagonally below the AST. The samples were screened in the field for TPH using USEPA method 418.1 and for organic vapors (OV) using a photoionization detector (PID). The center sample at four (4) feet BGS, #1 4ft, returned results of 10,400 ppm TPH and 144.1 ppm for OV and the sample collected from four (4) foot diagonally beneath the AST, *Horizontal 4ft*, returned results of 10,680 ppm TPH and 244 ppm OV; see enclosed *Appendix A, Field Notes, Table 1, Summary of Analytical Results*, and *Appendix B, Analytical Results*. Based on the above mentioned results, Envirotech recommends removal of the AST and excavation to five (5) feet BGS and a five (5) foot diameter of the impacted area, then sampling for closure.

On October 27, 2015, Envirotech, Inc. returned to the site to perform confirmation sampling activities. Prior to Envirotech's arrival, the contaminated area had been excavated to approximately a five (5) foot diameter by eight (8) feet BGS. Two (2) five (5)-point composite samples were collected from the excavation, one (1) from the bottom and one (1) from the walls. The samples were screened in the field for TPH using USEPA Method 418.1 and for OV using a PID. The *Bottom* sample returned results of 2,108 ppm TPH and 1,762 ppm OV and the *Walls* sample returned results of 1,408 ppm TPH and 123.3 OV; see enclosed *Appendix A, Field Notes, Table 1, Summary of Analytical Results*, and *Appendix B, Analytical Results*. Envirotech recommended further excavation of the bottom and walls, then resampling for closure.

On October 29, 2015, Envirotech, Inc. returned to the site to perform confirmation sampling activities. Prior to Envirotech's arrival the contaminated area had been excavated to approximately a 10 foot diameter by eight (8) to 12 feet BGS. Four (4) five (5)-point composite

samples were collected from the excavation, two (2) from the bottom, *Bottom 12ft* and *Bottom 8ft*, and two (2) from the walls, *North Walls* and *South Walls*. The samples were screened in the field for TPH using USEPA Method 418.1 and for OV using a PID. All four (4) samples returned results above the regulatory standard for TPH and OV with the exception of the *North Wall* sample that returned a result below the regulatory standard for OV; see enclosed *Appendix A, Field Notes Table 1, Summary of Analytical Results* and *Appendix B, Analytical Results*. Envirotech recommended further excavation and resampling for closure.

On November 9, 2015, Envirotech, Inc. returned to the site to continue confirmation sampling activities. Prior to Envirotech's arrival, impacted area was excavated to approximately 40 feet by 30 feet by 12 feet BGS. Six (6) five (5)-point composite samples were collected from the excavation, *South Wall, North Wall, West Wall, East Wall, Section 1*, and *Section 2*; see enclosed *Appendix A, Field Notes* for sample locations. The samples were screened in the field for TPH using USEPA Method 418.1 and for OV using a PID. All of the samples returned results above the regulatory standard for TPH. All samples returned results below regulatory standard for OV except, *South Wall* and *Section 2*, which returned results above the regulatory standard for OV; see enclosed *Appendix A, Field Notes Table 1, Summary of Analytical Results* and *Appendix B, Analytical Results*. Three (3) of the samples, *South Wall, West Wall, and East Wall*, were placed into four (4) ounce glass jars, capped headspace free, and transported on ice under chain of custody to Envirotech's Analytical laboratory to be analyzed for TPH using USEPA Method 8015 and BTEX using USEPA Method 8021. All three (3) samples returned results below regulatory standard for all constituents analyzed; see enclosed *Table 1, Summary of Analytical Results* and *Appendix B, Analytical Results*. Envirotech recommended further excavation of the north wall and bottom, followed by resampling for closure.

Based and the above stated analytical results, Envirotech, Inc. recommends no further action in regards to this event.

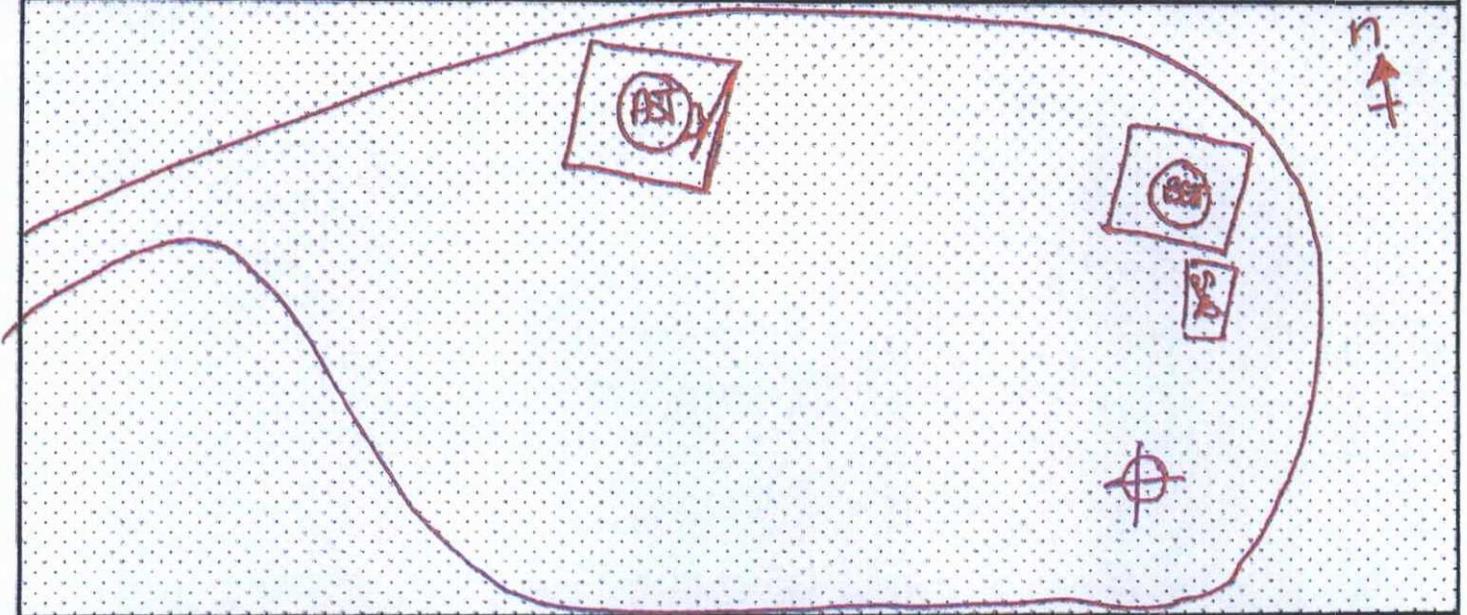
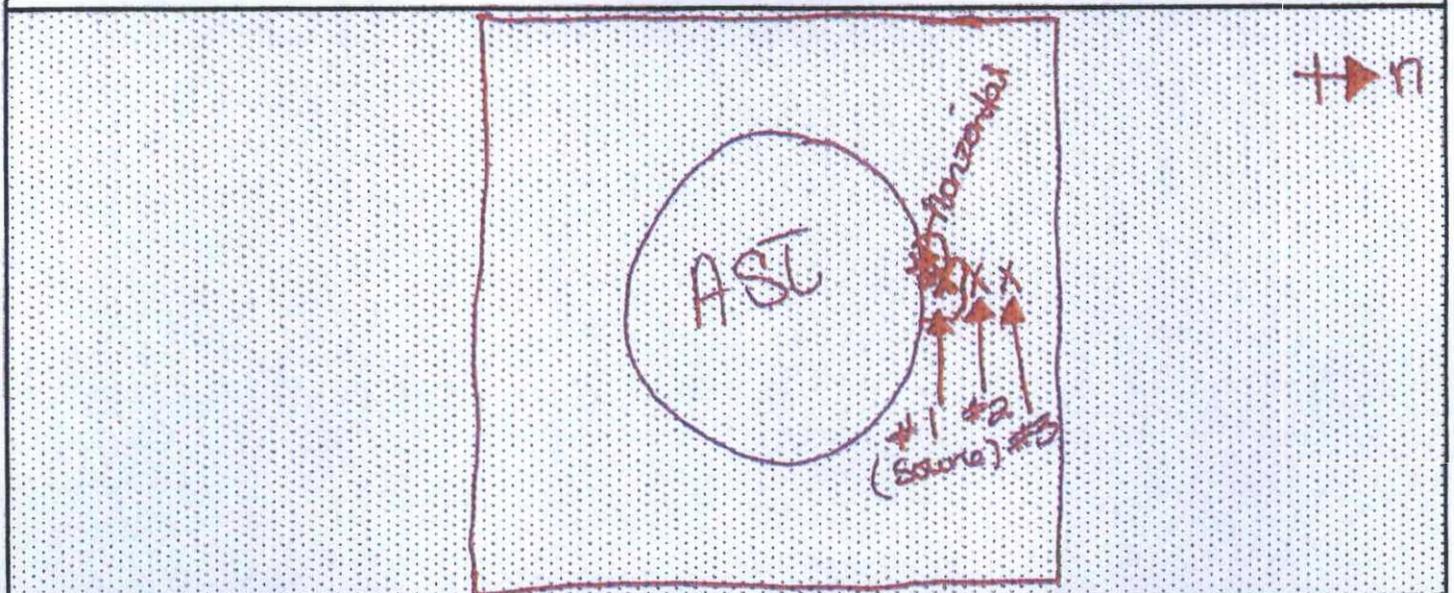
SPILL PERIMETER: Draw a schematic of the spill site. Attach photos and other diagrams as needed.

OVM Results				Lab Testing		
Sample ID	Field Headspace PID (ppm)	Sample ID	Field Headspace PID (ppm)	Sample ID	Analysis Type	Time
<u>1</u>	<u>226.7</u>					
<u>2</u>	<u>164.6</u>					
<u>3</u>	<u>144.1</u>					
<u>4</u>	<u>244.0</u>					
<u>5</u>	<u>69.2</u>					
<u>6</u>	<u>12.2</u>

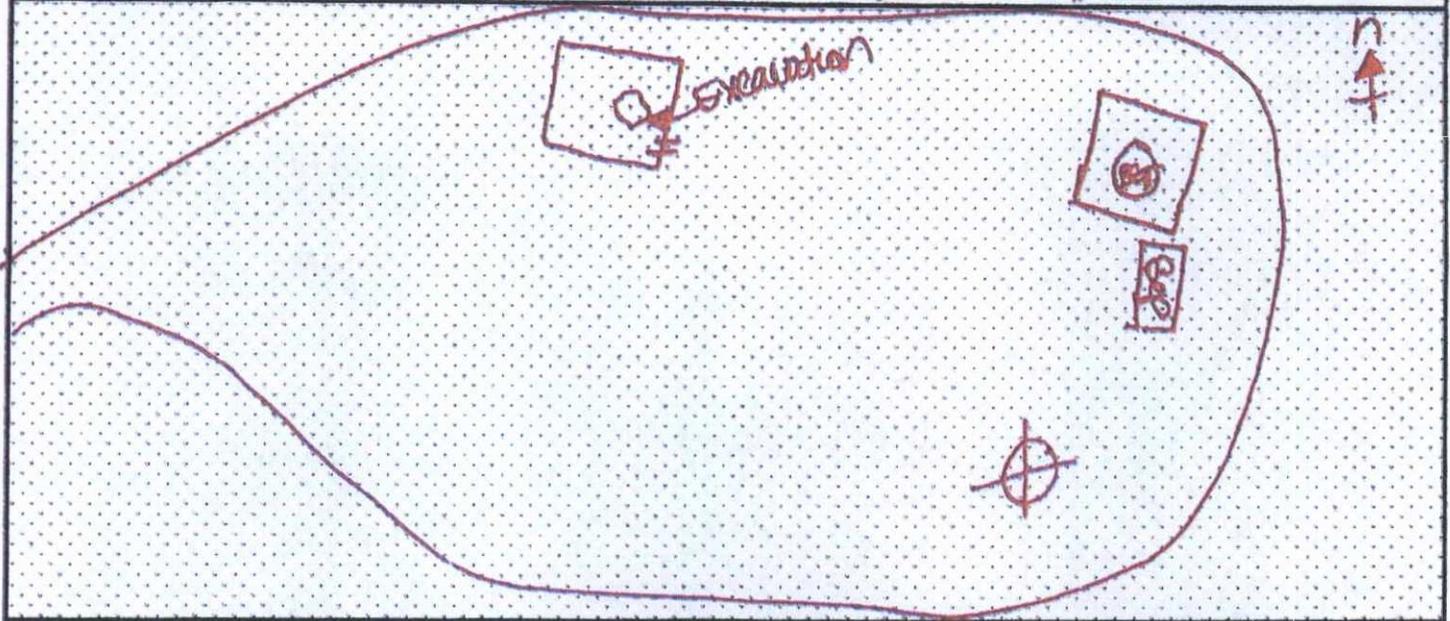
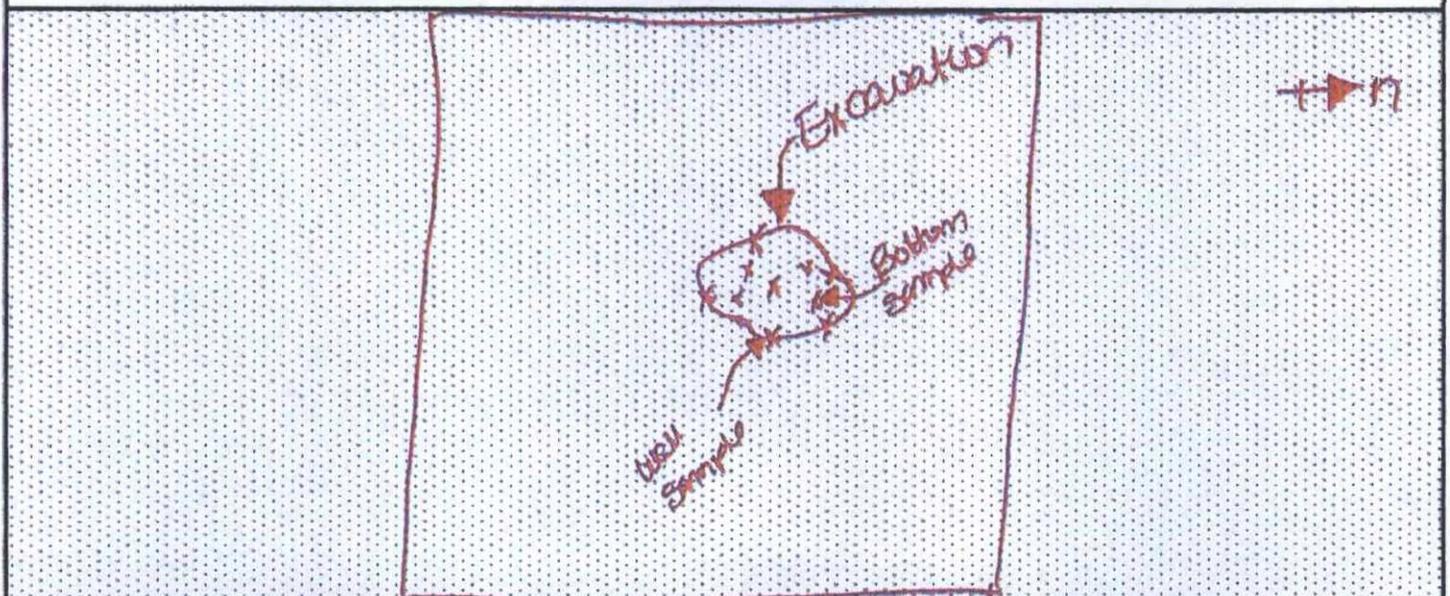
**SPILL PERIMETER:** Draw a schematic of the spill site. Attach photos and other diagrams as needed.

OVM Results				Lab Testing		
Sample ID	Field Headspace PID (ppm)	Sample ID	Field Headspace PID (ppm)	Sample ID	Analysis Type	Time
<u>Bottom</u>	<u>1762</u>					
<u>Walls</u>	<u>1036</u>

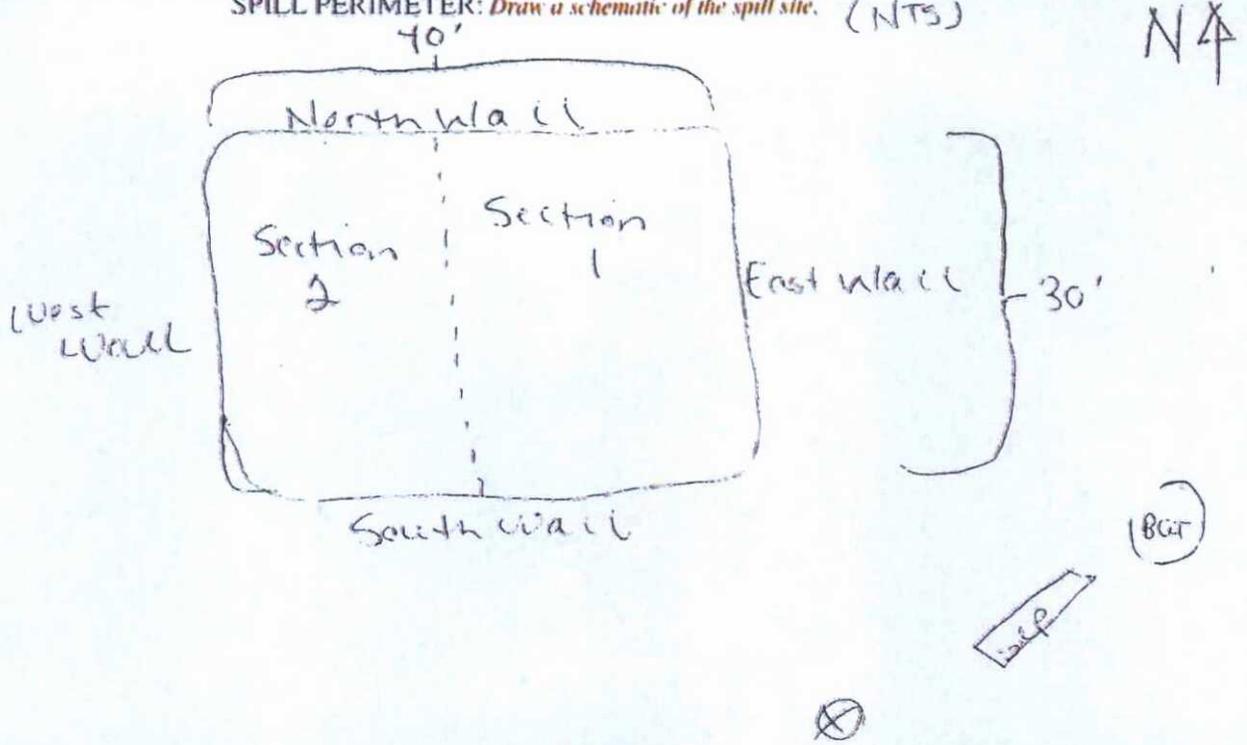
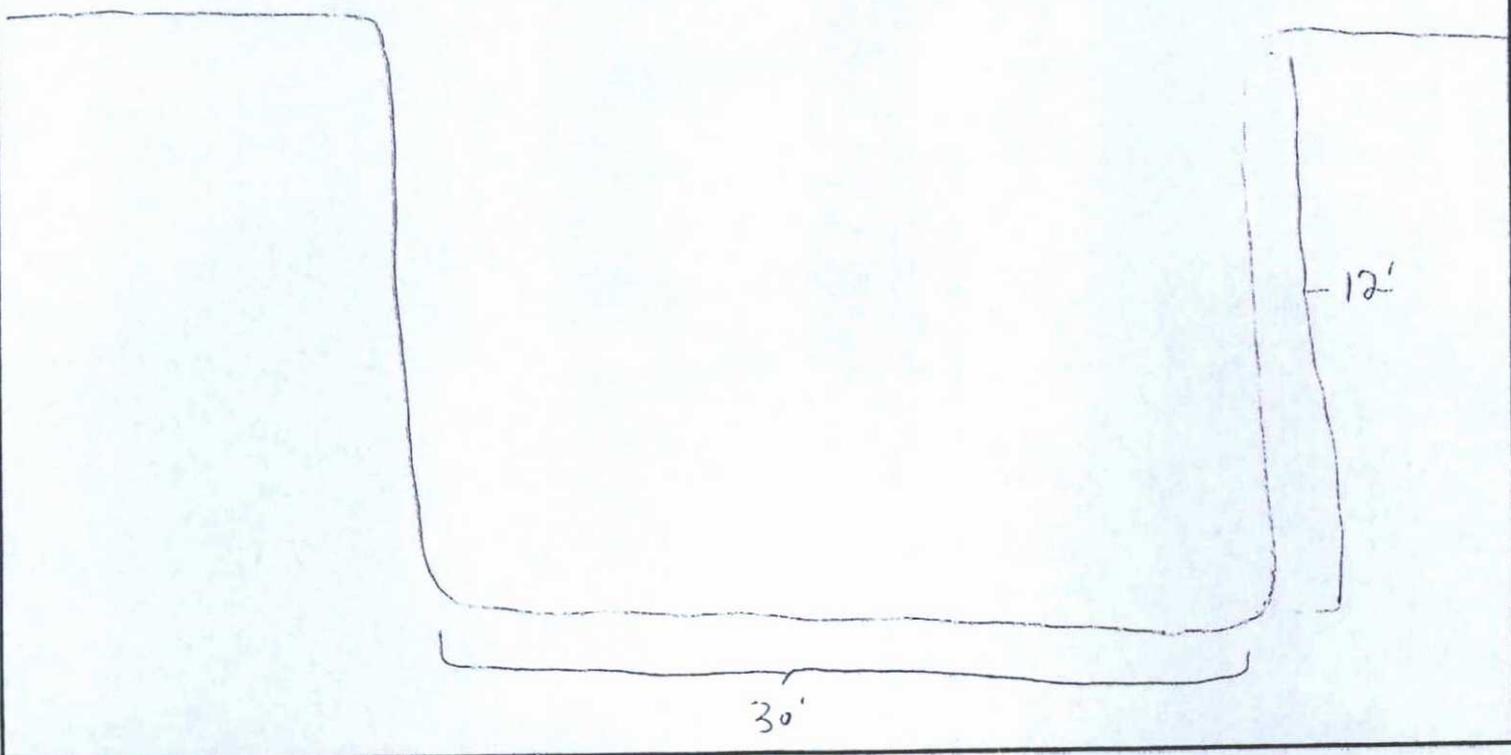
SPILL PERIMETER: Draw a schematic of the spill site. (NTS)

Cause of Release: leaking tank Material Released: condensate Amt. Released: unknown

OVM Results		Lab Testing			
Sample ID	Field Headspace PID (ppm)	Sample ID	To Lab Y/N	Analysis Type	Time
1	20.1	1	Y	EOIS, 8021	
2	687	2	N	n/a	
3	10.4	3	Y	EOIS, 8021	
4	0	4	Y	EOIS, 8021	
5	48.3	5	N	n/a	
6	1726	6	N	n/a

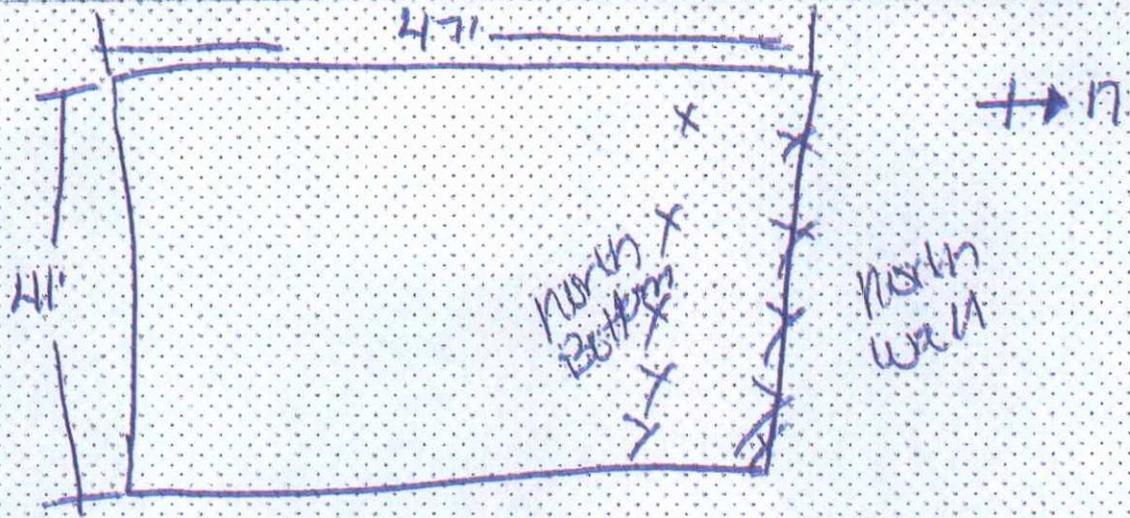
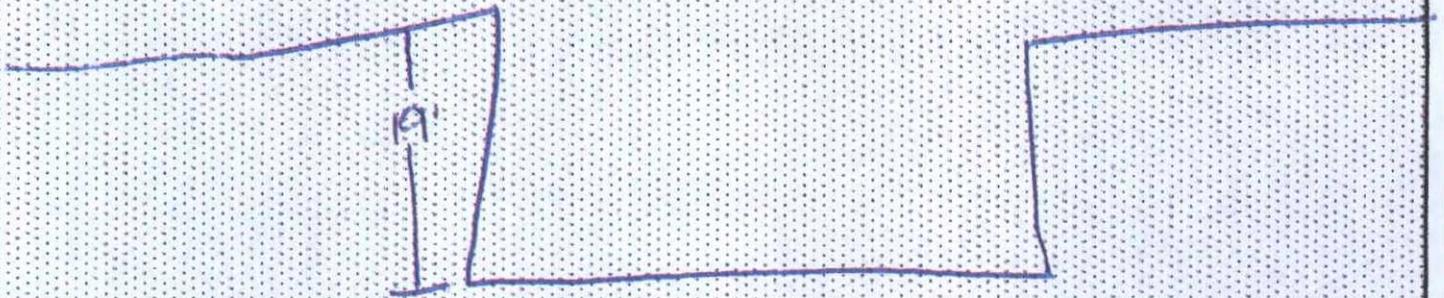
**SPILL PERIMETER:** Draw a schematic of the spill site. Attach photos and other diagrams as needed.

OVM Results				Lab Testing		
Sample ID	Field Headspace PID (ppm)	Sample ID	Field Headspace PID (ppm)	Sample ID	Analysis Type	Time
<u>2</u>	<u>11.1</u>					
<u>3</u>	<u>18.2</u>

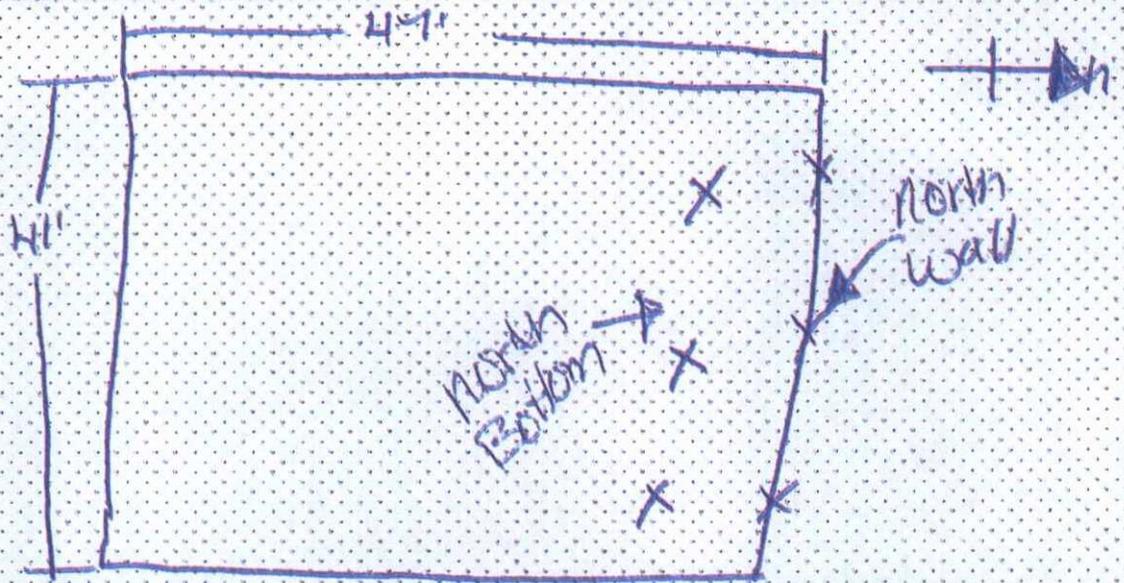
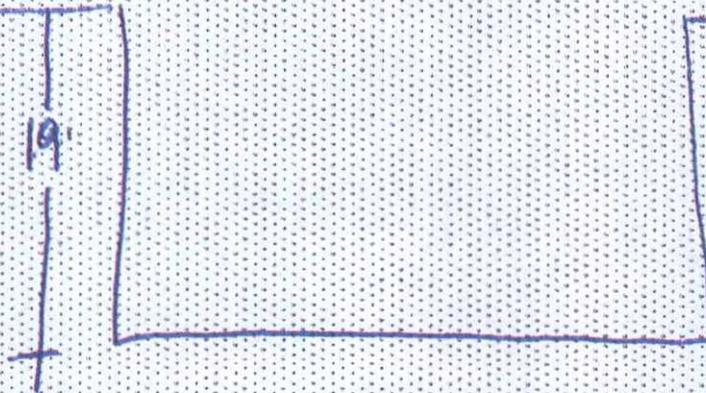
**SPILL PERIMETER:** Draw a schematic of the spill site. Attach photos and other diagrams as needed.

LOCATION: Name: <u>Wells Platero</u>	Well #: <u>5A</u>	API: _____
County: <u>San Juan</u>	State: <u>New Mexico</u>	
Cause of Release: <u>Leaking Pist</u>	Material Released: <u>Condensate</u>	Amt. Released: _____
QUAD/UNIT: _____ SEC: <u>11</u>	TWP: <u>21N</u>	RNG: <u>9W</u> PM: _____
Wellhead Lat/Long: _____	Land Jurisdiction: _____	QTR Footage: _____

OVM Results				Lab Testing		
Sample ID	Field Headspace PID (ppm)	Sample ID	Field Headspace PID (ppm)	Sample ID	Analysis Type	Time
				<u>North Well</u>	<u>SO15</u>	
				<u>North Bottom</u>	<u>SO15 SO21</u>

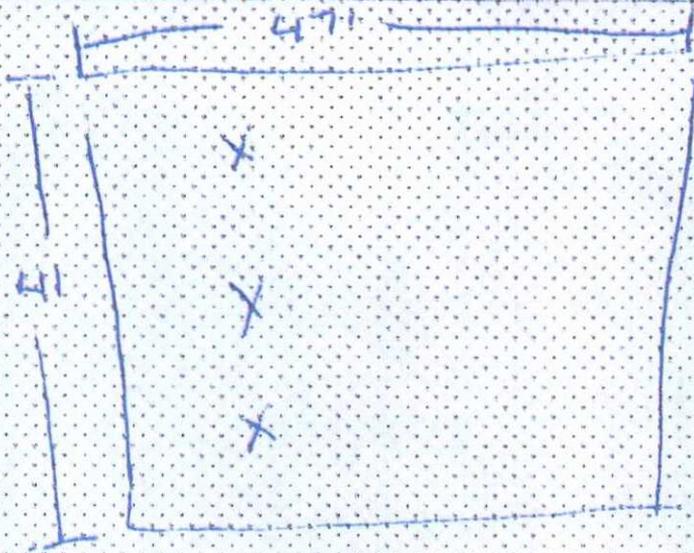
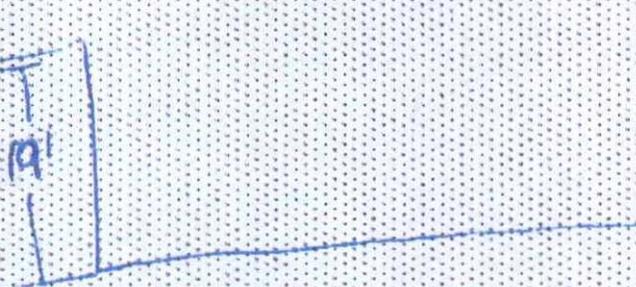
**SPILL PERIMETER:** Draw a schematic of the spill site. Attach photos and other diagrams as needed.

OVM Results				Lab Testing		
Sample ID	Field Headspace PID (ppm)	Sample ID	Field Headspace PID (ppm)	Sample ID	Analysis Type	Time
				<u>175' from location</u>	<u>GC/MS</u>	<u>8/21/15 12:30</u>

Collected one 3 point composite for  
lab analysis - only  
burn + oil - make
