Release Notification and Corrective Action

Name of Company: BP	Contact: Steve Moskal
Address: 200 Energy Court, Farmington, NM 87401	Telephone No.: 505-326-9497
Facility Name: Tapp LS 001A	Facility Type: Natural gas well
Surface Owner: Federal	Mineral Owner: Federal
API No. 3004523700

BP America
Tapp LS 1A
(C) Sec 22 – T22N – R8W
San Juan County, New Mexico
API: 30-045-23700

Summary Record of Impact Remediation

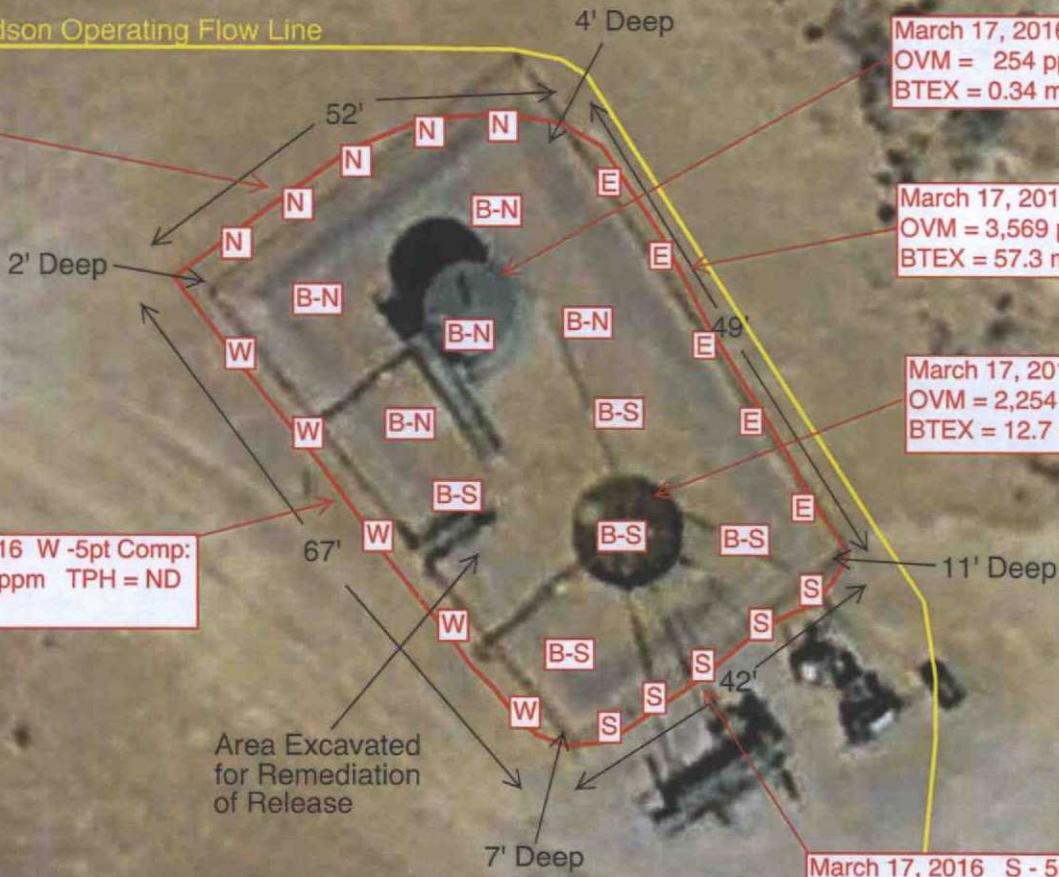
Area Excavated for Remediation of Release

Richardson Operating Flow Line

March 17, 2016 N - 5pt Comp:
OVM = 2,711 ppm TPH = 2,270 mg/Kg
BTEX = 60.1 mg/Kg

March 17, 2016 Base-North Comp:
OVM = 254 ppm TPH = 205 mg/Kg
BTEX = 0.34 mg/Kg

March 17, 2016 E - 5pt Comp:
OVM = 3,569 ppm TPH = 1,860 mg/Kg
BTEX = 57.3 mg/Kg

March 17, 2016 Base-South Comp:
OVM = 2,254 ppm TPH = 640 mg/Kg
BTEX = 12.7 mg/Kg

March 17, 2016 W - 5pt Comp:
OVM = 56 ppm TPH = ND
BTEX = ND

March 17, 2016 S - 5pt Comp:
OVM = 102 ppm TPH = ND
BTEX = ND

March 17, 2016 Final excavation size approximately 67' x 42' x 6' average depth. The dense sandstone has a definite slope towards the southeast, with the northwest corner of the excavation 2' deep and the southeast corner depth at 11'. Conduct closure sampling. Witnessed by NMOCD and BLM.

March 18, 2016 Receive rush lab results. All samples pass on TPH, Benzene and Chloride. Total BTEX exceeds the 50 ppm closure standard on the north wall (60.1 ppm) and east wall (57.3 ppm). Request authorization to close out remedial effort.
