Release Notification and Corrective Action

Name of Company: BP	Contact: Steve Moskal	
Address: 200 Energy Court, Farmington, NM 87401	Telephone No.: 505-326-9497	
Facility Name: Gallegos Canyon Unit 307	Facility Type: Natural gas well	
Surface Owner: Fee	Mineral Owner: Fee	API No. 3004524248

CLIENT: <u>BP</u>	BLAGG ENGINEERING, INC. P.O. BOX 87, BLOOMFIELD, NM 87413 (505) 632-1199	API #: <u>30-045-24248</u> TANK ID (if applicable): <u> </u>
FIELD REPORT: (circle one): BGT CONFIRMATION <u>RELEASE INVESTIGATION</u> OTHER:		PAGE #: <u>1</u> of <u>1</u>
SITE INFORMATION: SITE NAME: <u>GCU 307 SWD</u> QUAD/UNIT: <u>(L) SEC: 30 TWP. 29N RING: 12W PM: NM CNTY: SJ ST: NM</u> 1/4-1/4/FOOTAGE: <u>NW/4 SW/4</u> LEASE TYPE: FEDERAL/STATE <u>(FEE) INDIAN</u> LEASE #: <u> </u> PROD. FORMATION: <u> </u> CONTRACTOR: <u> </u>		DATE STARTED: <u>3/11/2016</u> DATE FINISHED: <u>3/11/2016</u> ENVIRONMENTAL SPECIALIST(S): <u>JCB</u>
REFERENCE POINT: WELL HEAD (W.H.) GPS COORD.: <u>36.69402 x 108.14682</u> GL ELEV.: <u>5418</u>

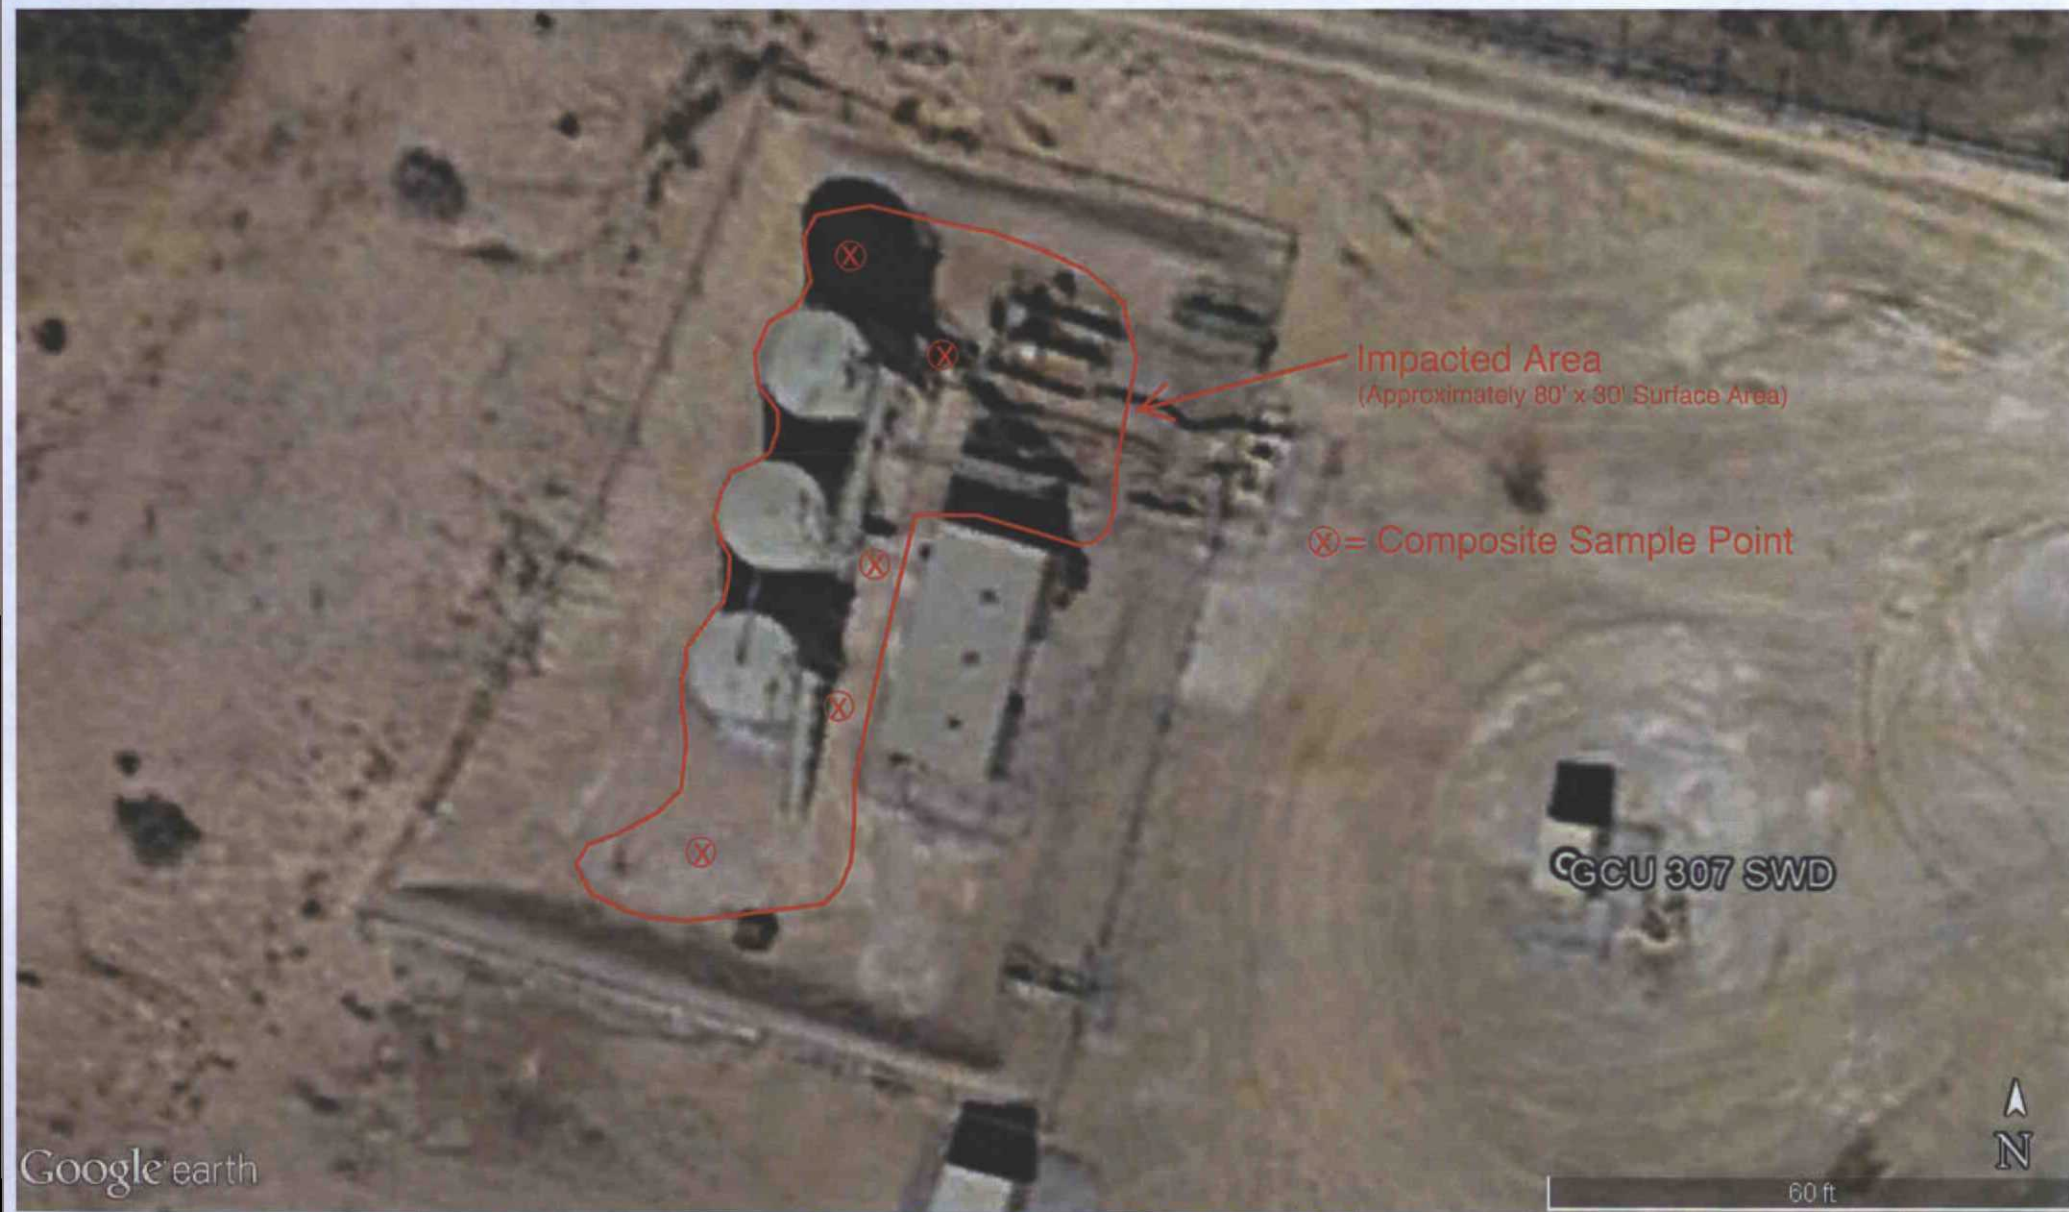
CGCU 307 SWD

SITE OBSERVATIONS: LOST INTEGRITY OF EQUIPMENT: <u>(YES)</u> NO EXPLANATION: <u>TANK</u> APPARENT EVIDENCE OF A RELEASE OBSERVED AND/OR OCCURRED <u>(YES)</u> NO EXPLANATION: <u>Moist soils</u> EQUIPMENT SET OVER RECLAIMED AREA: YES / NO EXPLANATION: <u>NA</u> OTHER: _____		
SOIL IMPACT DIMENSION ESTIMATION: <u>80</u> ft X <u>30</u> ft X <u>?</u> ft EXCAVATION ESTIMATION (Cubic Yards): _____ DEPTH TO GROUNDWATER: <u><50'</u> NEAREST WATER SOURCE: <u>>1000'</u> NEAREST SURFACE WATER: <u><1000'</u> NM OGD TPH CLOSURE STD: <u>100</u> ppm		
SITE SKETCH BGT Located: off / on site PLOT PLAN circle: <u>attached</u> 		
NOTES: BGT = BELOW-GRADE TANK; E.D. = EXCAVATION DEPRESSION; B.G. = BELOW GRADE; B = BELOW; T.H. = TEST HOLE; - = APPROX.; W.H. = WELL HEAD; T.B. = TANK BOTTOM; PBGT = PREVIOUS BELOW-GRADE TANK LOCATION; SPD = SAMPLE POINT DESIGNATION; R.W. = RETAINING WALL; NA = NOT APPLICABLE OR NOT AVAILABLE; SW - SINGLE WALL; DW - DOUBLE WALL; SB - SINGLE BOTTOM; DB - DOUBLE BOTTOM		MISCELL. NOTES WO: _____ PO #: _____ PK: <u>VID: VM056HQFEC</u> PJ #: _____ Permit date(s): _____ OCD Appr. date(s): _____ Tank ID: _____ OVM = Organic Vapor Meter ppm = parts per million BGT Sidewalls Visible: Y / N BGT Sidewalls Visible: Y / N BGT Sidewalls Visible: Y / N Magnetic declination: <u>10° E</u>

Impacted Area
(Approximately 80' x 30' Surface Area)

⊗ = Composite Sample Point

Describe Area Affected and Cleanup Action Taken.* The produced water was removed from the below grade tank and bermed area. The pump discharge line was replaced. Soil samples for BTEX, TPH via 8015 and chlorides collected and submitted for laboratory analysis following the spill and release guidelines. BTEX and TPH below closure standards, chloride concentrations were elevated with 1,500 ppm. A field report and laboratory results are attached. The soil inside the berm was raked.
