**Release Notification and Corrective Action**

## **Decker #3 Release Report**

Unit Letter M, Section 23, Township 32 North, Range 12 West  
San Juan County, New Mexico

# ConocoPhillips Decker #3 Release Report

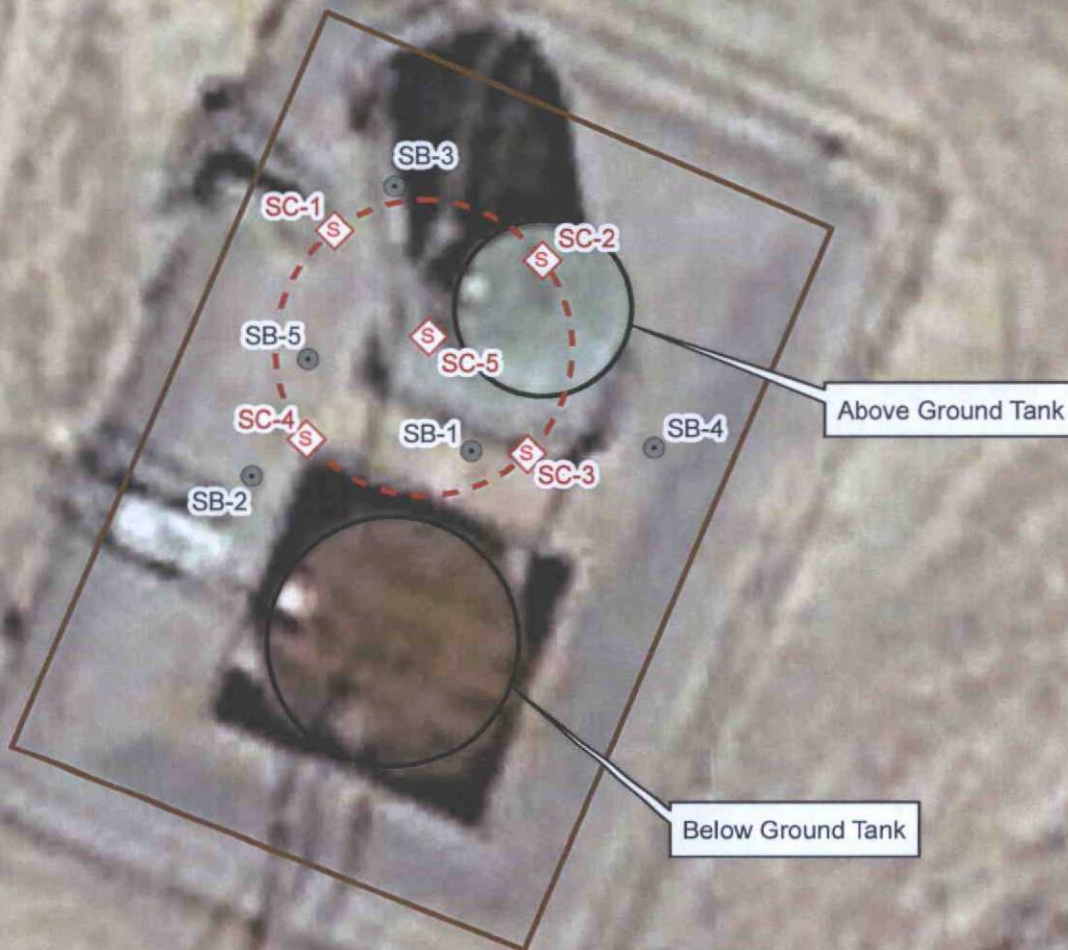
**Figure 2**  
**Sample Location Map**  
Decker #3

On May 10, 2016, Rule Engineering, LLC (Rule) personnel conducted an initial site assessment to delineate the extents of the release which included advancing five soil borings (SB-1 through SB-5) utilizing a hand auger. Soil borings were advanced to approximately 13 feet bgs which is the maximum extent of the equipment. A sample location map showing the boring locations is included as Figure 3.

On August 3, 2016, Rule personnel returned to the location to provide excavation guidance and collect confirmation samples from the resultant excavation. The maximum extent of the excavation measured approximately 17 feet by 17 feet by 15 feet deep. Approximately 175 cubic yards of impacted soils were transported to a local NMOCD approved landfarm for disposal/remediation and the excavation was backfilled with clean, imported material. A depiction of the final excavation with sample locations is included on Figure 3.
