Release Notification and Corrective Action

RE: SPILL ASSESSMENT REPORT FOR THE NICKSON #16 WELL SITE, SAN JUAN COUNTY, NEW MEXICO

Nickson #16

**SITE PHOTOGRAPHY
NICKSON #16
SPILL ASSESSMENT REPORT
SAN JUAN COUNTY, NEW MEXICO
PROJECT NUMBER 96052-2484
FEBRUARY 2015**

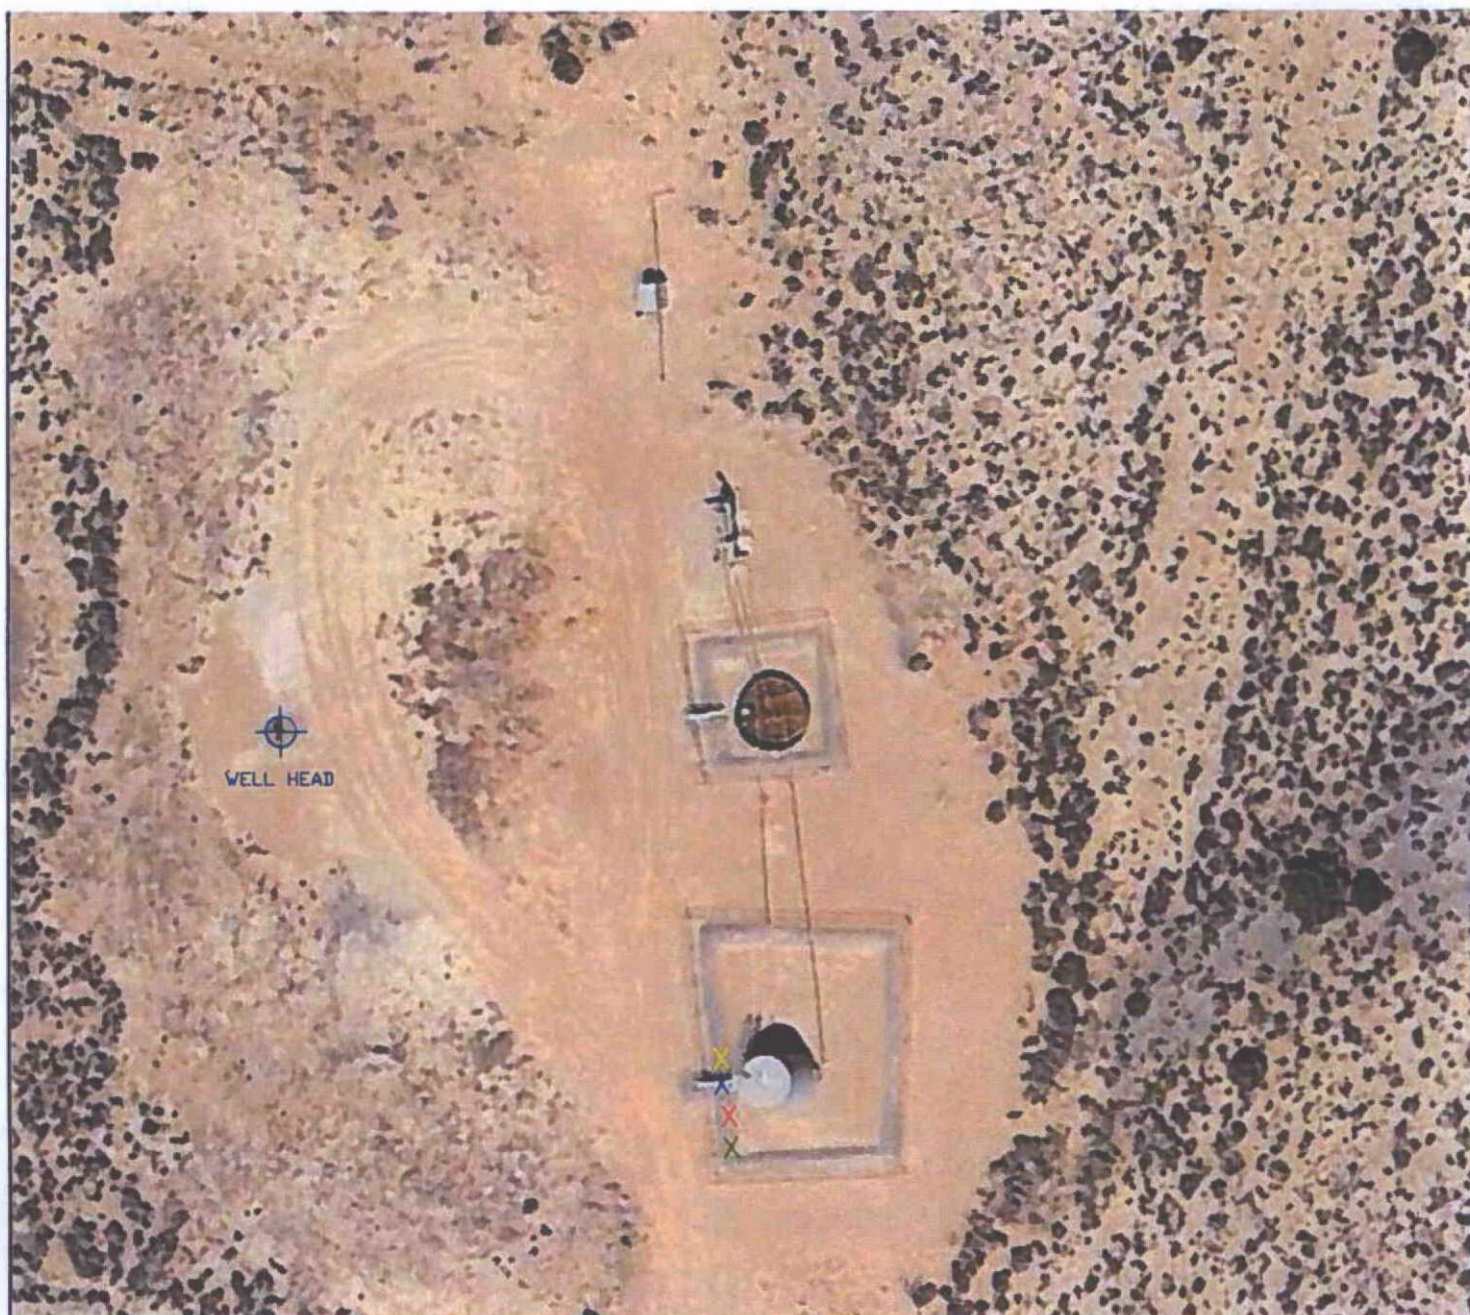
FIGURE NO. 1

SAMPLE LOCATIONS

X Sample Hole 1

X Sample Hole 2

X Sample Hole 3

X Sample Hole 4

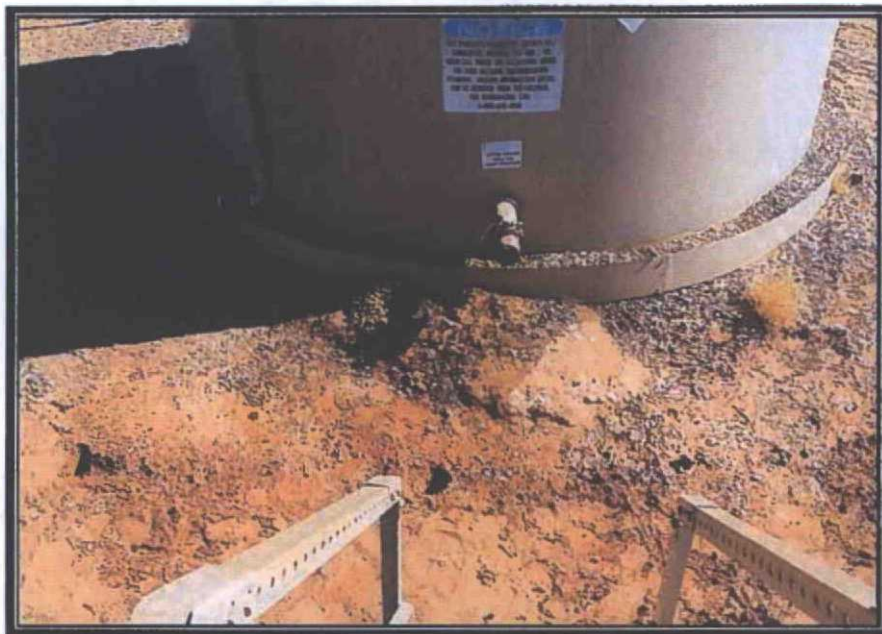
Upon Envirotech personnel's arrival, four (4) samples were collected from the location. One (1) sample was collected from the foot (4) feet below ground surface (BGS) from the area of visually impacted soil. One (1) sample was collected approximately five (5) feet south of the center of the impacted area at six (6) inches BGS. One (1) sample was collected from approximately 10 feet south of the center of the impacted area at six (6) inches BGS. One (1) sample was collected from approximately four (4) feet to the north of the center of the impacted area at six (6) inches BGS. The samples were analyzed in the field for TPH using USEPA Method 418.1 and for organic vapors using a photoionization detector (PID). All samples returned results below the regulatory standard for TPH and organic vapors; see enclosed *Field Notes* and *Analytical Results*. The sample from the center of the visually impacted soil at four (4) feet BGS was then collected into a four (4)-ounce glass jar, capped headspace free, and transported on ice, under chain of custody, to Envirotech's Analytical Laboratory to be analyzed for TPH using USEPA Method 8015, benzene and total BTEX using USEPA Method 8021 and chlorides using USEPA Method 300.0. The sample returned results below the regulatory standard for all constituents analyzed; see enclosed *Analytical Results*. Envirotech, Inc. recommends excavation visually stained area to four (4) feet BGS.

Picture 3: Sample hole 1 and 4

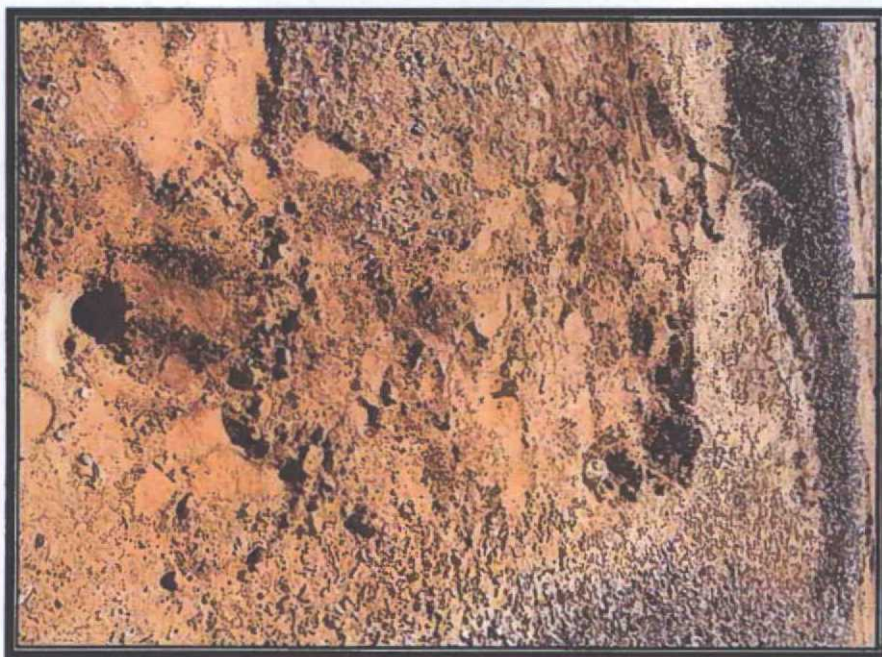
Picture 4: Sample holes 2 and 3
