Pit, Closed-Loop System, Below-Grade Tank, or  
Proposed Alternative Method Permit or Closure Plan Application

**BELOW-GRADE TANK CLOSURE PLAN**

**NEBU SIMS MESA SWD 001 – Tank ID: A**

**API #: 3003924236**

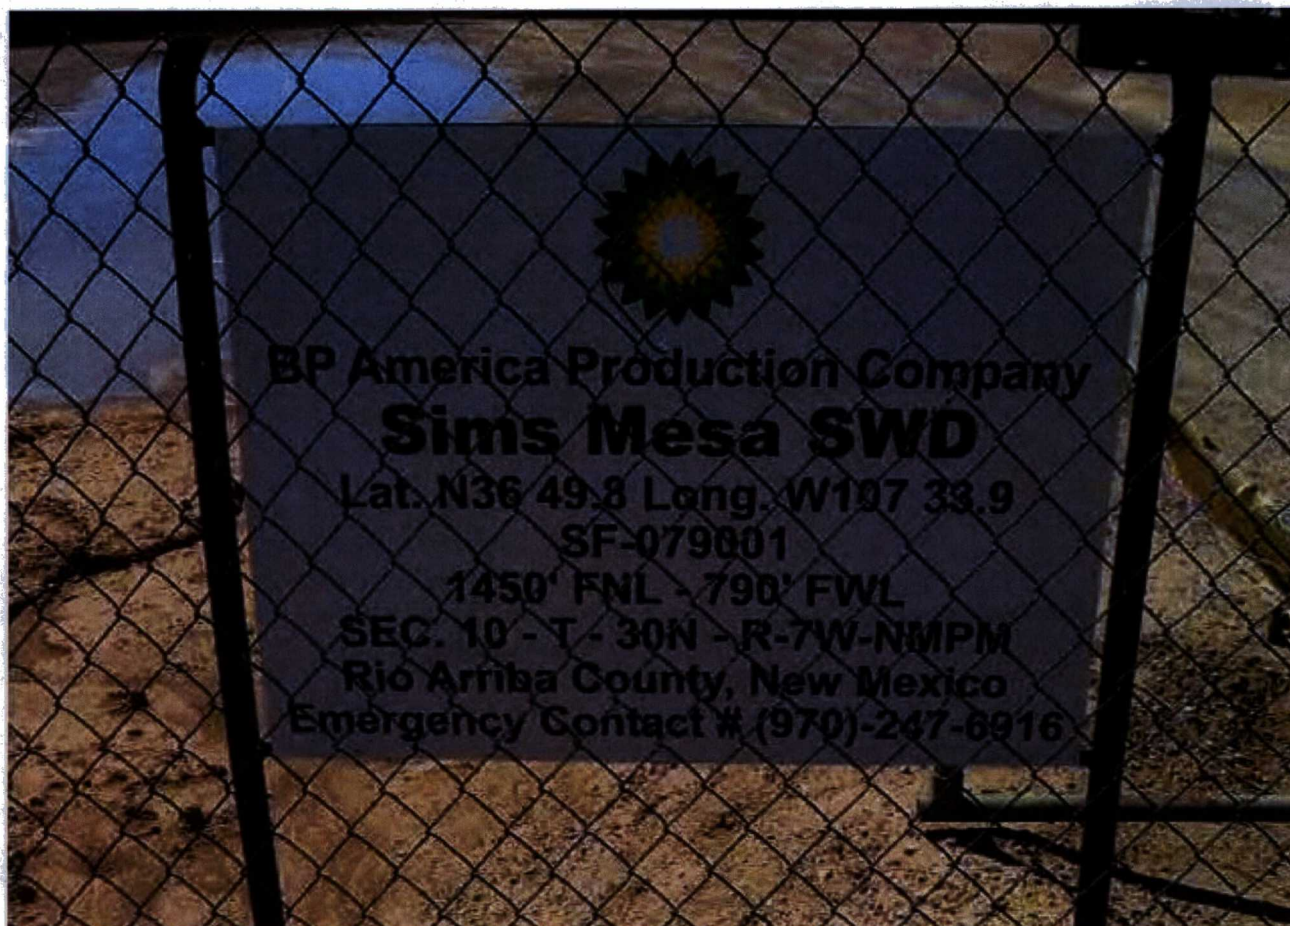
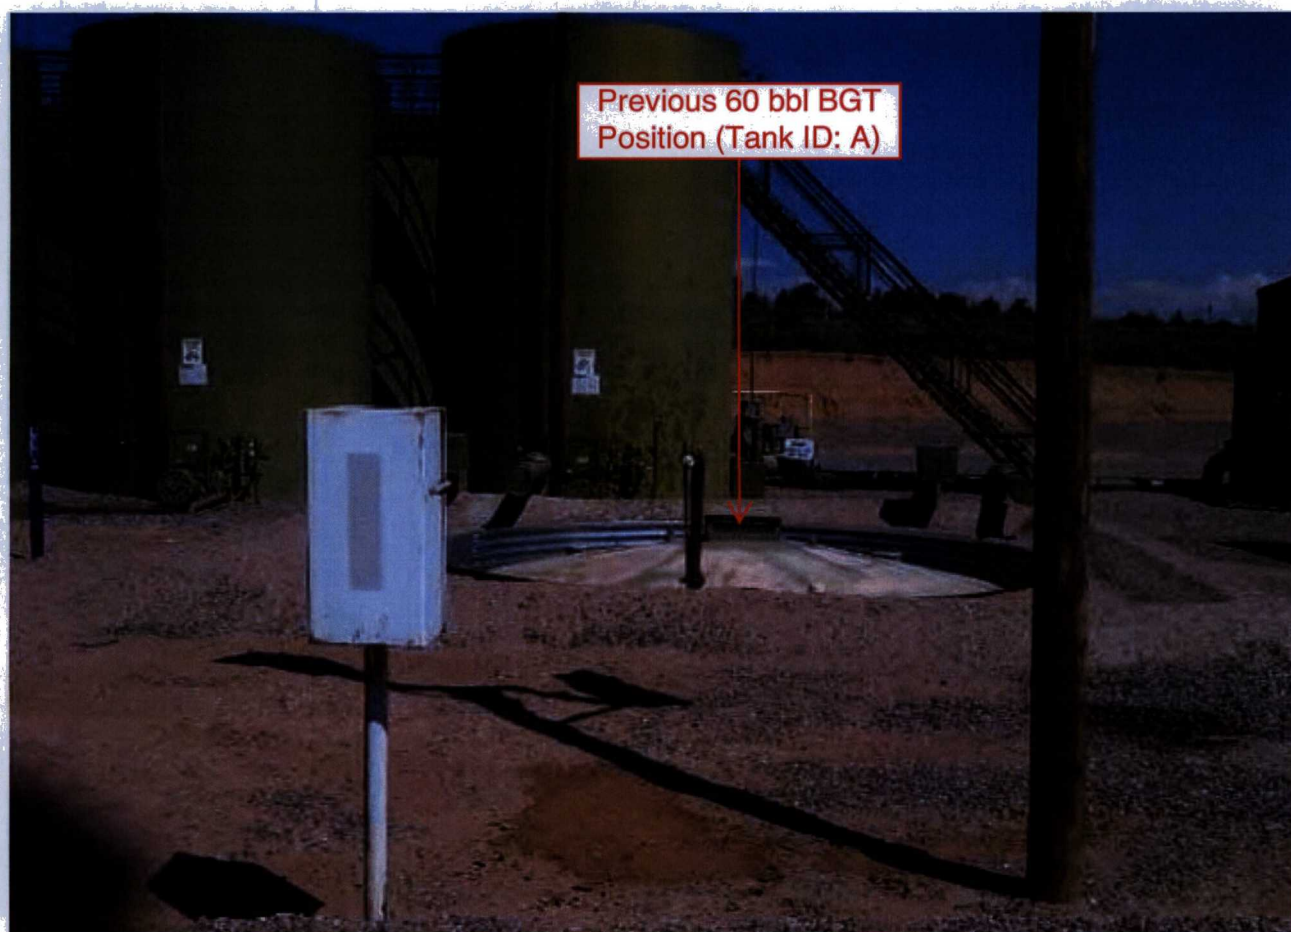
<b>SITE OBSERVATIONS:</b> LOST INTEGRITY OF EQUIPMENT: <u>YES</u> NO EXPLANATION - <b>FLUID FLOWING FROM BGT BOTTOM CREASE.</b> APPARENT EVIDENCE OF A RELEASE OBSERVED AND/OR OCCURRED: <u>YES</u> NO EXPLANATION: <b>FLUID IN EXCAVATION &amp; DISCOLORED SOILS.</b> EQUIPMENT SET OVER RECLAIMED AREA: YES <u>NO</u> EXPLANATION - <b>BETTER DESIGNED BGT TO BE INSTALLED.</b> OTHER: <b>NORTH &amp; EAST SIDEWALLS DISCOLORED FROM 7 - 10 FT. BELOW GRADE. SANDSTONE @ 9 - 10 FT. BELOW GRADE, MOSTLY DARK GRAY TO BLACK, VERY HARD, COMPETENT. NMOCD REP. PRESENT DURING SAMPLE COLLECTION.</b> SOIL IMPACT DIMENSION ESTIMATION: _____ ft. X _____ ft. X _____ ft. EXCAVATION ESTIMATION (Cubic Yards): _____ ? DEPTH TO GROUNDWATER: <b>&gt;100'</b> NEAREST WATER SOURCE: <b>&gt;1,000'</b> NEAREST SURFACE WATER: <b>&gt;1,000'</b> NMOCD TPH CLOSURE STD: <b>5,000</b> ppm		
<b>SITE SKETCH</b> BGT Located : off <u>on</u> site      PLOT PLAN circle: <u>attached</u> <b>FIGURE 3</b> <div style="text-align: center;"> </div>
