Pit, Below-Grade Tank, or
Proposed Alternative Method Permit or Closure Plan Application

Burlington Resources Oil & Gas Company
San Juan Basin: New Mexico Assets
Below Grade Tank Closure Report

Lease Name: Hale 352
API No.: 30-045-27650

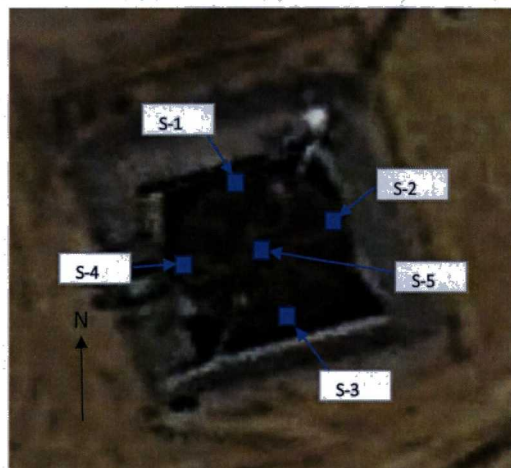
Observations: No staining or excess moisture was observed below the tank.

SC-1 is a 5-point composite of S-1 through S-5, collected 0.5 ft below BGT.

Sample SC-1 was laboratory analyzed for TPH (8015 and 418.1), BTEX (8021) and chlorides (300.0).
