Pit, Below-Grade Tank, or  
Proposed Alternative Method Permit or Closure Plan Application

**Burlington Resources Oil & Gas Company, LP  
San Juan Basin  
Below Grade Tank Closure Report**

**Lease Name: Huerfanito Unit 47S**

**API No.: 30-045-34559**

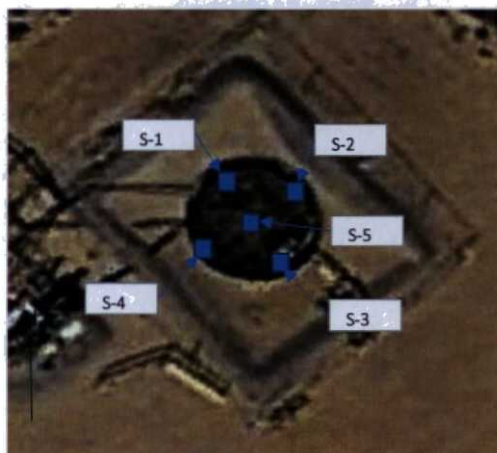
Observations: No staining or excess moisture was observed below the tank.

SC-1 is a 5-point composite of S-1 through S-5, collected 0.5 ft below BGT.

Sample SC-1 was laboratory analyzed for TPH (8015 and 418.1), BTEX (8021) and chlorides (300.0).
