15637
Pit, Below-Grade Tank, or
Proposed Alternative Method Permit or Closure Plan Application

Facility or well name: SAN JUAN 29-6 UNIT 13

**ConocoPhillips Company
San Juan Basin
Below Grade Tank Closure Report**

Lease Name: San Juan 29-6 Unit 13

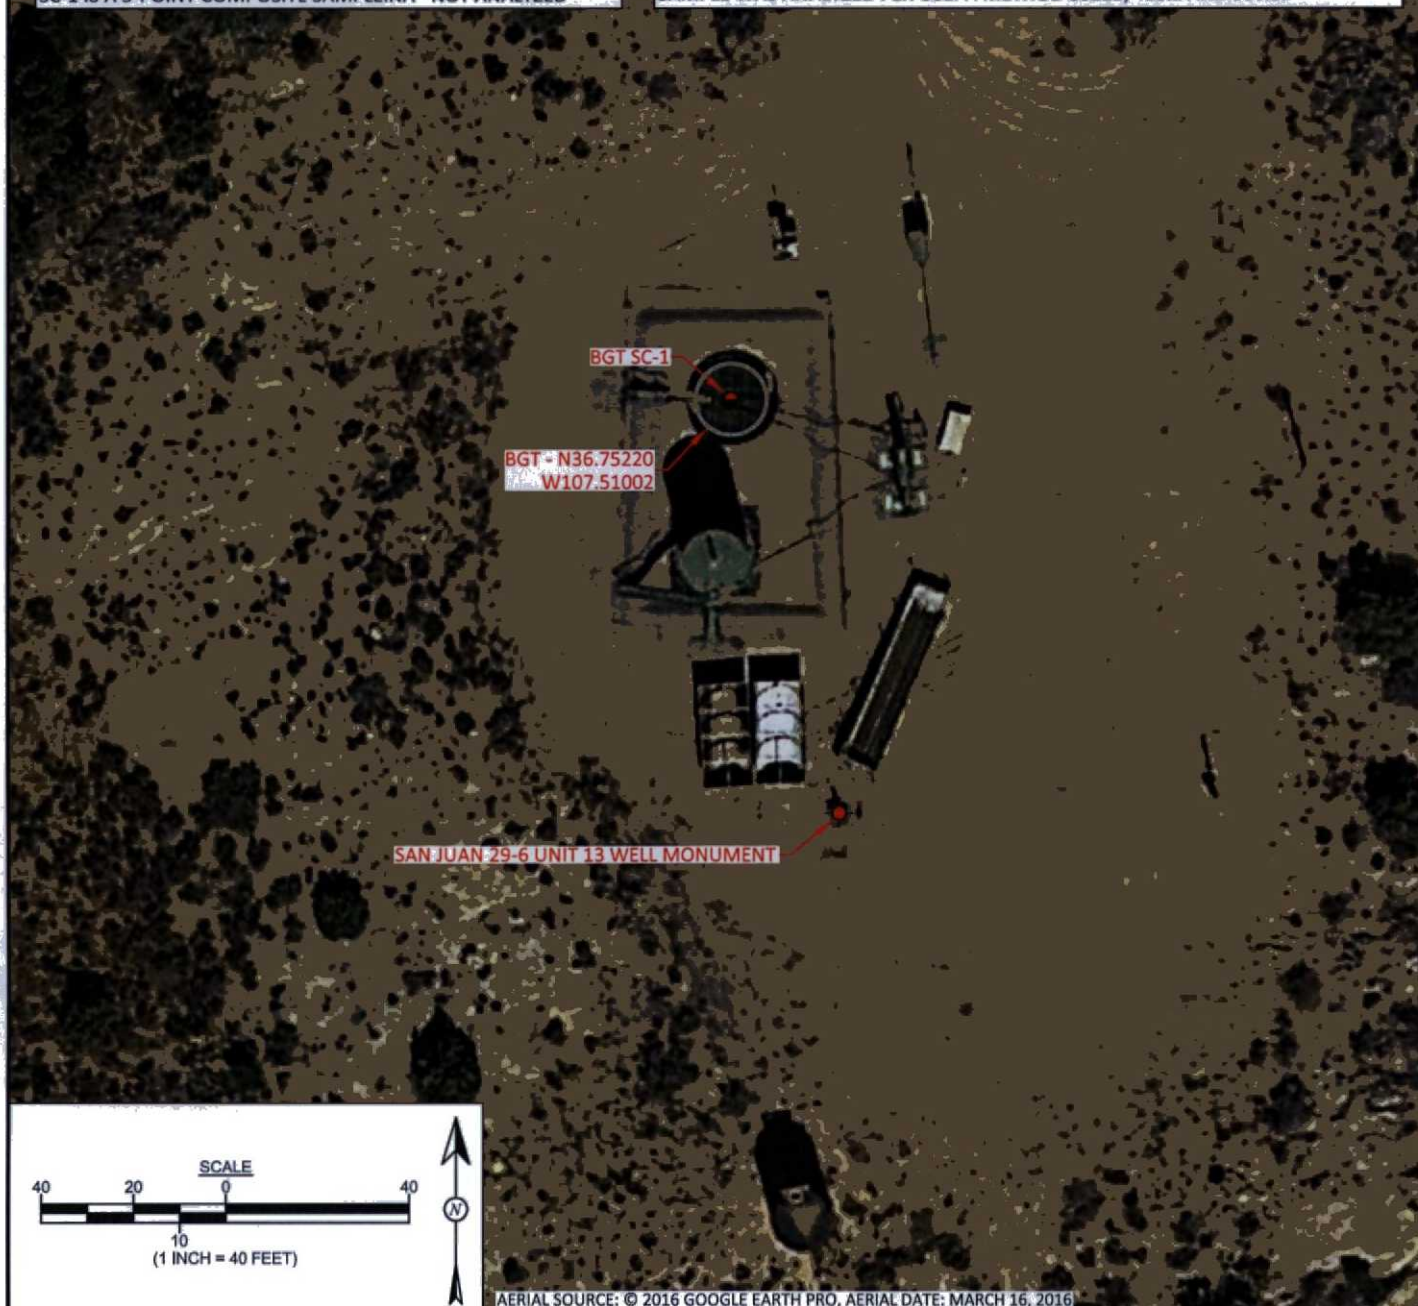
Sample ID	Date	Depth (ft)	Benzene (mg/kg)	Total BTEX (mg/kg)	TPH (mg/kg)	Chlorides (mg/kg)
NMOCD ACTION LEVEL			0.2	50	100	250
BGT SC-1	8/25/16	0.5	<0.024	<0.22	<19	<30

AERIAL SOURCE: © 2016 GOOGLE EARTH PRO, AERIAL DATE: MARCH 16, 2016

NMOCD action levels for BGT closures are specified in New Mexico Administrative Code (NMAC) 19.15.17.13E. Field TPH concentrations in BGT SC-1 were below the NMOCD action level of 100 mg/kg, with a concentration reported at 21.6 mg/kg. Benzene and total BTEX concentrations were below the NMOCD action levels of 0.2 mg/kg and 50 mg/kg, respectively. Chloride concentrations in BGT SC-1 were below the NMOCD action level of 250 mg/kg. Based on field sampling and laboratory analytical results for benzene, total BTEX, TPH, and chlorides, no further work is recommended at San Juan 29-6 Unit 13.
