**Release Notification and Corrective Action**

## **San Juan 28-6 #78 Release Report**

Unit Letter A, Section 1, Township 27 North, Range 6 West  
Rio Arriba County, New Mexico

August 3, 2016

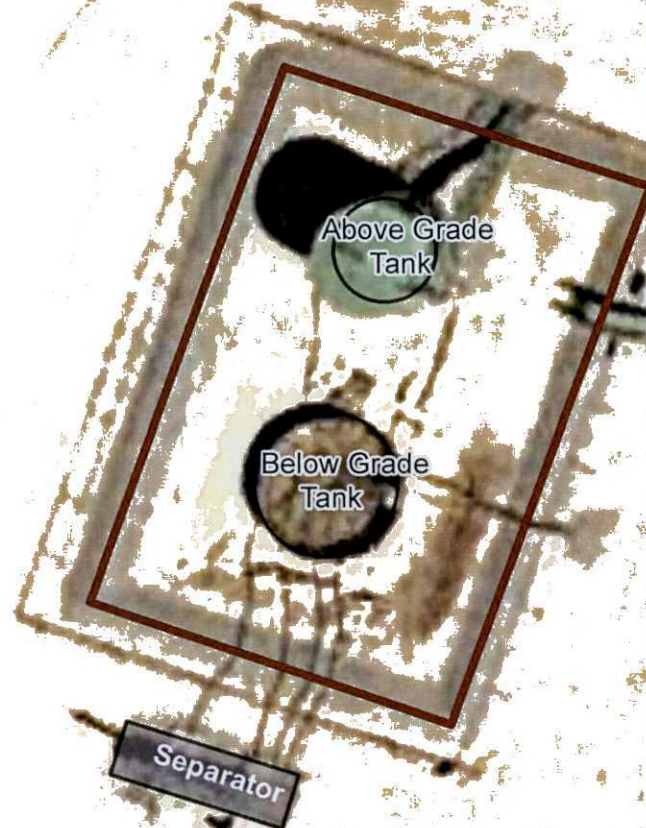
**Figure 2**  
**Aerial Site Map**  
San Juan 28-6 #78

A topographic map of the location reproduced from the United States Geological Society quadrangle map of the area is included as Figure 1 and an aerial site map is included as Figure 2.

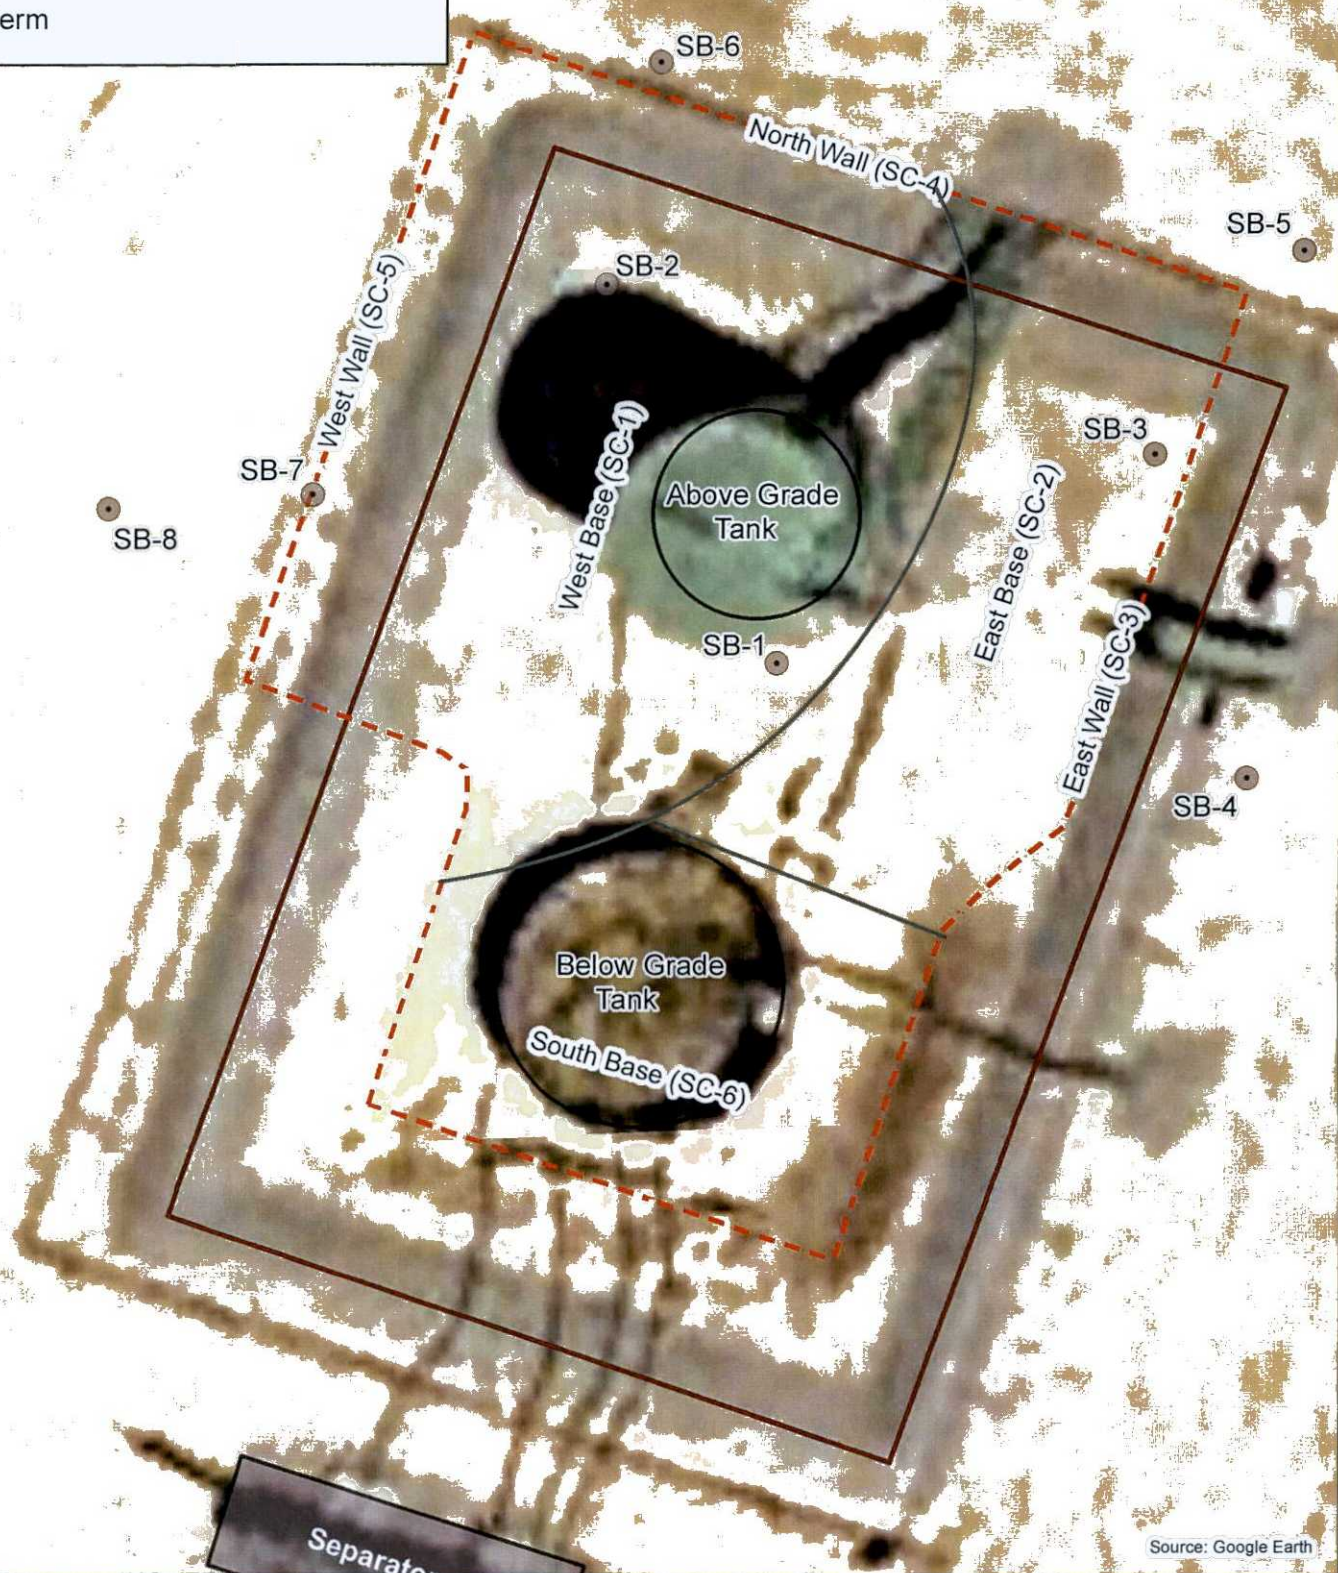
**Figure 3**  
**Sample Location Map**  
San Juan 28-6 #78

On April 7, 2016, Rule Engineering, LLC (Rule) personnel conducted an initial site assessment to delineate the extents of the release which included advancing eight soil borings (SB-1 through SB-8) utilizing a hand auger. Soil borings were advanced to depths ranging from 4.5 to 7 feet bgs where auger refusal was encountered on sandstone. A sample location map showing the boring locations is included as Figure 3.

The maximum extent of the excavation measured approximately 36 feet by 42 feet by 7 to 9 feet deep in the main excavation area and approximately 18.5 feet by 25.5 feet by 5 to 6 feet in depth (1.5 feet below the original depth) in the BGT area. The impacted soils were transported to the Envirotech Landfarm near Bloomfield, New Mexico for disposal/remediation and the excavation was backfilled with clean, imported material. A depiction of the final excavation with sample locations is included on Figure 3.
