**Release Notification and Corrective Action**

## **San Juan 28-7 #153E Release Report**

Unit Letter I, Section 20, Township 27 North, Range 7 West  
Rio Arriba County, New Mexico

December 1, 2016

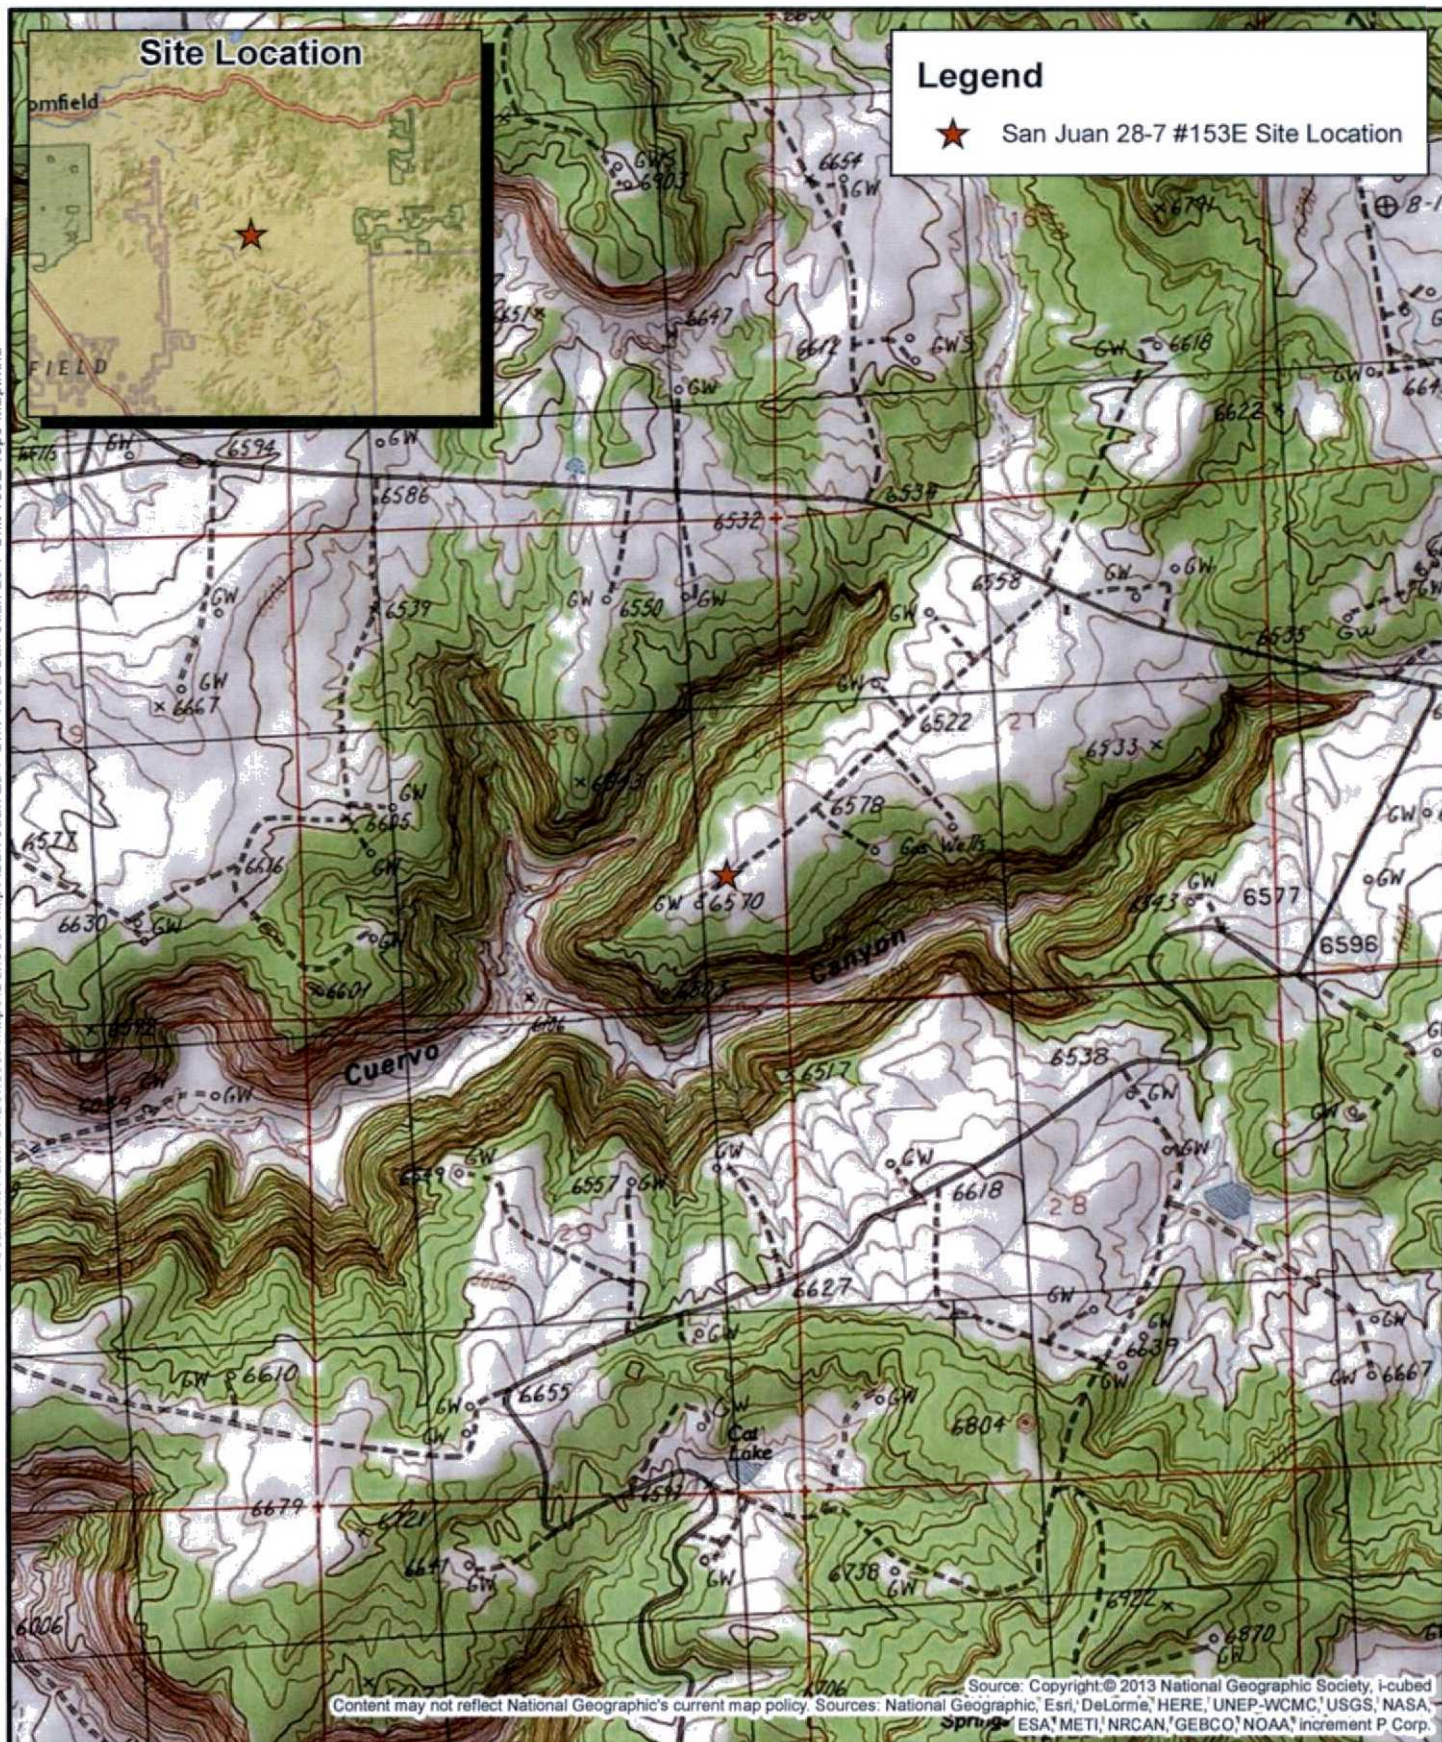
**Figure 1**  
**Topographic Map**  
 San Juan 28-7 #153E

A topographic map of the location reproduced from the United States Geological Society quadrangle map of the area is included as Figure 1 and an aerial site map is included as Figure 2.

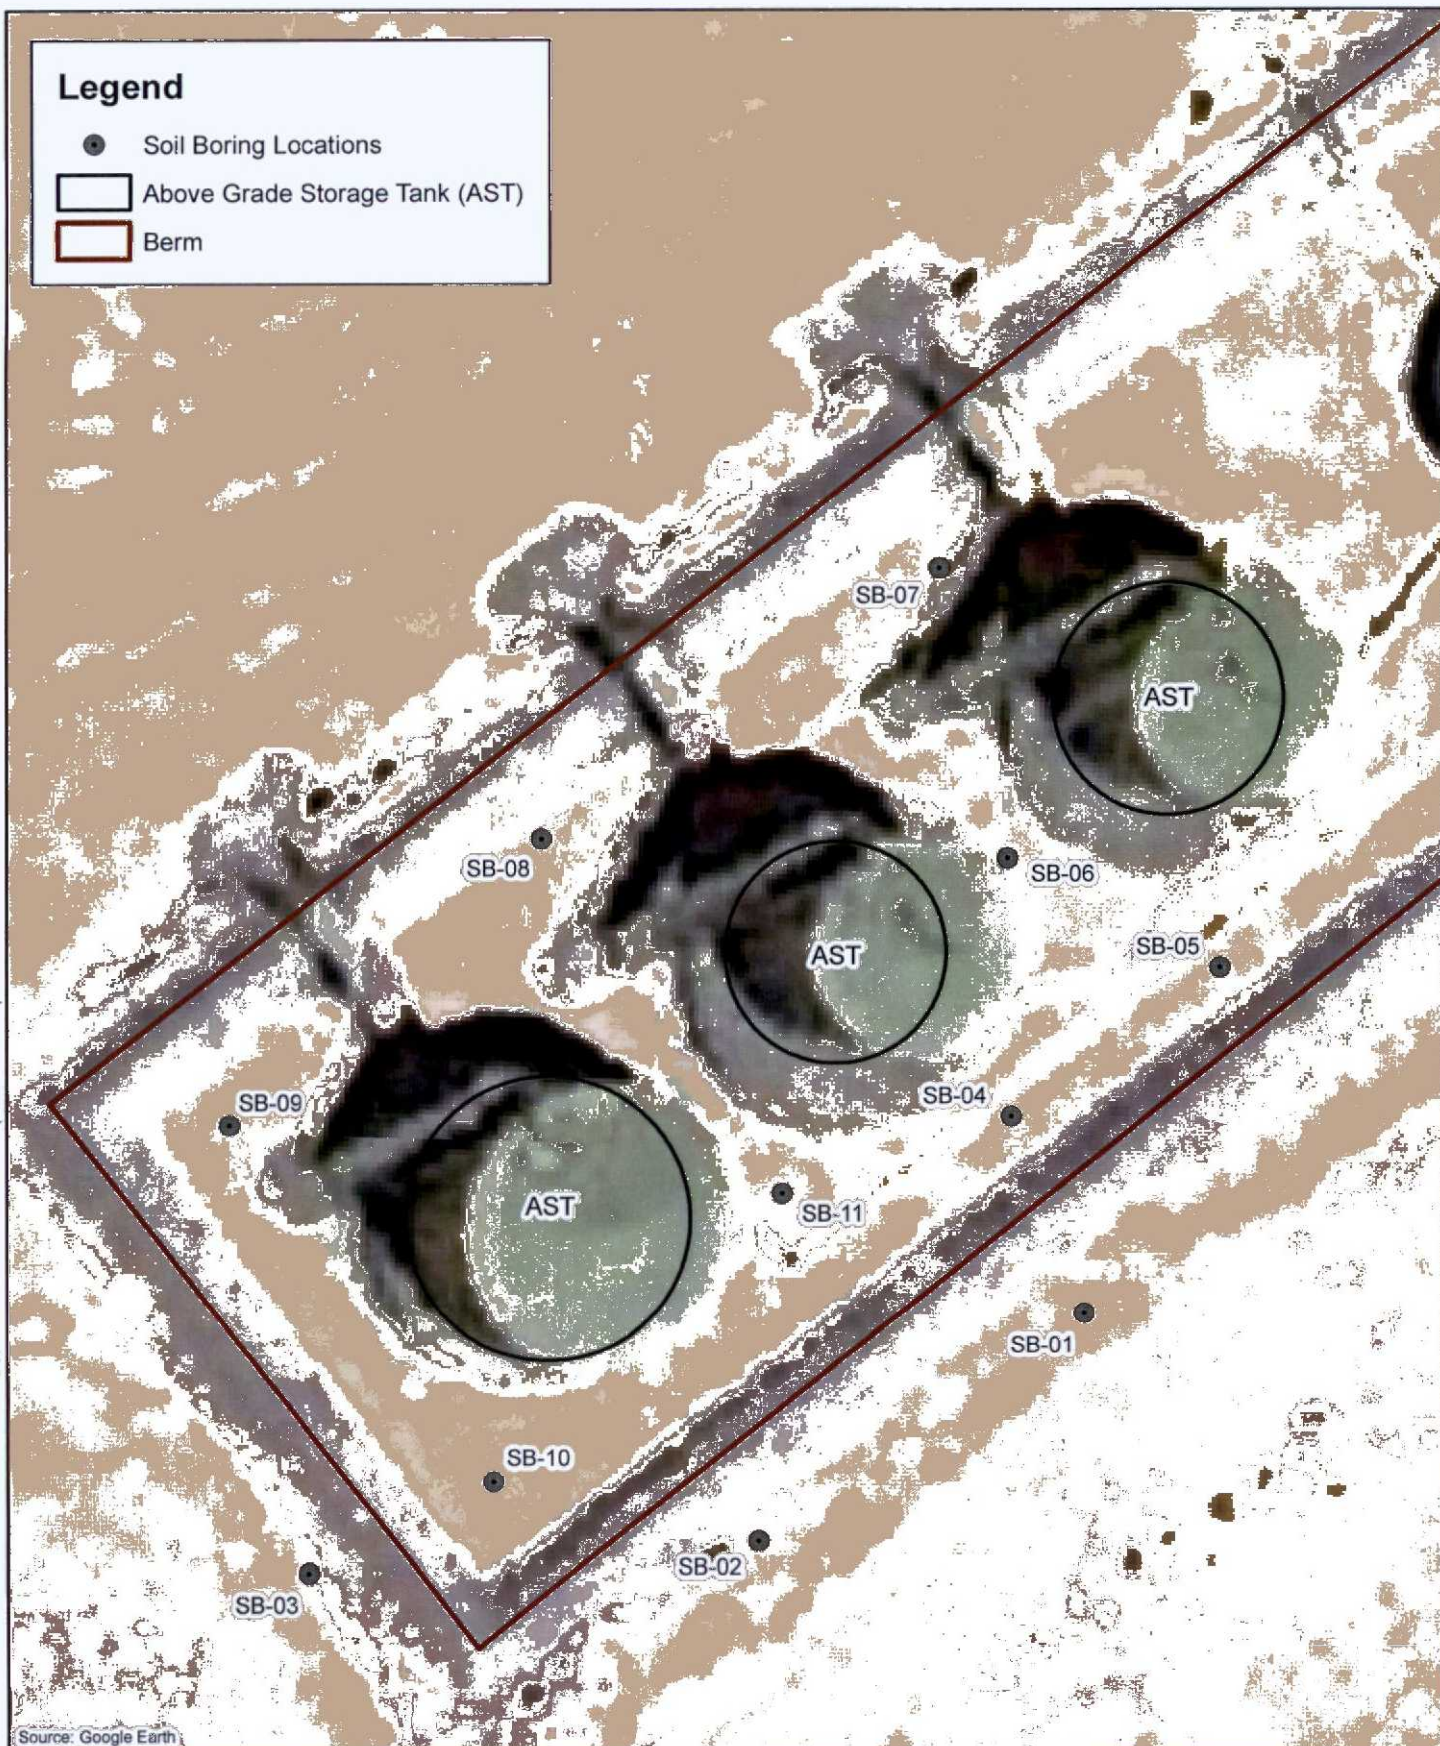
On February 24, 2016, Rule Engineering, LLC (Rule) personnel conducted a site assessment to delineate the extent of the release which included advancing 11 soil borings (SB-1 through SB-11) utilizing a hand auger. Soil borings were advanced to depths ranging from approximately 2 to 3.5 feet bgs where refusal was encountered on hard soils or sandstone. Boring locations are illustrated on Figure 3.

Field screening results for samples collected from soil borings SB-1 through SB-11 indicated VOC concentrations ranging from 0.1 ppm to 3,621 ppm. Field TPH results for samples collected from soil borings SB-1 through SB-11 indicated TPH concentrations ranging from below the reporting limit of 20 mg/kg to greater than 2,500 mg/kg. Field screening results are summarized in Table 2.

Laboratory analytical results for site assessment sample SB-6 at 3.25 feet reported concentrations of 2.7 mg/kg benzene, 214 mg/kg total BTEX, 2,200 mg/kg GRO, and 1,200 mg/kg DRO.

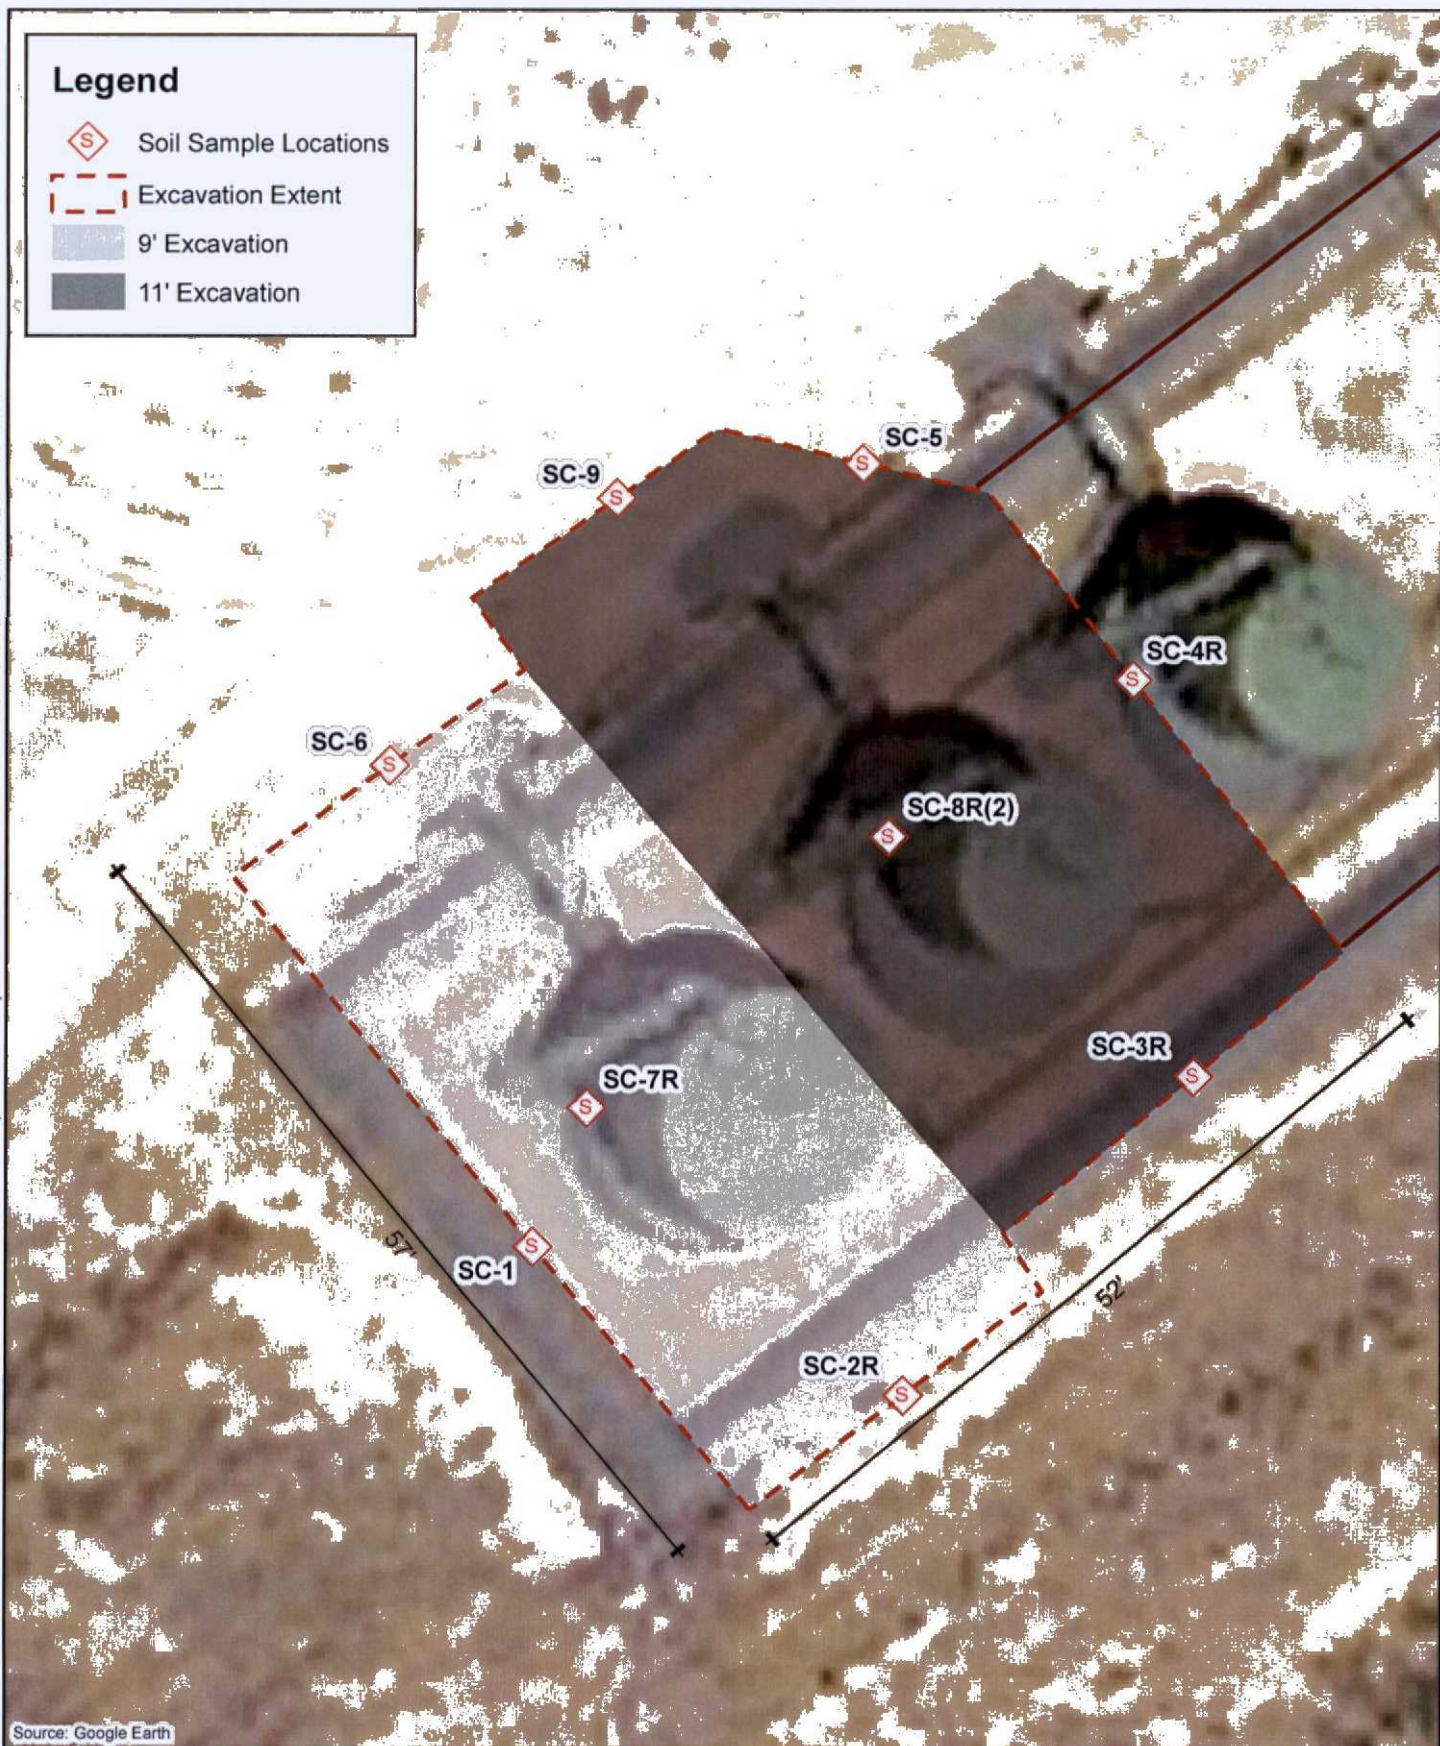
**Figure 4**  
**Excavation Confirmation**  
**Sample Location Map**  
San Juan 28-7 Unit 153E

On June 29, 2016, Rule personnel collected confirmation samples from the resultant excavation. Laboratory analysis indicated concentrations of total BTEX and/or TPH in excess of NMOCD action levels. Additional material was removed from the portions of the excavation represented by these samples, and resampling was conducted on July 14 through 15, 2016. Laboratory results again indicated concentrations in excess of NMOCD action levels, and following additional excavation of the north base, one additional sample was collected on August 11, 2016. The maximum extent of the final excavation measured approximately 57 feet by 53 feet by 9 to 11 feet in depth. Excavated hydrocarbon impacted soils and rock were transported to a local NMOCD approved landfarm for disposal/remediation and the excavation was backfilled with clean, imported material. A depiction of the final excavation with sample locations is included on Figure 4.

**Final Excavation Confirmation Samples:** Samples collected for final excavation confirmation include SC-1, SC-2R, SC-3R, SC-4R, SC-5, SC-6, SC-7R, SC-8R(2), and SC-9. Laboratory analytical results for final excavation confirmation samples reported benzene concentrations ranging from below the laboratory reporting limit to 0.4 mg/kg, which are below the NMOCD action level of 10 mg/kg. Total BTEX concentrations for the final excavation samples ranged from below the laboratory reporting limit to 58 mg/kg, which were below the NMOCD action level for all the final excavation confirmation samples except for SC-7R, which exceeded the NMOCD action level of 50 mg/kg. The area of the base represented by SC-7 and SC-7R showed a significant reduction in total BTEX concentrations subsequent to the removal of an additional one to two feet of sandstone from 152 mg/kg on June 29, 2016, as sampled as SC-7 to 58 mg/kg on August 11, 2016 as samples as SC-7R. Laboratory analytical results indicate that TPH

(GRO/DRO) concentrations range from below the laboratory reporting limit to 1,740 mg/kg, which are below the NMOCD action level of 5,000 for a site rank of 0.

Laboratory analytical results for final excavation confirmation samples (SC-1, SC-2R, SC-3R, SC-4R, SC-5, SC-6, SC-7R, SC-8R(2), and SC-9) reported benzene, total BTEX, and total TPH (GRO/DRO) concentrations below the applicable NMOCD action levels for a site rank of 0, except for sample SC-7R which exceeded the NMOCD action level for total BTEX. Total BTEX concentrations for the northeast portion of the sandstone base represented by sample SC-7 decreased significantly from 152 mg/kg as sampled on June 29, 2016 to 58 mg/kg as sampled as SC-7R on August 11, 2016, subsequent to the removal of an additional one to two feet of sandstone from the base. Excavated hydrocarbon impacted soils and rock were transported to a local NMOCD approved landfarm for disposal/remediation and the excavation was backfilled with clean, imported material.
