Pit, Below-Grade Tank, or
Proposed Alternative Method Permit or Closure Plan Application

1. Operator: Burlington Resources Oil & Gas Company, LP OGRID #: 14538
Address: PO BOX 4289, Farmington, NM 87499
Facility or well name: SAN JUAN 30-6 UNIT 101
API Number: 30-039-07731 OCD Permit Number: _____
U/L or Qtr/Qtr H Section 35 Township 30N Range 7W County: Rio Arriba
Center of Proposed Design: Latitude 36.77133 °N Longitude -107.53467 °W NAD: ☐ 1927 ☒ 1983
Surface Owner: ☒ Federal ☐ State ☐ Private ☐ Tribal Trust or Indian Allotment

Burlington Resources Oil & Gas Company, LP
San Juan Basin
Below Grade Tank Closure Report

Lease Name: San Juan 30-6 Unit 101
API No.: 30-039-07731

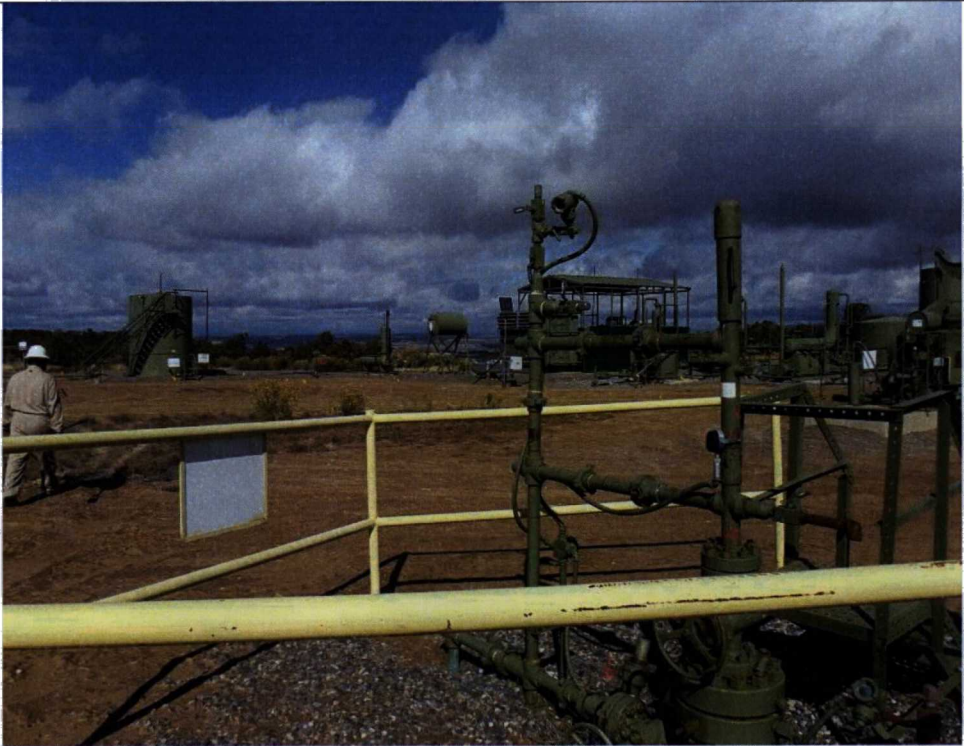
Photo #1

Client: ConocoPhillips	
Project Name: San Juan 30-6 Unit 101 P&A	
Rio Arriba County, NM	
Date Photo Taken: October 25, 2016	
BGT GPS and Location: 36.77133, -107.53467 SE¼ NE¼, Section 35, T30N, R7W	
Taken by: Corwin Lameman, AES	Subject: BGT sampling, October 2016
	Description: Facing W, overview of entire location.

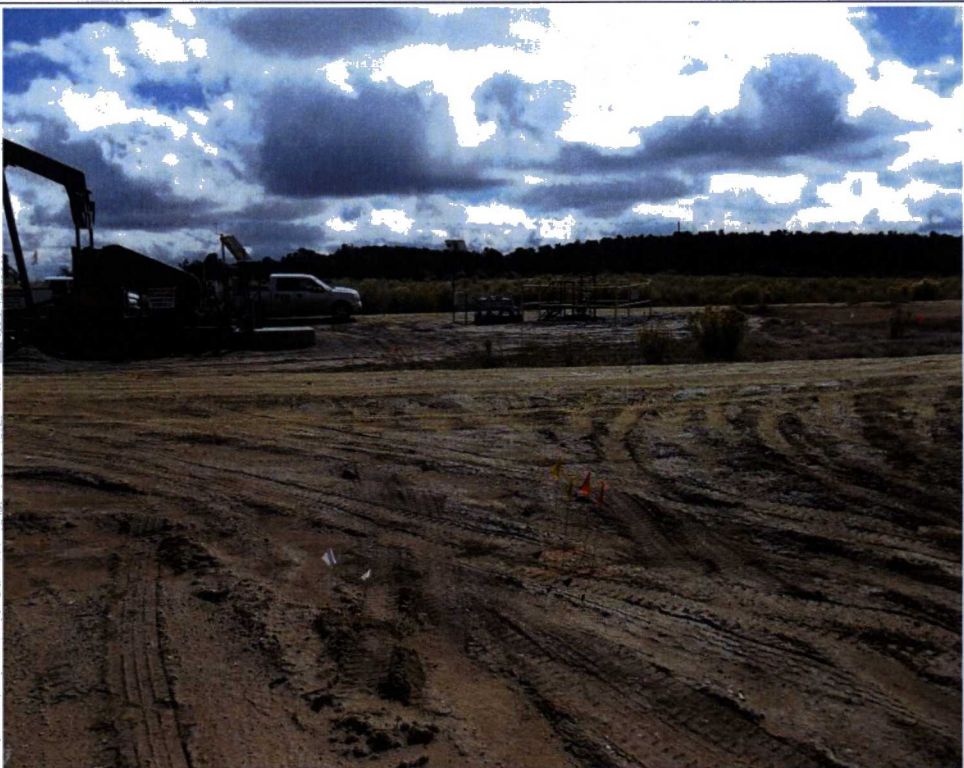
Photo #2

Client: ConocoPhillips	
Project Name: San Juan 30-6 Unit 101 P&A	
Rio Arriba County, NM	
Date Photo Taken: October 25, 2016	
BGT GPS and Location: 36.77133, -107.53467 SE¼ NE¼, Section 35, T30N, R7W	
Taken by: Corwin Lameman, AES	Subject: BGT sampling, October 2016
	Description: Facing E, sample location.

A five point composite sample was taken of the below-grade tank using sampling tools and all samples tested per Subsection B of 19.15.17.1 3(B)(1)(b). (Sample results attached). Form C-141 is attached.
