Pit, Below-Grade Tank, or
Proposed Alternative Method Permit or Closure Plan Application

Facility or well name: SAN JUAN 27-4 UNIT 82

API Number: 30-039-20823

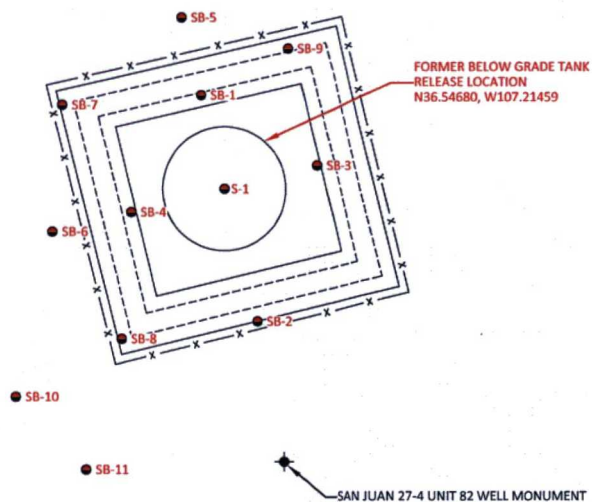
On May 24, 2016, AES personnel completed the release assessment field work. The assessment included collection and field sampling of 37 soil samples from 11 soil borings (SB-1 through SB-11). Based on field sampling results, AES recommended excavation of the release area. Sample locations are shown on Figure 3.

Field Screening Results				
Sample ID	Date	Depth (ft)	OV/M-PID (ppm)	TPH (mg/kg)
		NMOC ACTION LEVEL		100
SB-1	5/24/16	0.5	0.0	NA
		2	0.0	NA
		3.5	0.0	34.5
		5	2,475	NA
		6	2,810	2,110
SB-2	5/24/16	0.5	0.0	NA
		2	0.0	NA
		3.5	0.0	36.2
		4.5	18.9	79.7
		0.5	0.0	NA
SB-3	5/24/16	2	0.0	NA
		4	90.1	76.4
		0.5	0.0	NA
		2	0.0	NA
		3.5	2,274	NA
SB-4	5/24/16	4	2,329	5,220
		0.5	0.9	NA
		2	0.0	NA
		4	0.0	<20.0
		0.5	0.0	NA
SB-6	5/24/16	2	0.0	NA
		3.5	1.1	NA
		5	0.0	<20.0
		0.5	0.0	NA
		4.0	0.0	<20.0
SB-8	5/24/16	0.5	0.0	NA
		2	0.0	NA
		3.5	3,858	805
		0.5	0.0	NA
		2	0.0	NA
SB-9	5/24/16	3.5	0.0	24.4
		0.5	0.0	NA
		2	0.0	21.1
		0.5	0.0	NA
		2	0.0	NA
SB-11	5/24/16	3.5	0.0	22.8
		0.5	0.0	NA
		2	0.0	NA
		0.5	0.0	NA
		2	0.0	NA

In May 2016, release assessment field sampling results above the NMOCD action level of 100 ppm VOCs and 100 mg/kg TPH were reported in SB-1, SB-4 and SB-8. The highest VOC concentration was reported in SB-8 with 3,858 ppm, and the highest TPH concentration was reported in SB-4 with 5,220 mg/kg. Excavation of the release area was recommended.

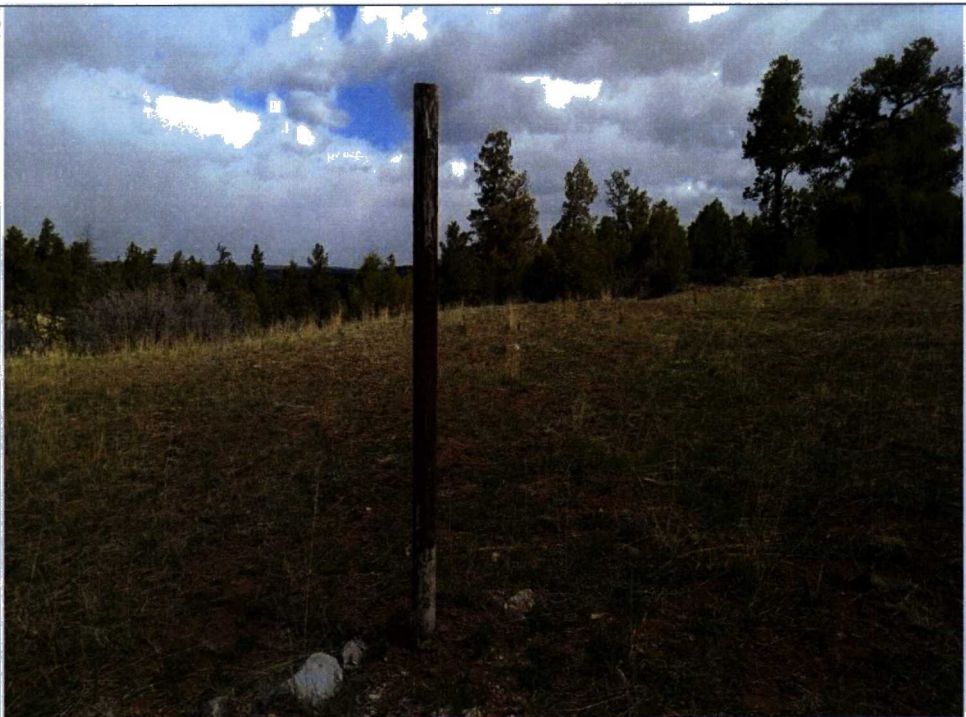
Photo #1

Client: ConocoPhillips	
Project Name: San Juan 27-4 Unit 82 Rio Arriba County, NM	
Date Photo Taken: April 26, 2016	
BGT GPS and Location: 36.5468, -107.21459 SE¼ NE¼, Section 26, T27N, R4W	
Taken by: Delilah Dougi, AES	
Subject: BGT sampling, April 2016	
Description: Facing N, overview of entire location.

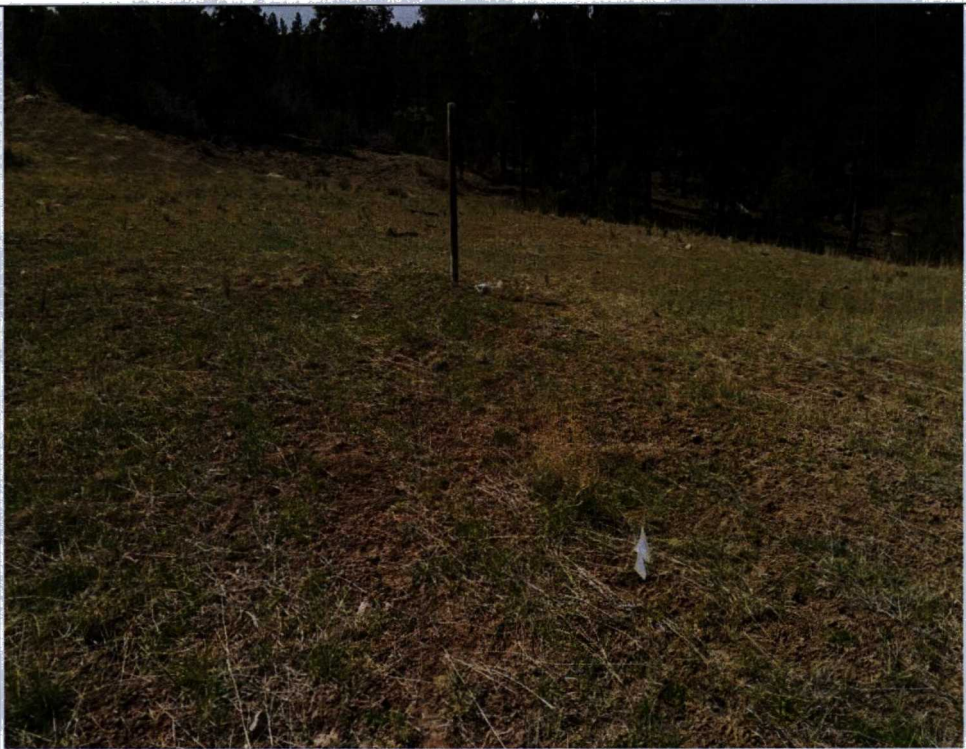
Photo #2

Client: ConocoPhillips	
Project Name: San Juan 27-4 Unit 82 Rio Arriba County, NM	
Date Photo Taken: April 26, 2016	
BGT GPS and Location: 36.5468, -107.21459 SE¼ NE¼, Section 26, T27N, R4W	
Taken by: Delilah Dougi, AES	
Subject: BGT sampling, April 2016	
Description: Facing S, sample location.
