Pit, Below-Grade Tank, or
Proposed Alternative Method Permit or Closure Plan Application

**ConocoPhillips Company
San Juan Basin
Below Grade Tank Closure Report**

Lease Name: SAN JUAN 28-7 UNIT 32A

API No.: 30-039-22240

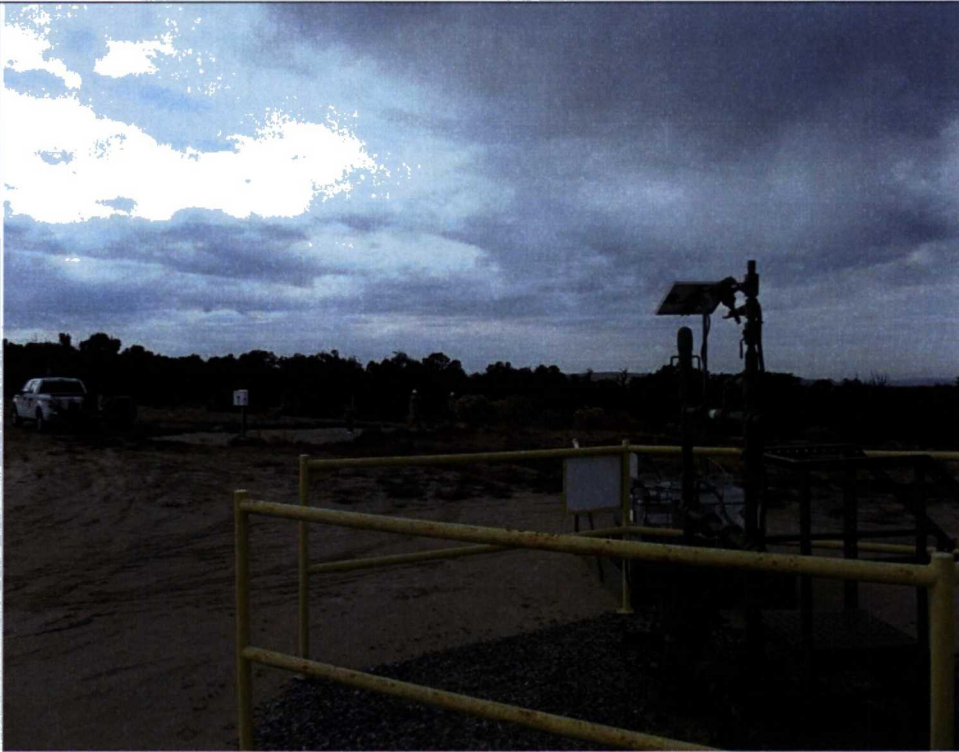
Photo #1

Client: ConocoPhillips	
Project Name: San Juan 28-7 Unit 32A	
Rio Arriba County, NM	
Date Photo Taken: October 24, 2016	
BGT GPS and Location: 36.65076, -107.61804	
NE¼ NW¼, Section 19, T28N, R7W	
Taken by: Corwin Lameman, AES	Subject: BGT sampling, October 2016
	Description: Facing W, overview of entire location.

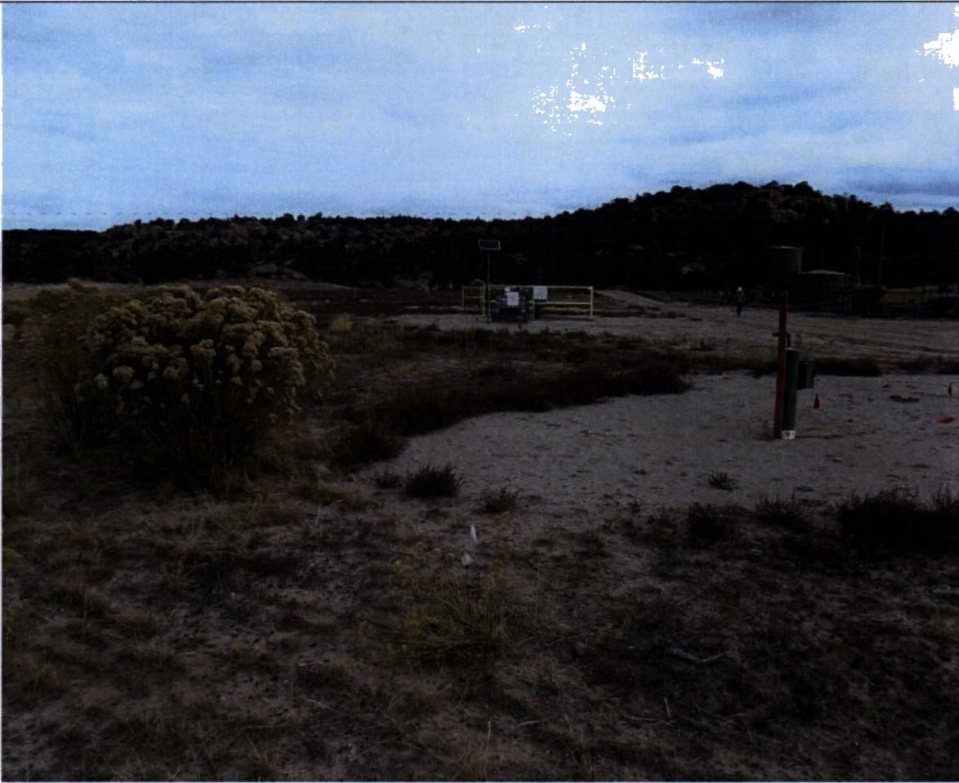
Photo #2

Client: ConocoPhillips	
Project Name: San Juan 28-7 Unit 32A	
Rio Arriba County, NM	
Date Photo Taken: October 24, 2016	
BGT GPS and Location: 36.65076, -107.61804	
NE¼ NW¼, Section 19, T28N, R7W	
Taken by: Corwin Lameman, AES	Subject: BGT sampling, October 2016
	Description: Facing NE, sample location.

A five point composite sample was taken of the below-grade tank using sampling tools and all samples tested per Subsection B of 19.15.17.1 3(B)(1)(b). (Sample results attached). Form C-141 is attached.
