Pit, Below-Grade Tank, or
Proposed Alternative Method Permit or Closure Plan Application

**ConocoPhillips Company
San Juan Basin
Below Grade Tank Closure Report**

Lease Name: San Juan 30-5 Unit 71F

API No.: 30-039-30366

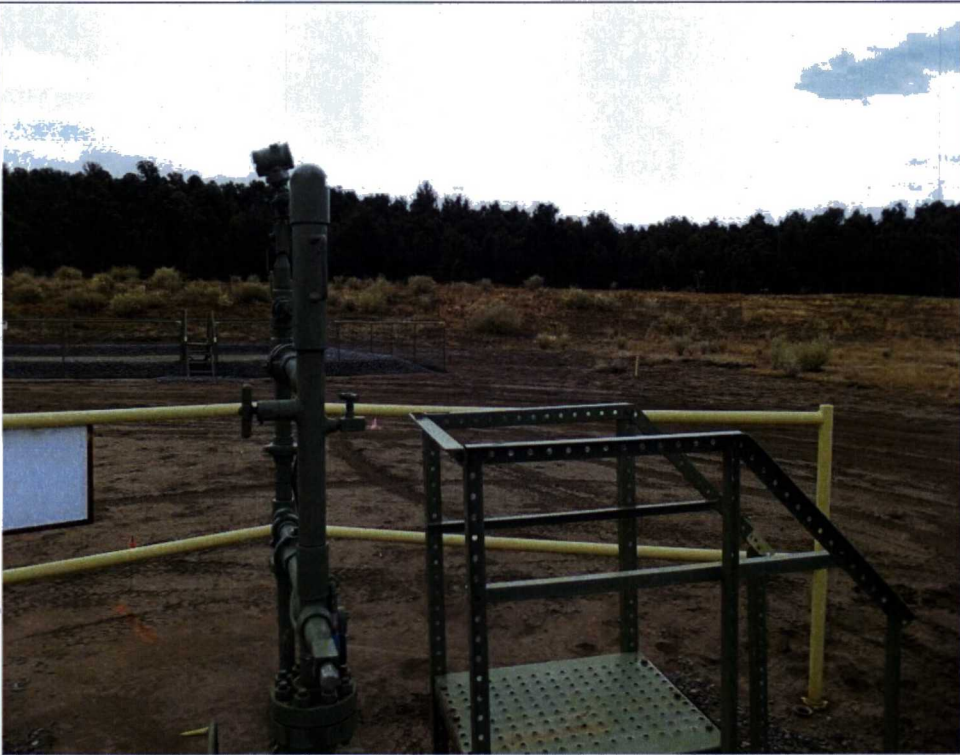
Photo #1

Client: ConocoPhillips	
Project Name: San Juan 30-5 Unit 71F	
Rio Arriba County, NM	
Date Photo Taken: October 25, 2016	
BGT GPS and Location: 36.80379, -107.34568	
NE¼ NW¼, Section 22, T30N, R5W	
Taken by: Corwin Lameman, AES	Subject: BGT sampling, October 2016
	Description: Facing S, overview of entire location.

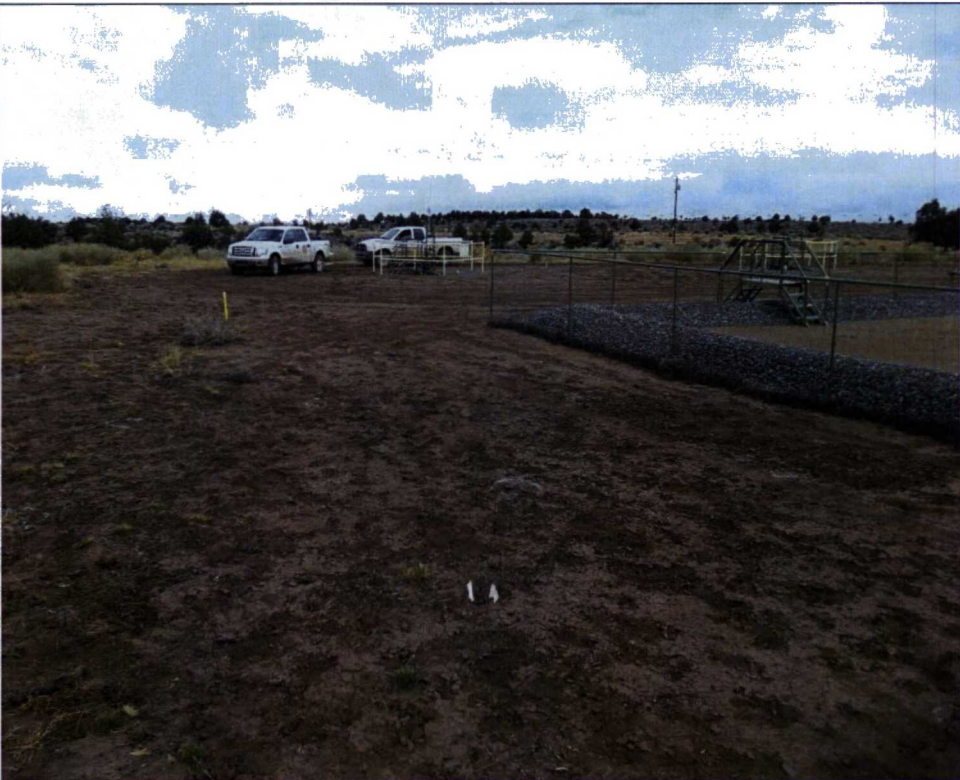
Photo #2

Client: ConocoPhillips	
Project Name: San Juan 30-5 Unit 71F	
Rio Arriba County, NM	
Date Photo Taken: October 25, 2016	
BGT GPS and Location: 36.80379, -107.34568	
NE¼ NW¼, Section 22, T30N, R5W	
Taken by: Corwin Lameman, AES	Subject: BGT sampling, October 2016
	Description: Facing N, sample location.

A five point composite sample was taken of the below-grade tank using sampling tools and all samples tested per Subsection B of 19.15.17.1 3(B)(1)(b). (Sample results attached). Form C-141 is attached.
