Pit, Below-Grade Tank, or
Proposed Alternative Method Permit or Closure Plan Application

**Burlington Resources Oil & Gas Company, LP
San Juan Basin
Below Grade Tank Closure Report**

**Lease Name: Aztec A 1A
API No.: 30-045-29483**

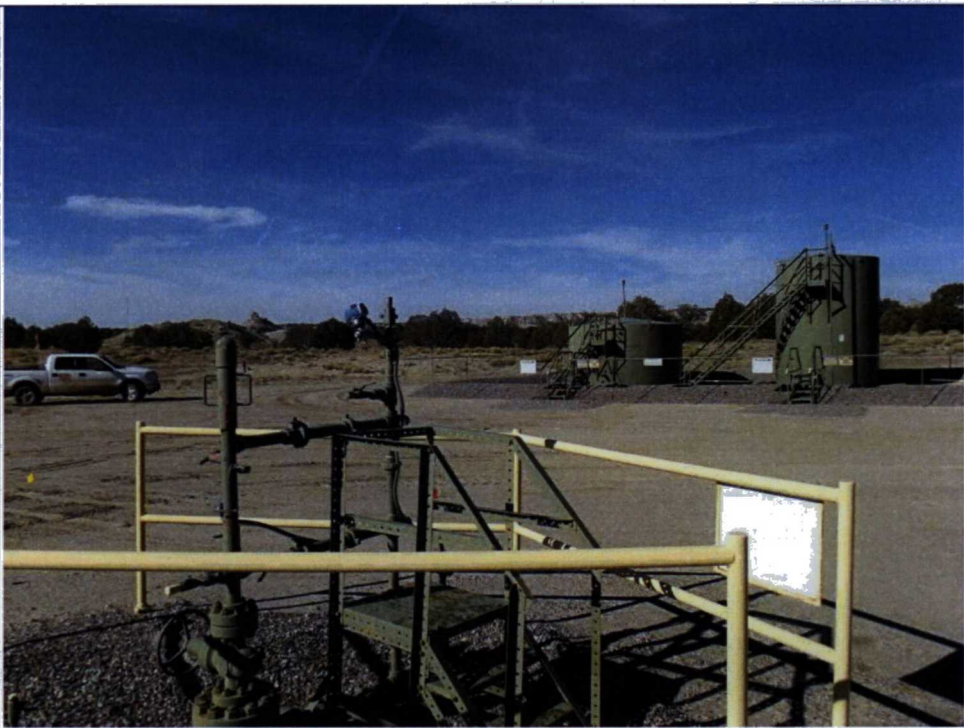
Photo #1

Client: ConocoPhillips	
Project Name: Aztec a 1A San Juan County, NM	
Date Photo Taken: October 27, 2016	
BGT GPS and Location: 36.88112, -107.97277 NE¼ SE¼, Section 22, T31N, R11W	
Taken by: Corwin Lameman, AES	
Subject: BGT sampling, October 2016	
Description: Facing W, overview of entire location.

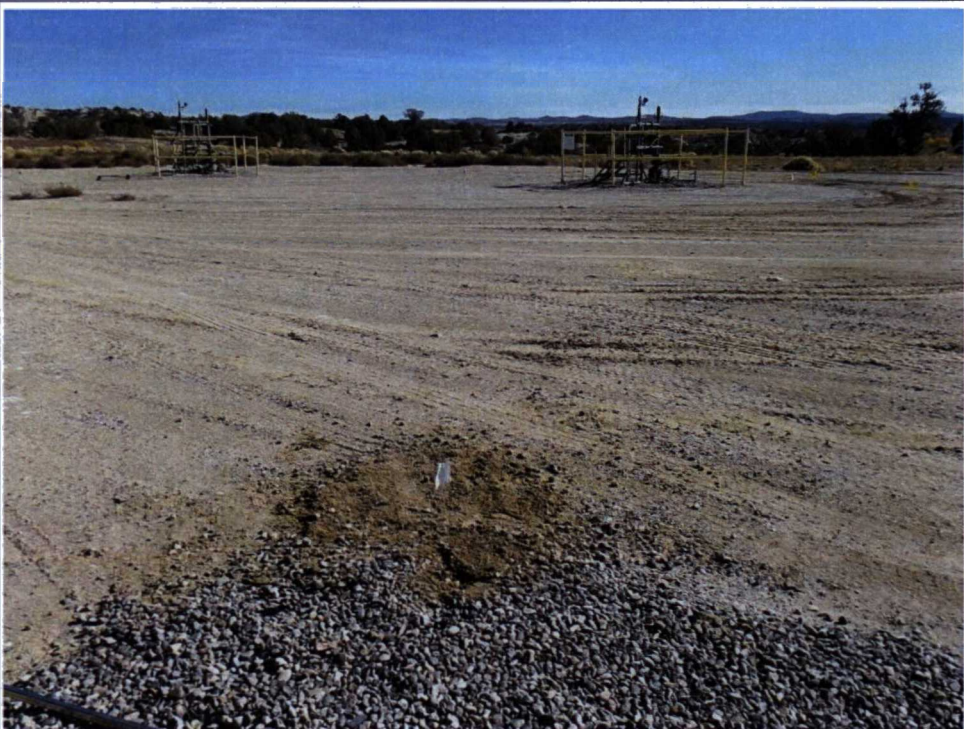
Photo #2

Client: ConocoPhillips	
Project Name: Aztec a 1A San Juan County, NM	
Date Photo Taken: October 27, 2016	
BGT GPS and Location: 36.88112, -107.97277 NE¼ SE¼, Section 22, T31N, R11W	
Taken by: Corwin Lameman, AES	
Subject: BGT sampling, October 2016	
Description: Facing E, sample location.

A five point composite sample was taken of the below-grade tank using sampling tools and all samples tested per Subsection B of 19.15.17.1 3(B)(1)(b). (Sample results attached). Form C-141 is attached.
